Maisonettes

Golden Lane Windows Project

This document has been prepared by Studio Partington on behalf of the City of London Corporation. It explores several possible approaches for improvements to the condition and performance of windows in the Maisonette blocks. Please note that Basterfield, Bayer, Bowater, Cuthbert Harrowing and Hatfield House are grouped together and referred to as the 'Maisonettes' within this study.

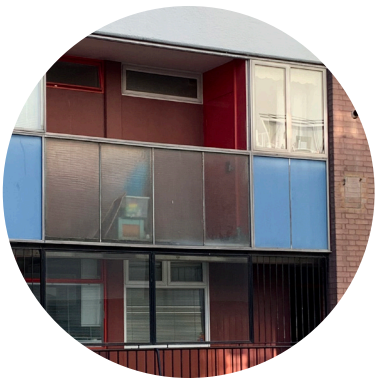
Right: a number of timber windows look to have been replaced with uPVC windows, confirming issues with condition or thermal comfort, or both.

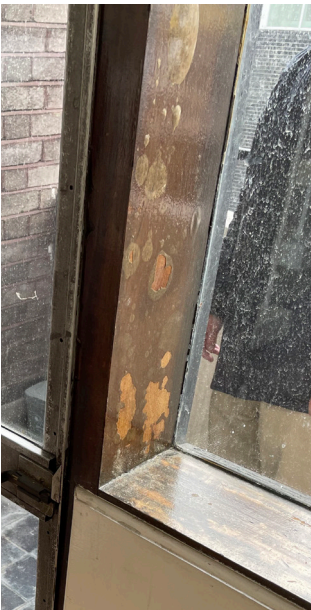
Protective coating on timber frame

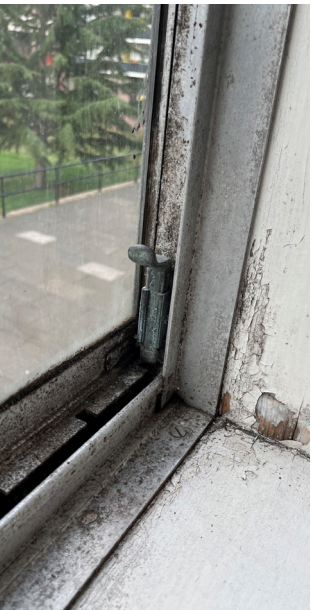
Oxidisation of the aluminium frames internally and externally (sliding). Peeling paintwork to timber reveal

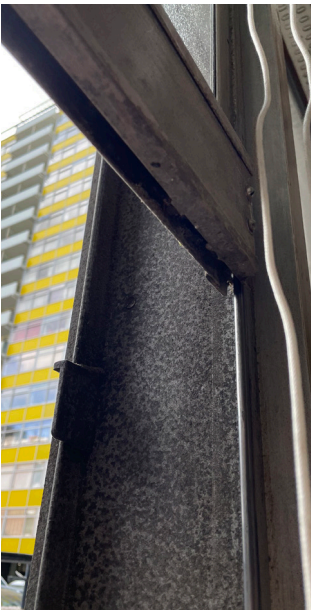
Oxidisation of the aluminium frames internally and externally (door system)

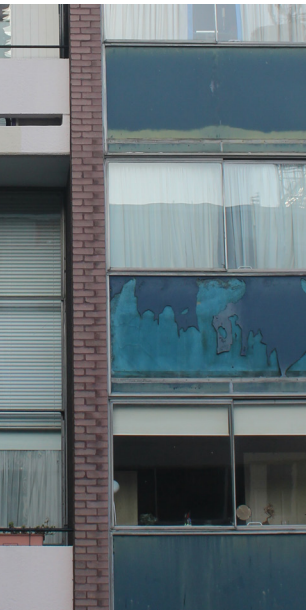
The Muroglass panels are most significantly deteriorated or damaged on the south elevations. There is also evidence that faded panels have been painted ad-hoc. It is worth noting that deterioration of the hardwood frames has occurred on the interior side of the windows, suggesting that the damage has been caused by condensation, rather than exposure to the elements externally.

Damage/deterioration of the Muroglass spandrel panels. Many are faded or have been replaced with a poor colour match
