6.4 Refurbishment

CRESCENT HOUSE PILOT PROJECT

Airtightness Testing

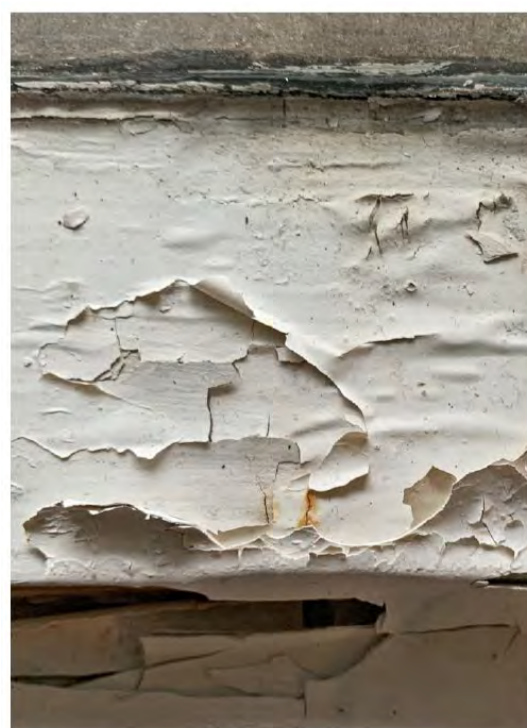
Paintwork deteriorating on timber frame/sill (internal). Evidence of mould growth.

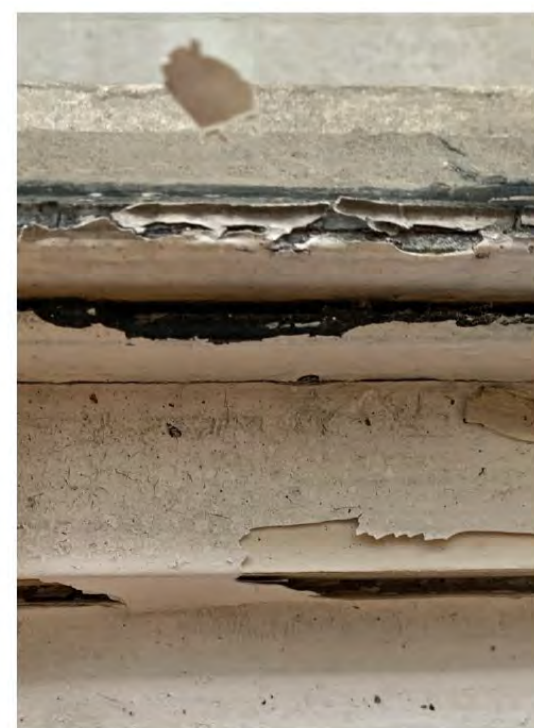
Paintwork deteriorating on timber frame/sill and steel opening lights (internal).

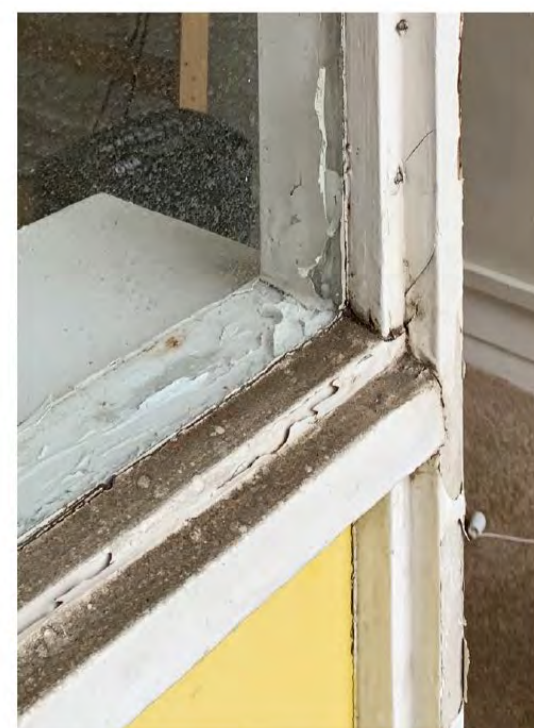
Paintwork deteriorating on timber frame/sill (internal and external).

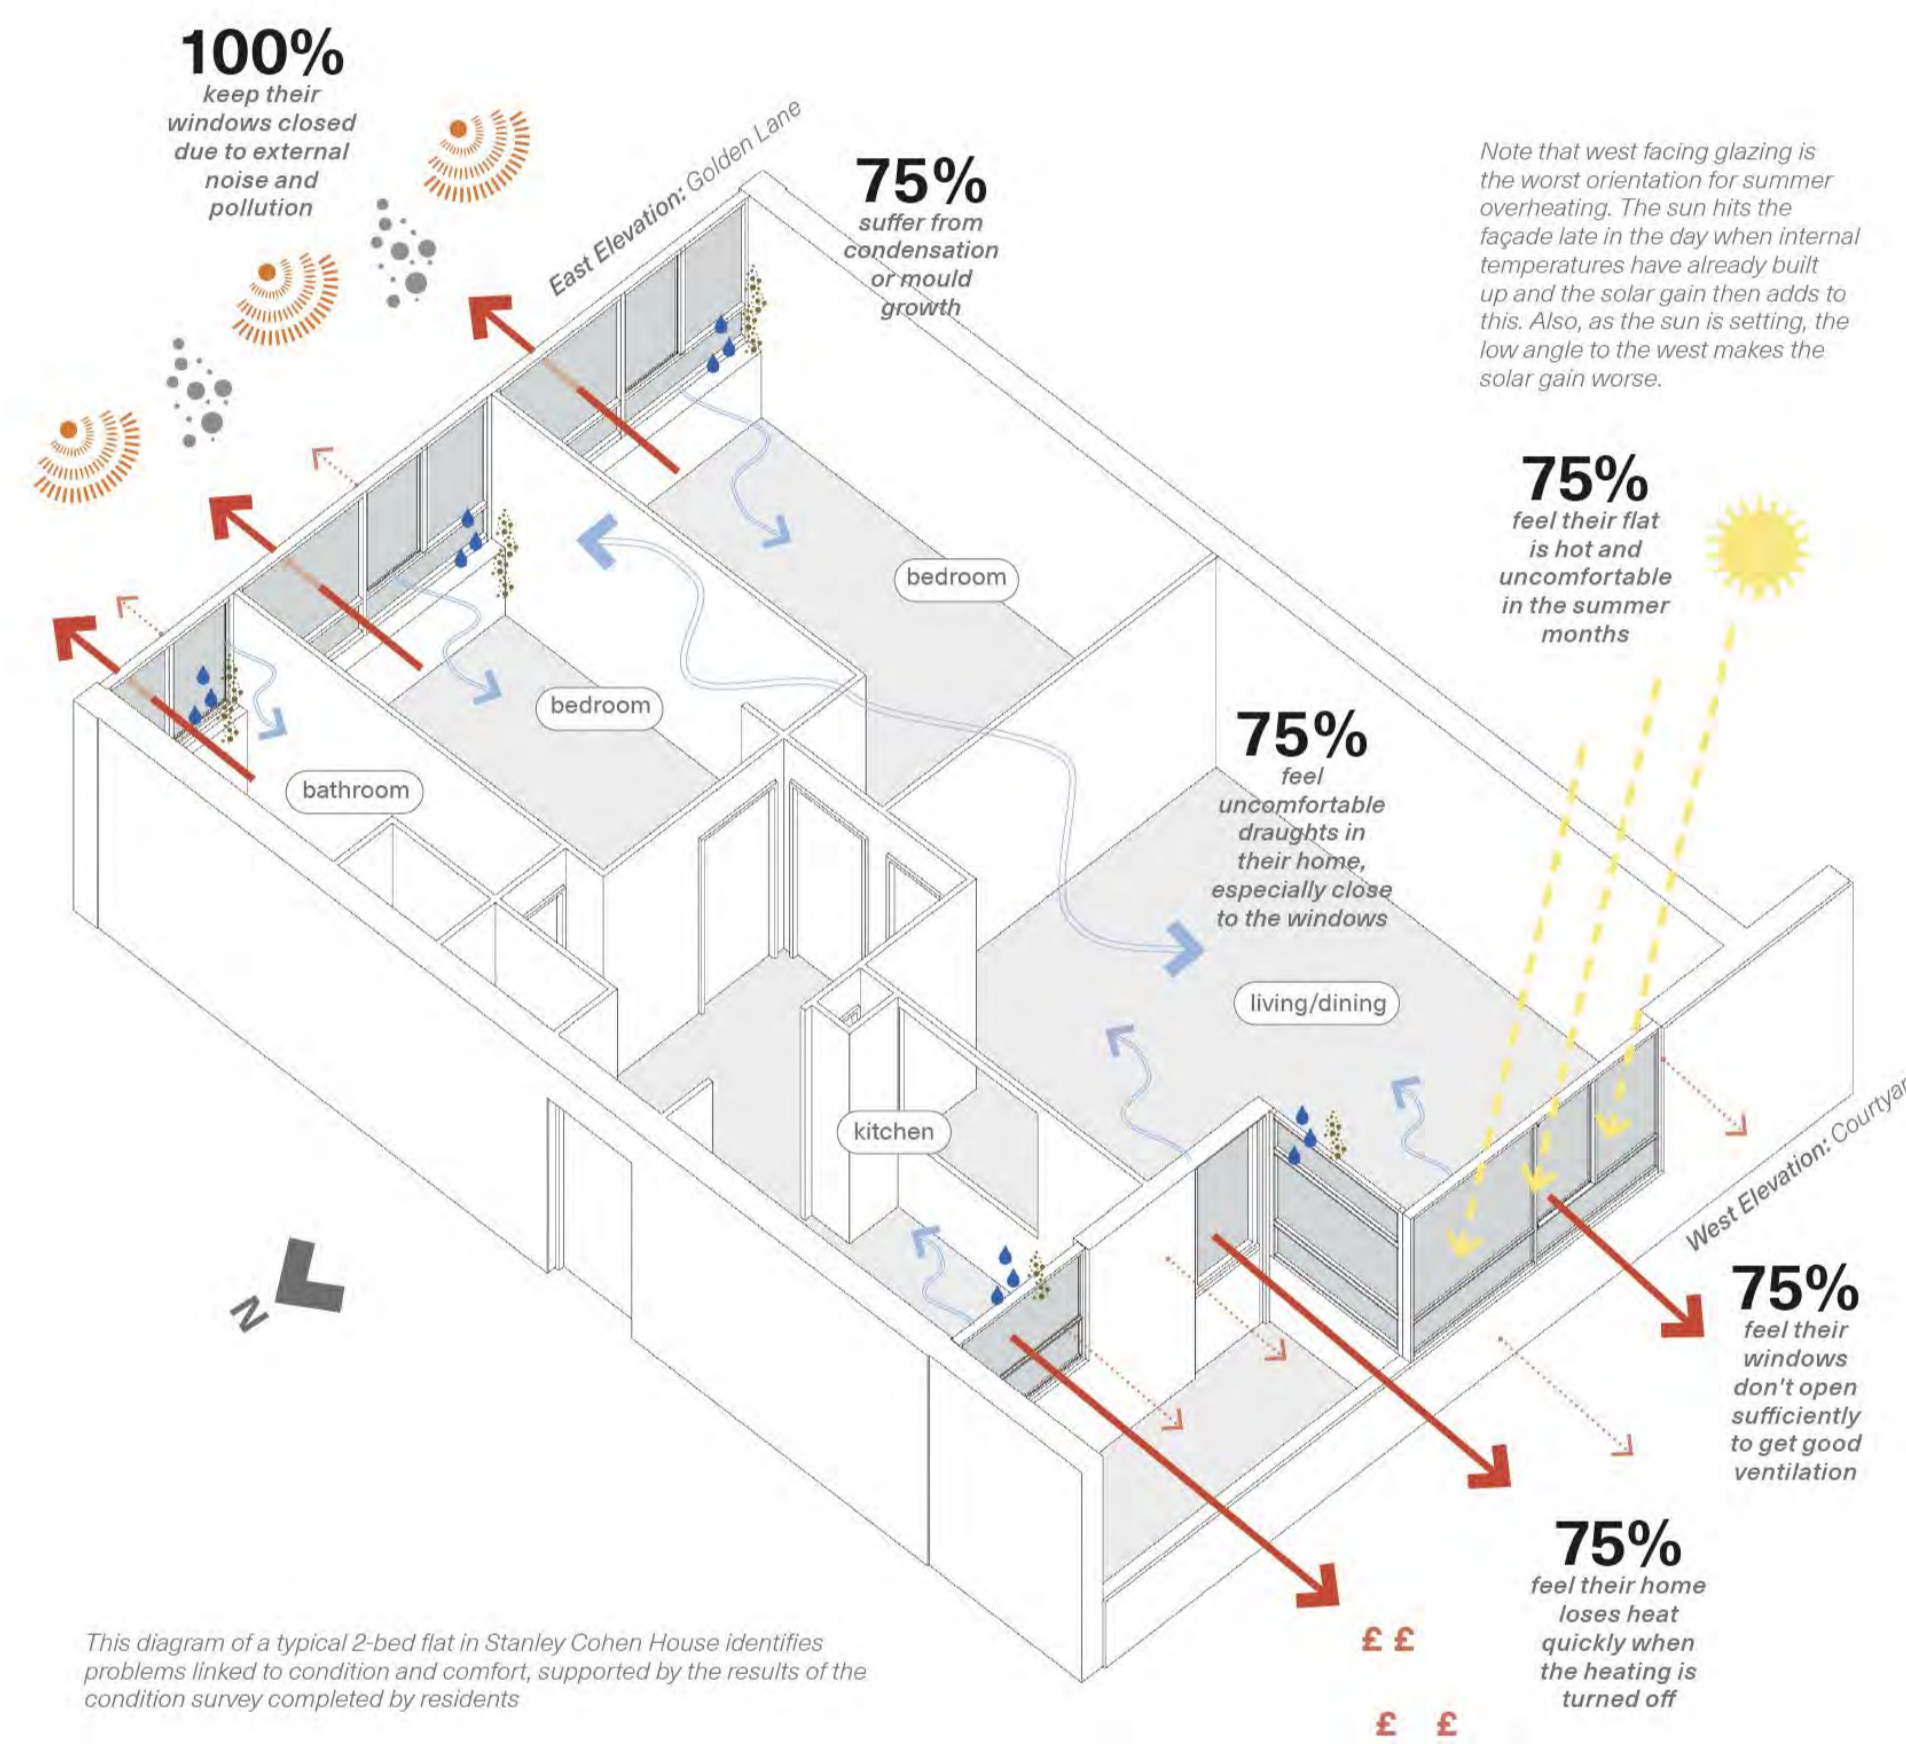
This diagram of a typical 2-bed flat in Stanley Cohen House identifies problems linked to condition and comfort, supported by the results of the condition survey completed by residents

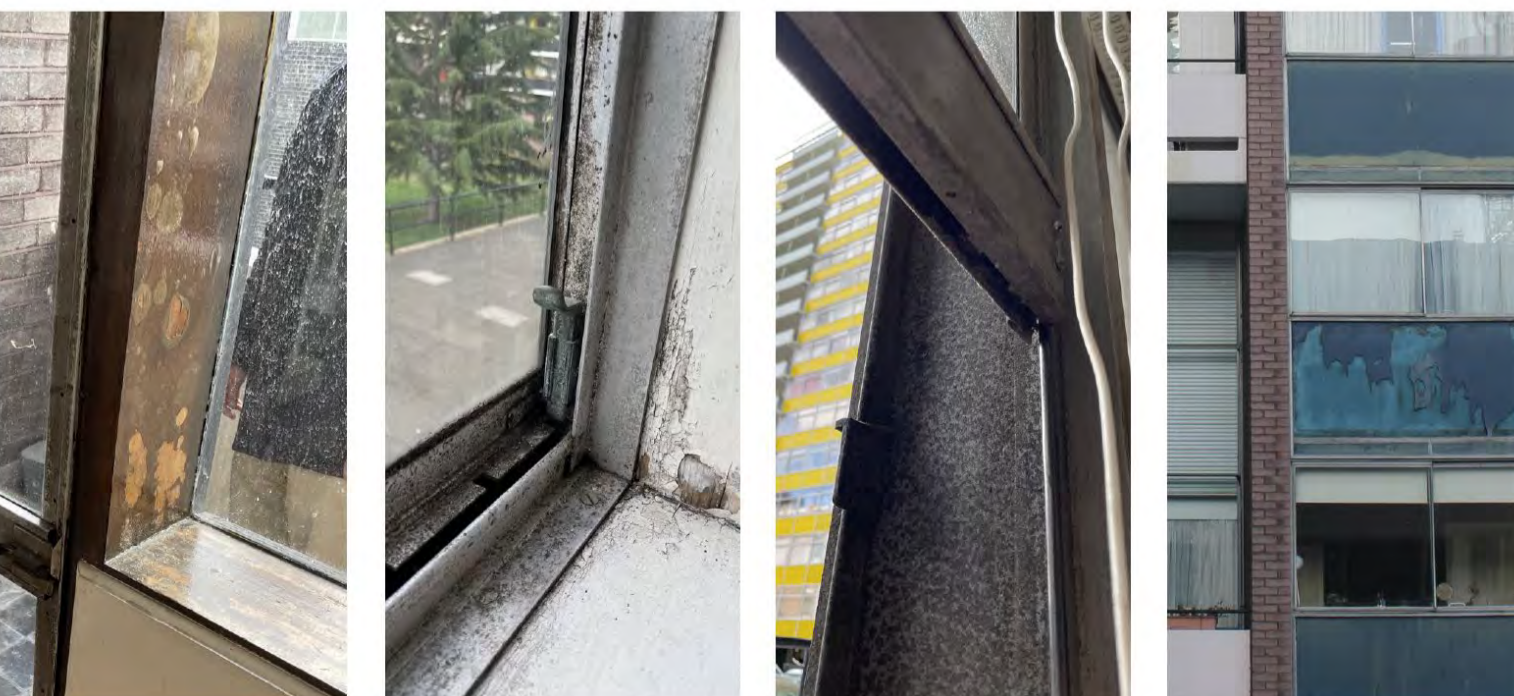
Protective coating on timber frame Oxidisation of the aluminium frames internally and externally (sliding). Peeling paintwork to timber reveal Oxidisation of the aluminium frames internally and externally (door system) Damage/deterioration of the Miroglass spandrel panels. Many are faded or have been replaced with a poor colour match

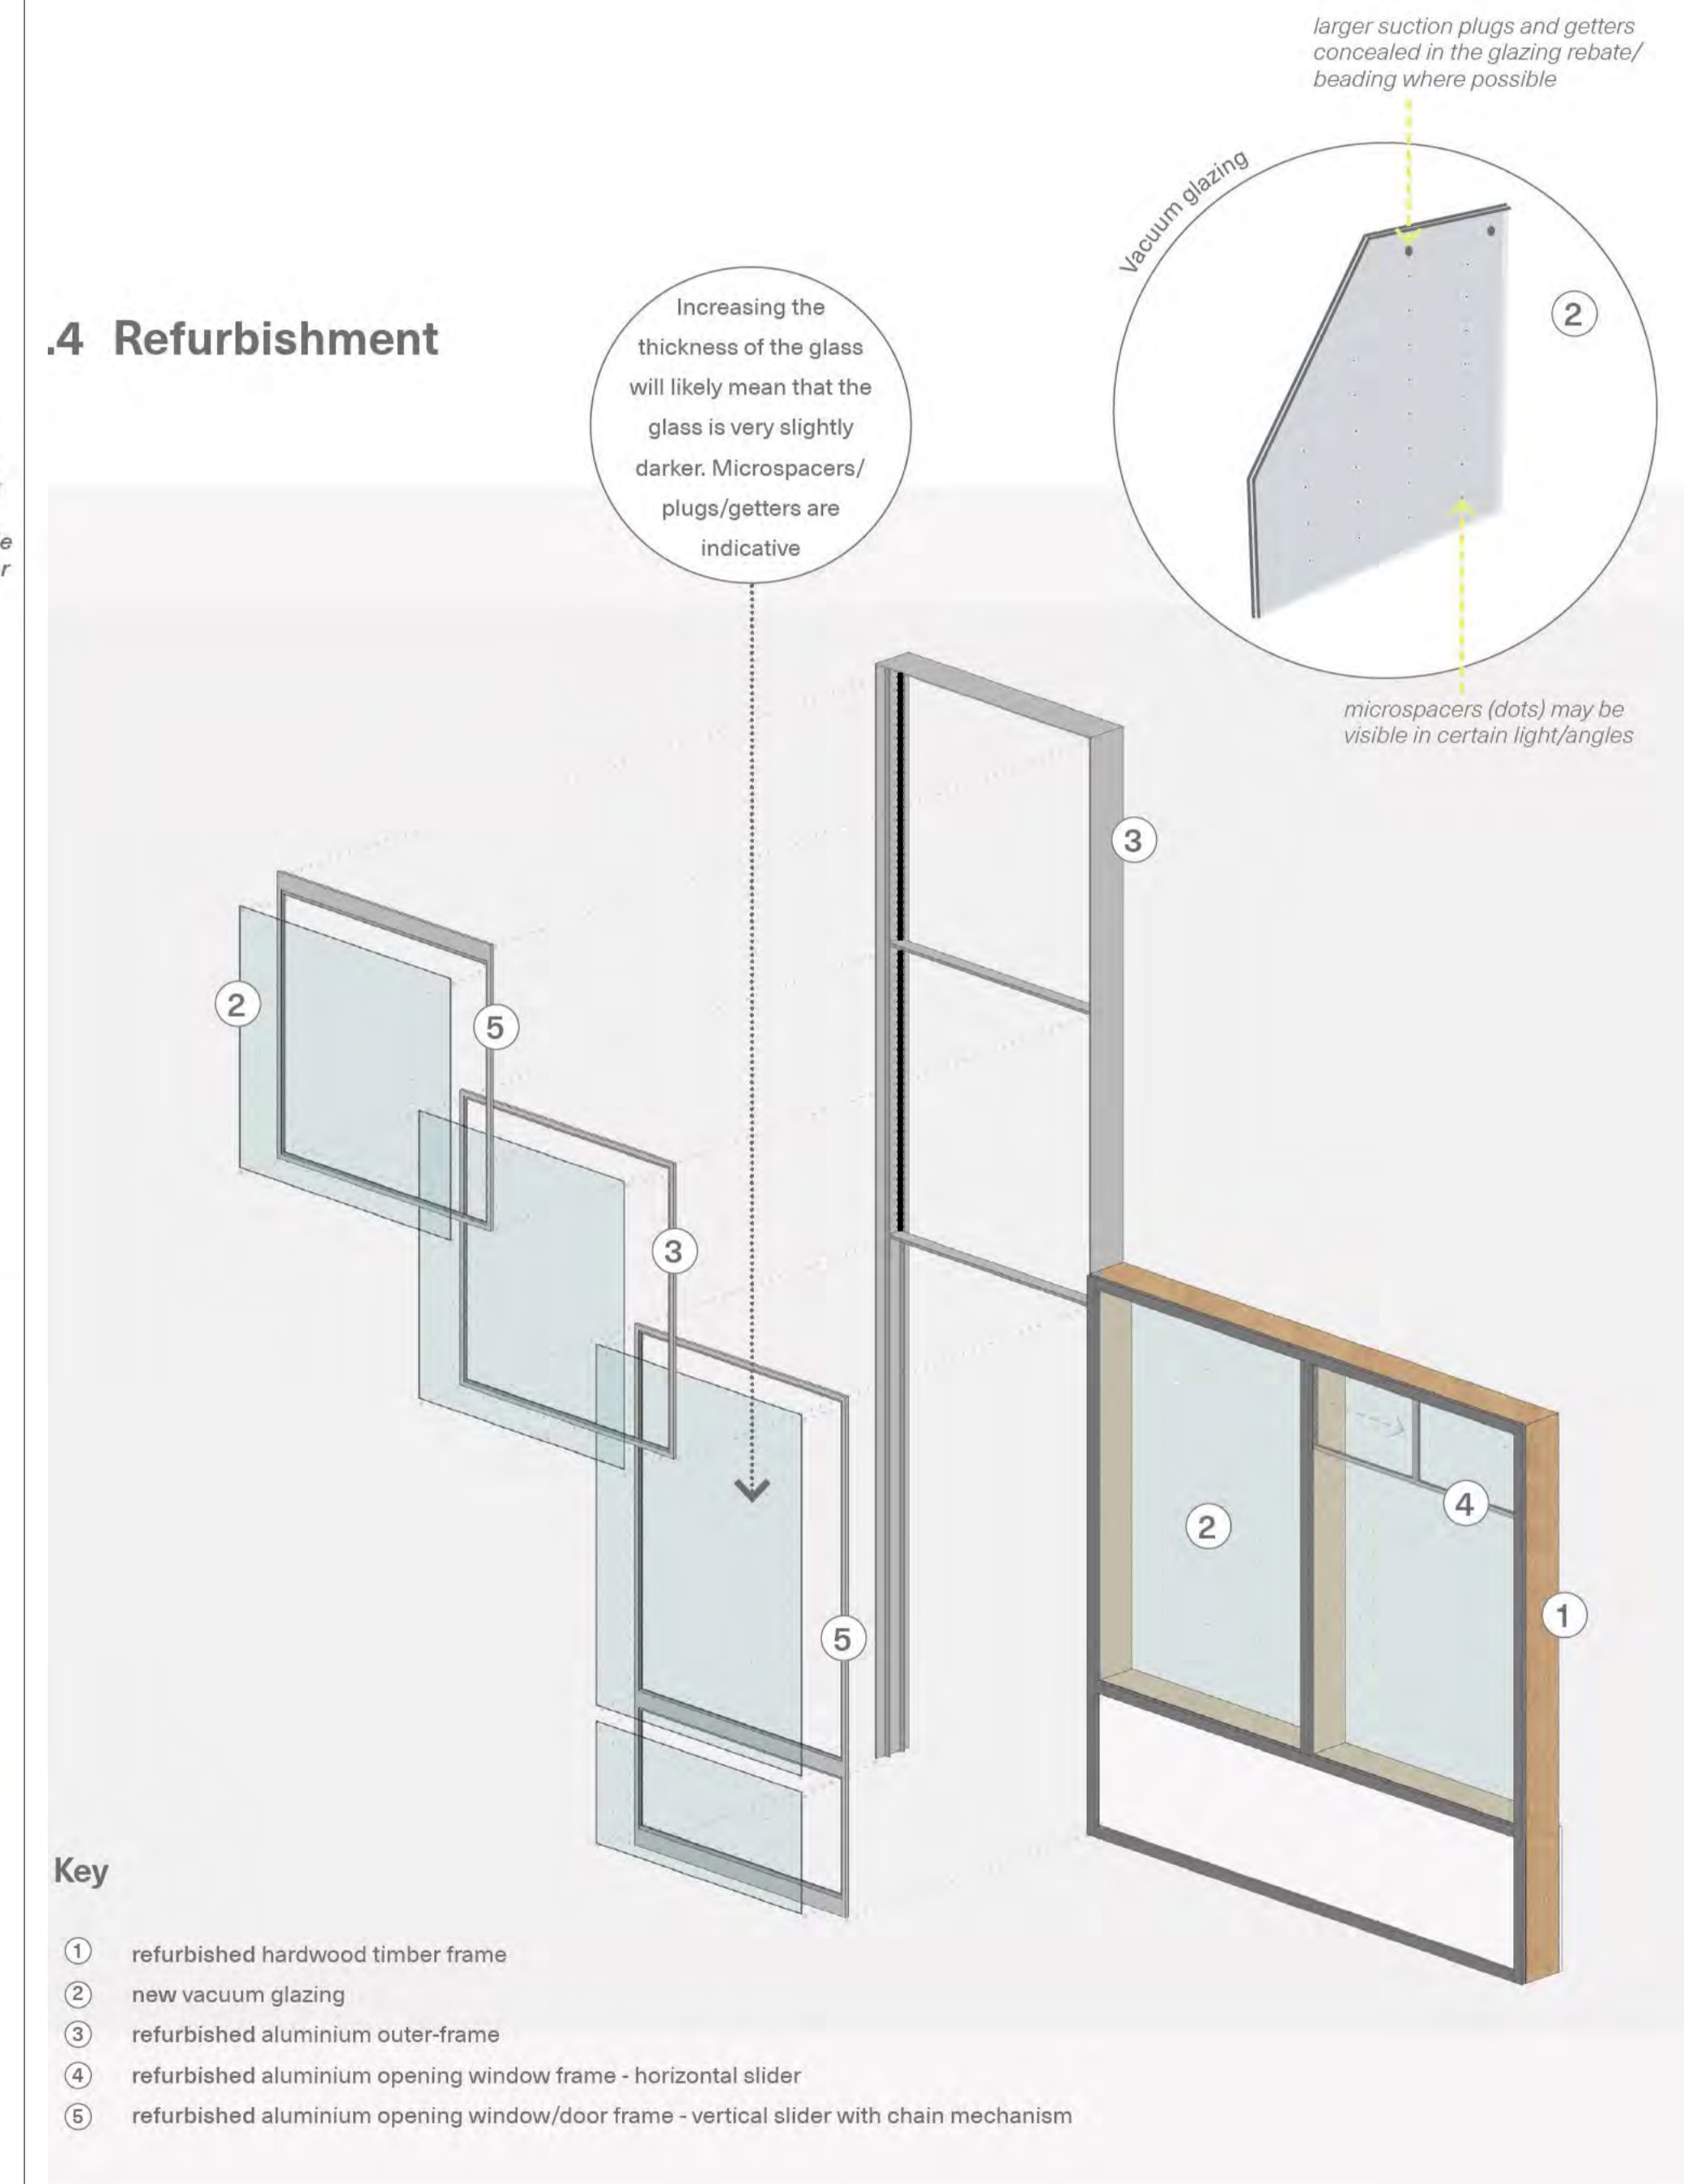
This drawing highlights the different elements of a typical, refurbished window in one of the Maisonette blocks. The principles can be applied to all windows in the block, apart from the north facing softwood window (these are described as significant in heritage terms). Principally, the vast majority of the

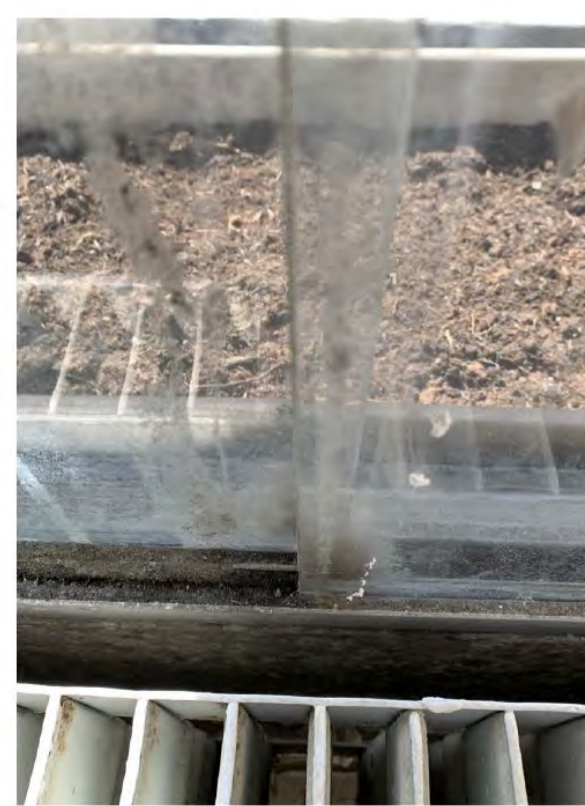
The original sliding aluminium bar appears to be missing on some of the unframed sliding windows, leaving a gap for warm to escape out of.

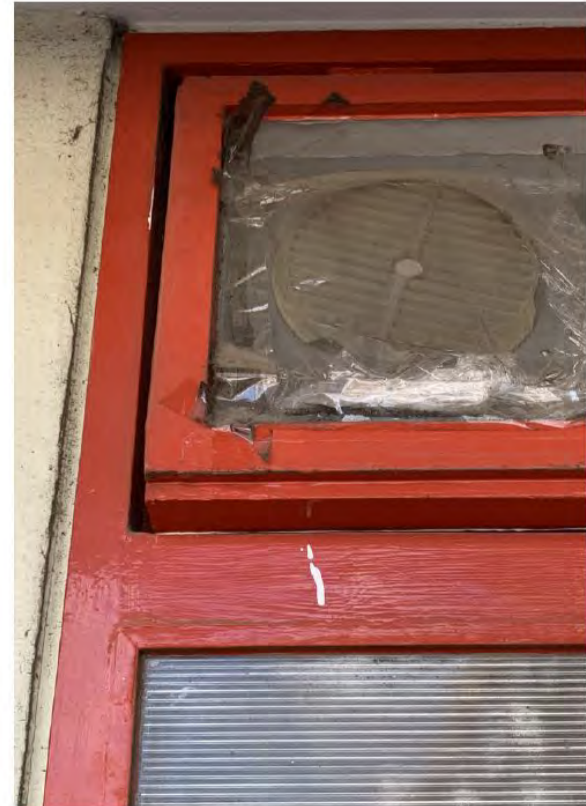
Ventilation panels have been retrofitted into some windows and some have subsequently been covered to stop any draughts.

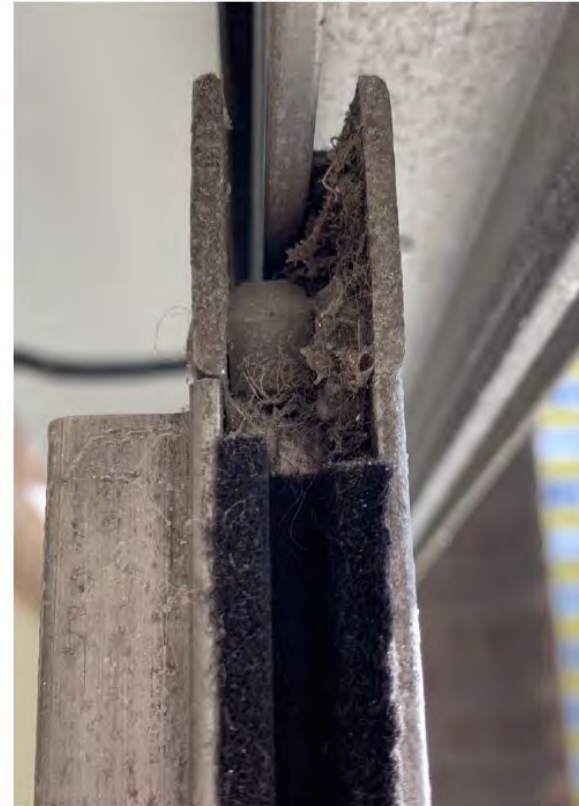
The original aluminium frames and runners are weathered and stiff, showing signs of oxidation.

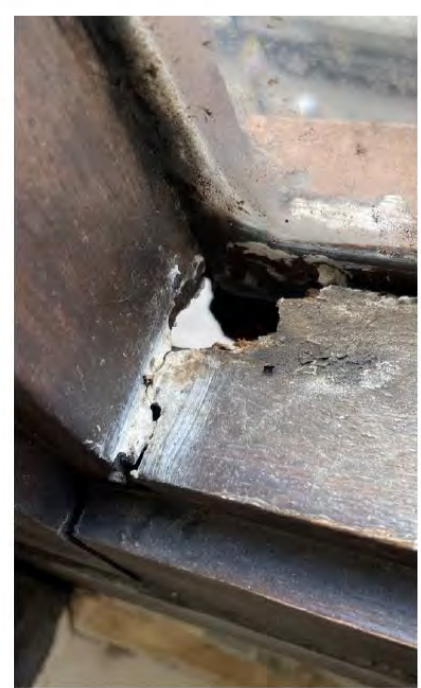
Deterioration of the hardwood frame/sill on the west facade where the glass pane has become exposed to the elements. Evidence of mould growth.

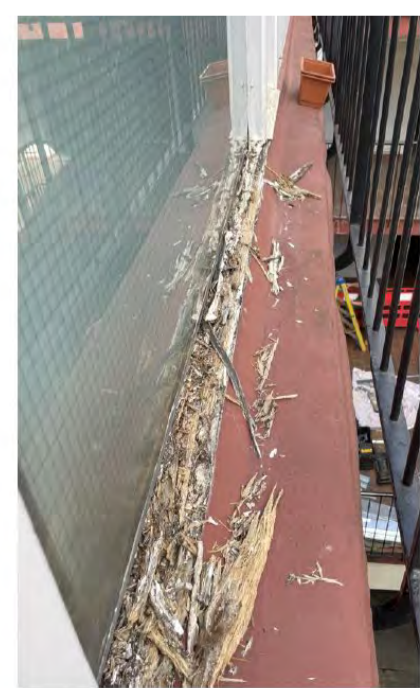
Deterioration of the softwood frame/sill on the kitchen window facing the internal lightwells.

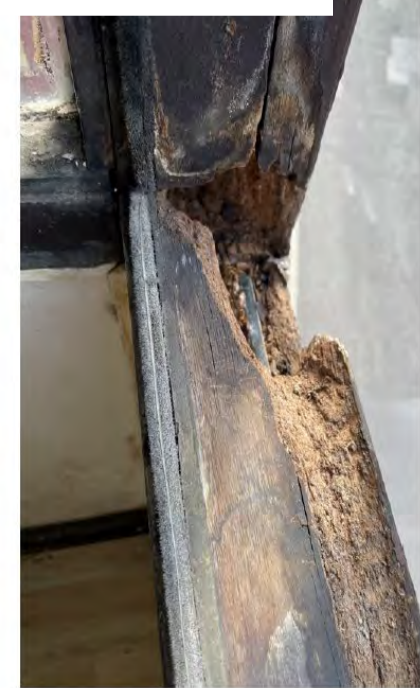
Deterioration of the hardwood frame/sill on the west facade (oriel window).

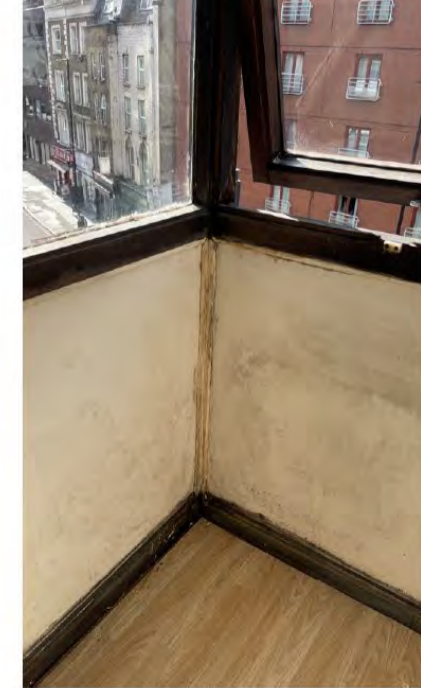
Paintwork deteriorating on timber frame and the spandrel panel. Evidence of mould growth.

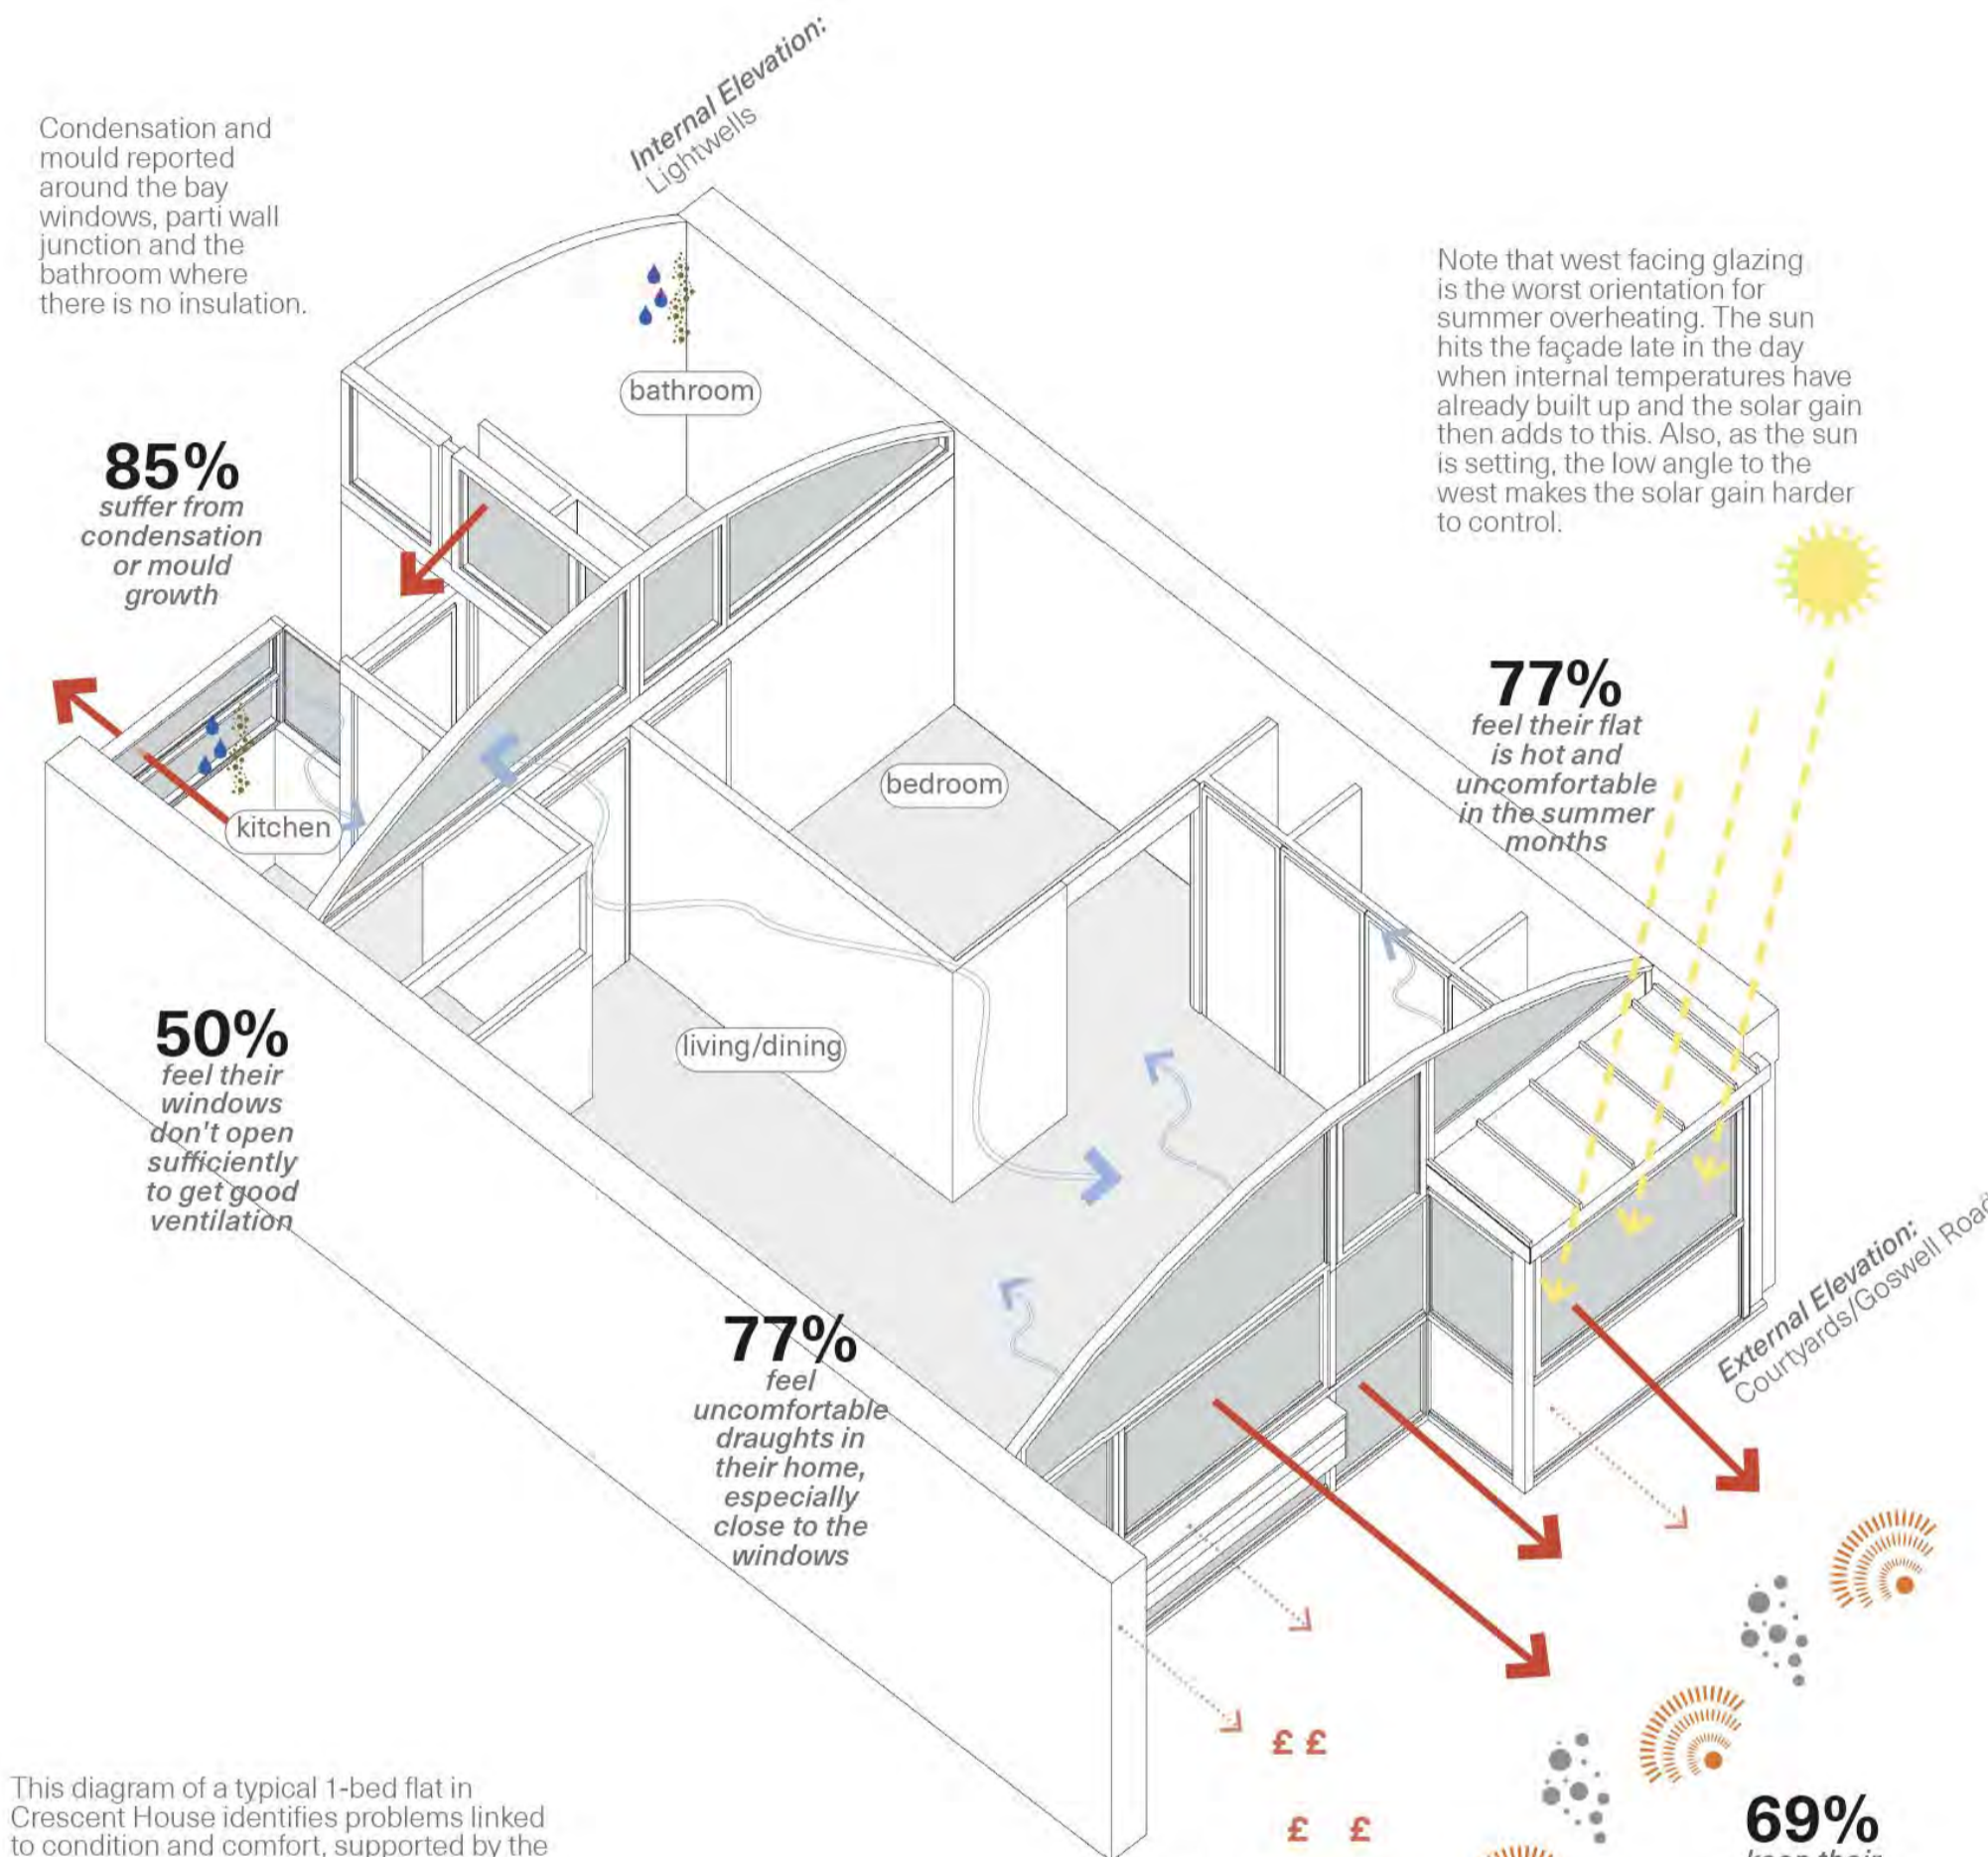
This diagram of a typical 1-bed flat in Crescent House identifies problems linked to condition and comfort, supported by the results of the condition survey completed by residents.

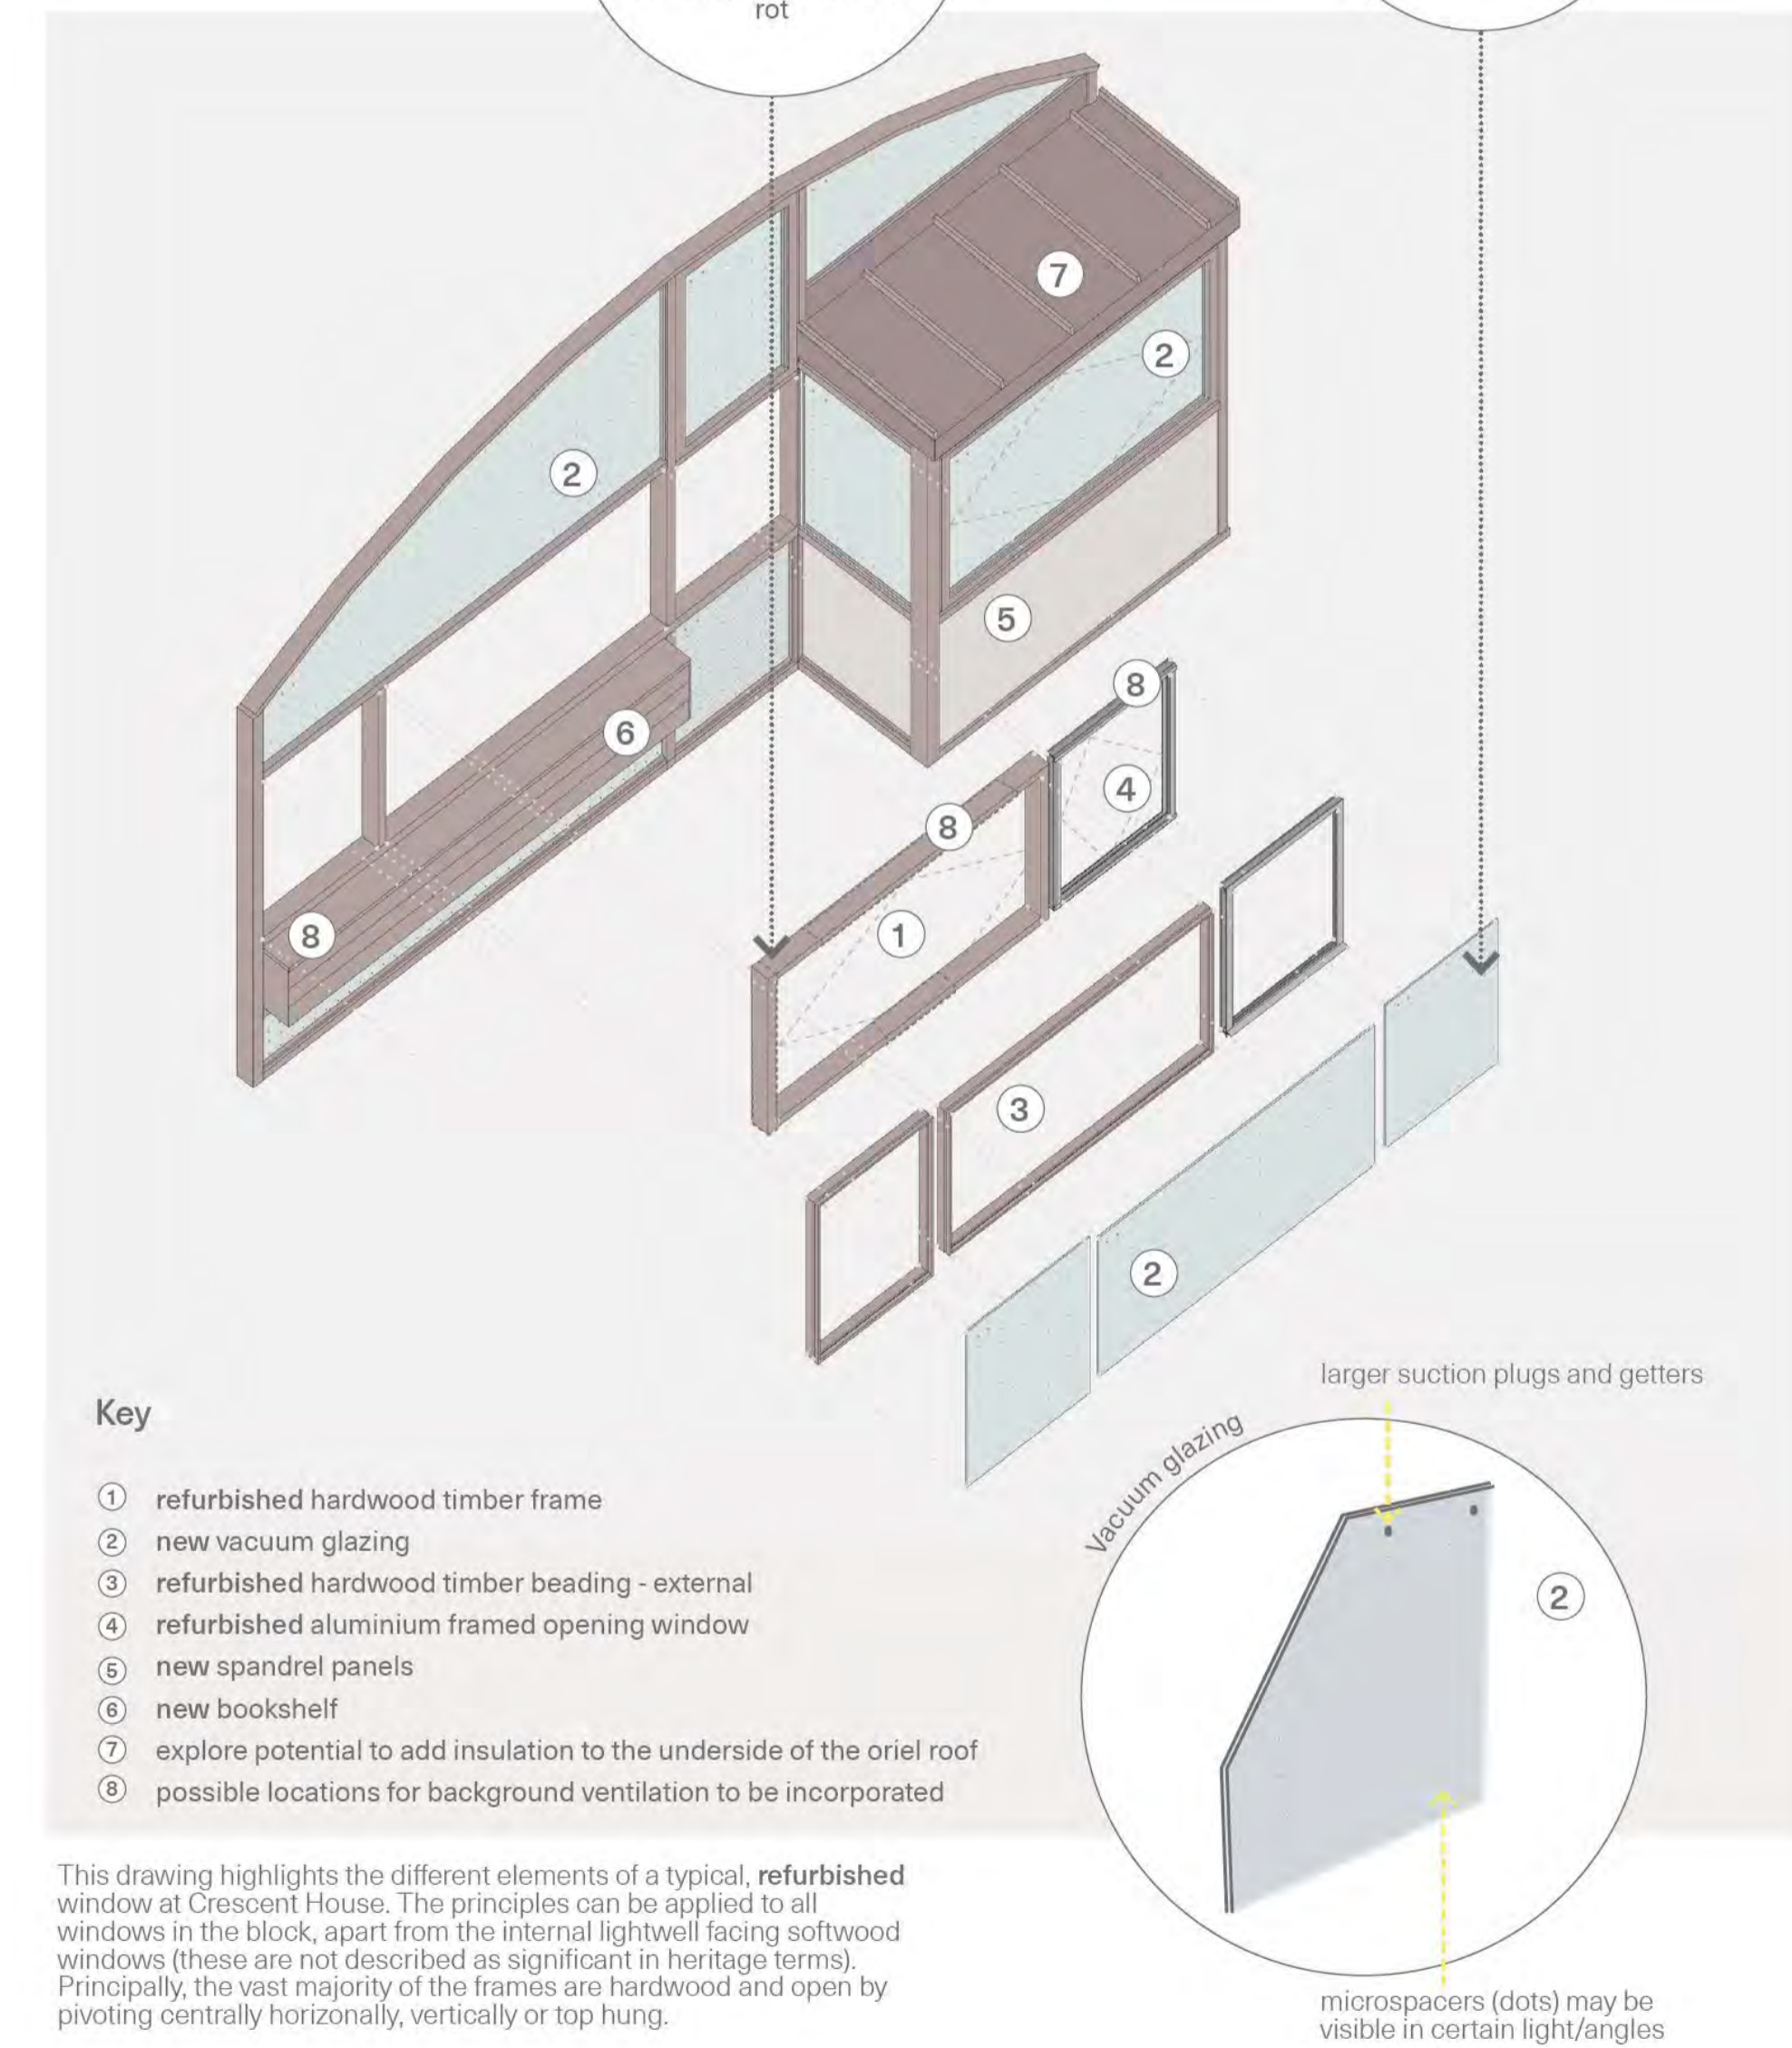
This drawing highlights the different elements of a typical, **refurbished** window at Crescent House. The principles can be applied to all windows in the block, apart from the internal lightwell facing softwood windows (these are not described as significant in heritage terms). Principally, the vast majority of the frames are hardwood and open by pivoting centrally horizontally, vertically or top hung.

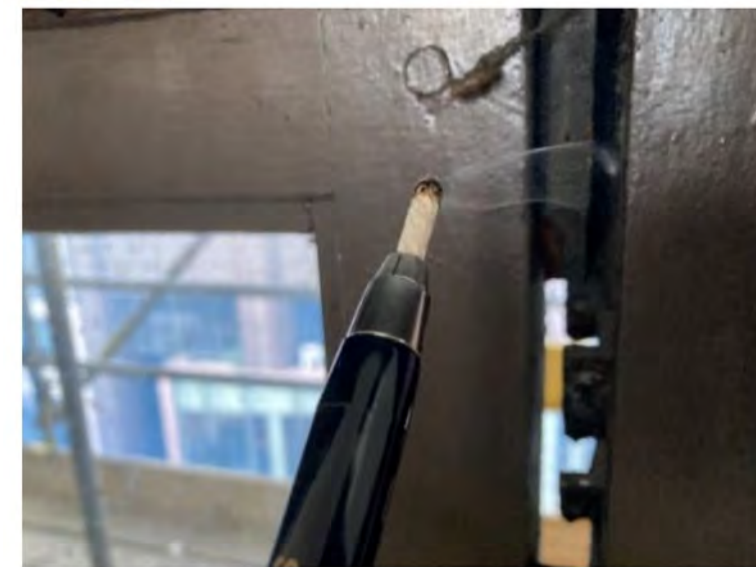
Photograph 9: Air Leakage - main window frame (SAL7)

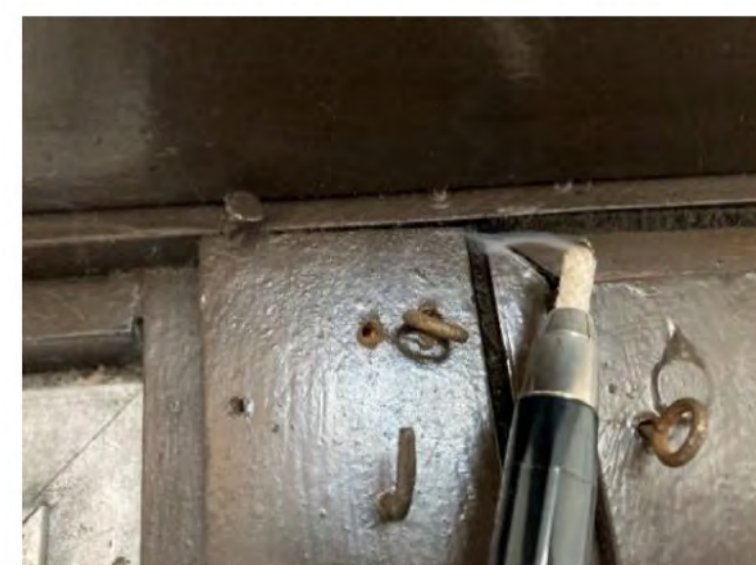
Photograph 10: Air Leakage - window frame (SAL8)

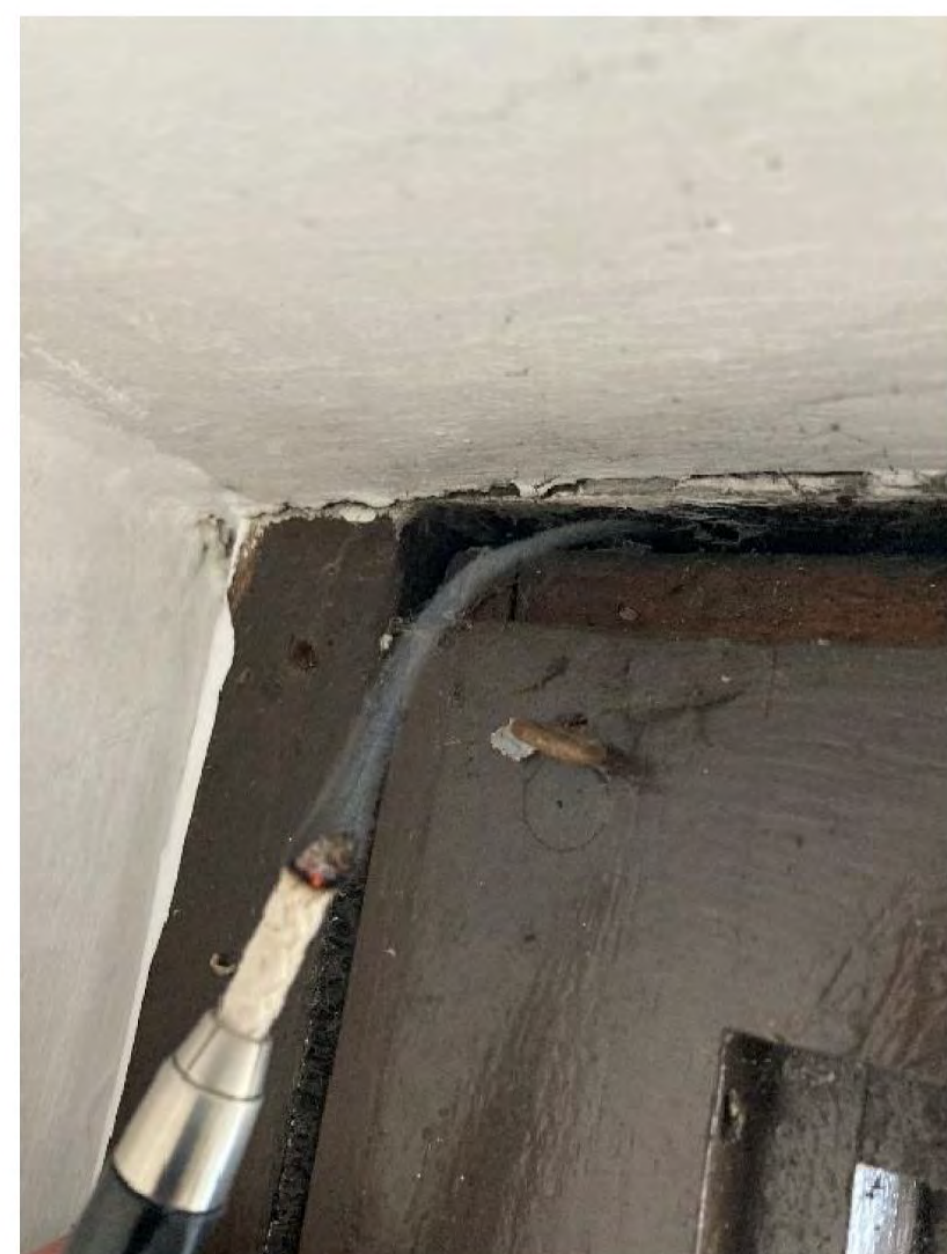
Photograph 14: Air Leakage - window frame (SAL12)

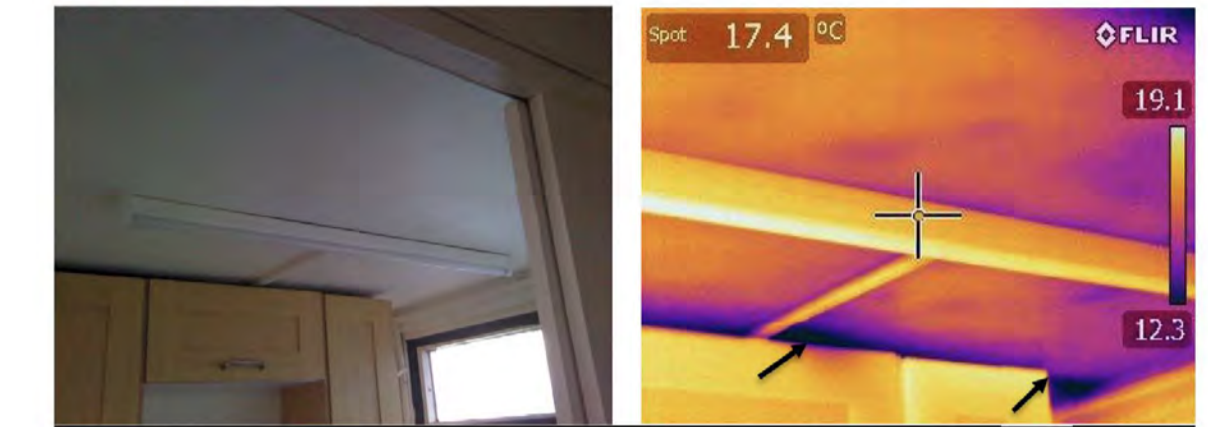
Figure 11: Thermal Image kitchen - heat loss highlighted Location THL4

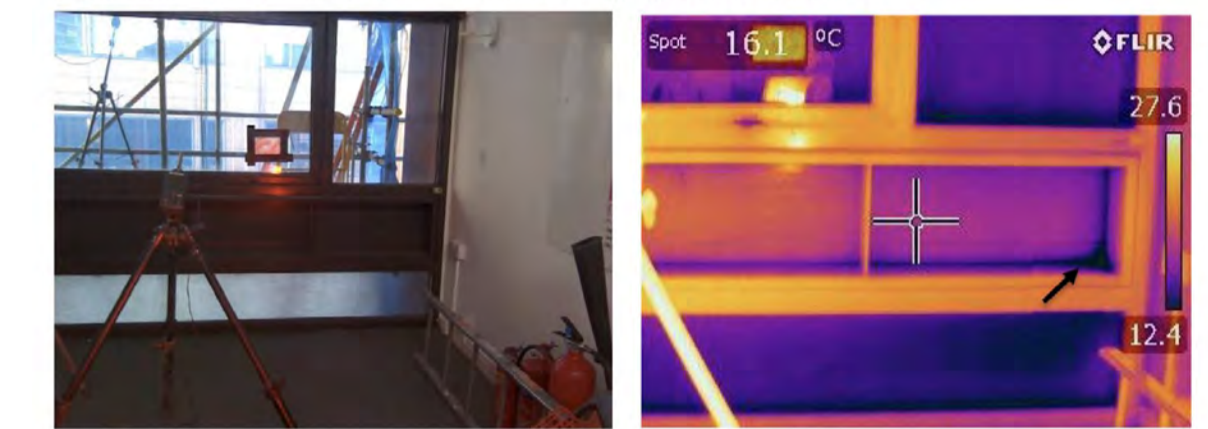
Figure 12: Thermal Image shelving - heat loss highlighted Location THL5 (see Figure 7)
