6.4 Refurbishment

CRESCENT HOUSE PILOT PROJECT

Airtightness Testing

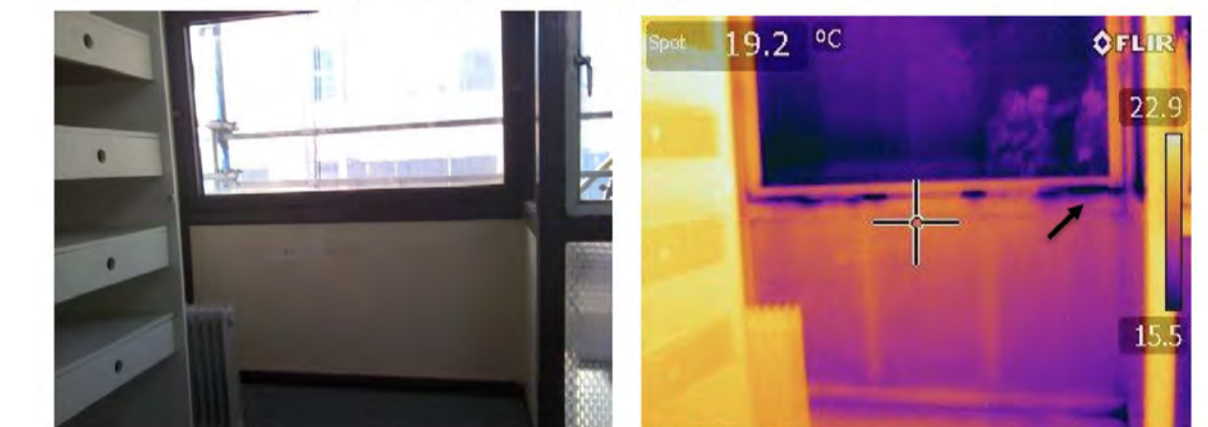
Figure 13: Thermal Image front window - heat loss highlighted Location THL6

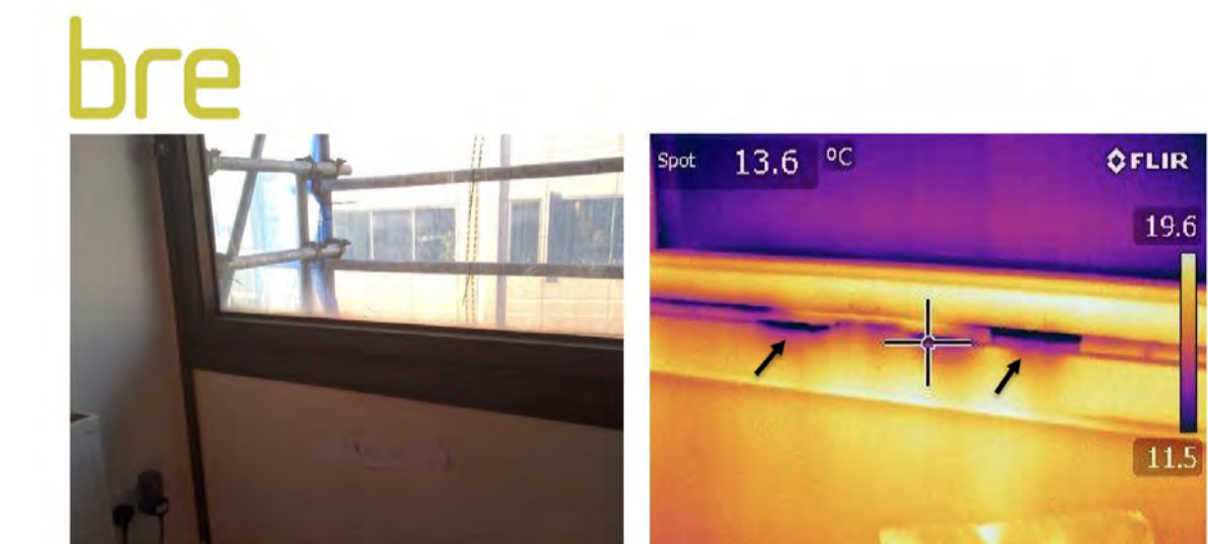
Figure 14: Thermal Image - close up of front window - heat loss highlighted Location THL6

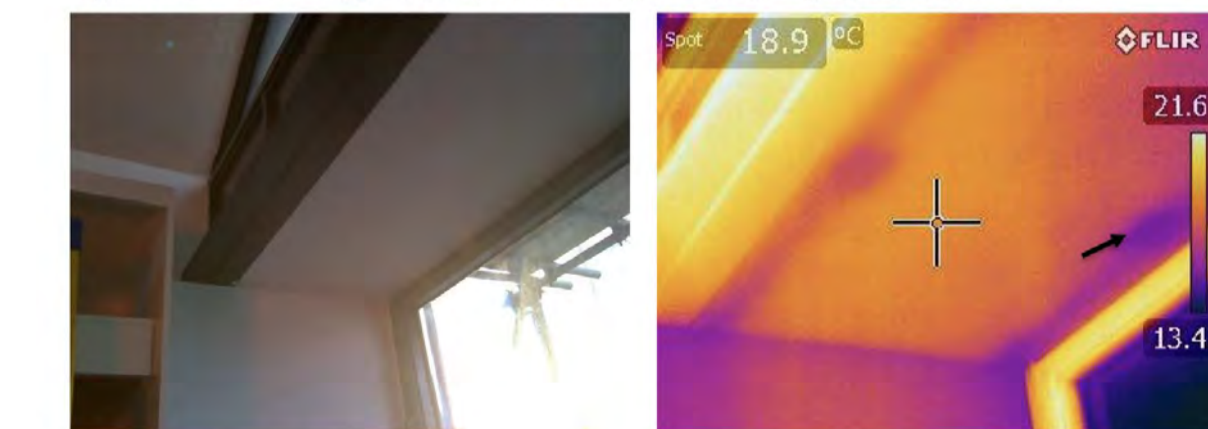
Figure 15: Thermal Image - front window reveal - heat loss highlighted Location THL7

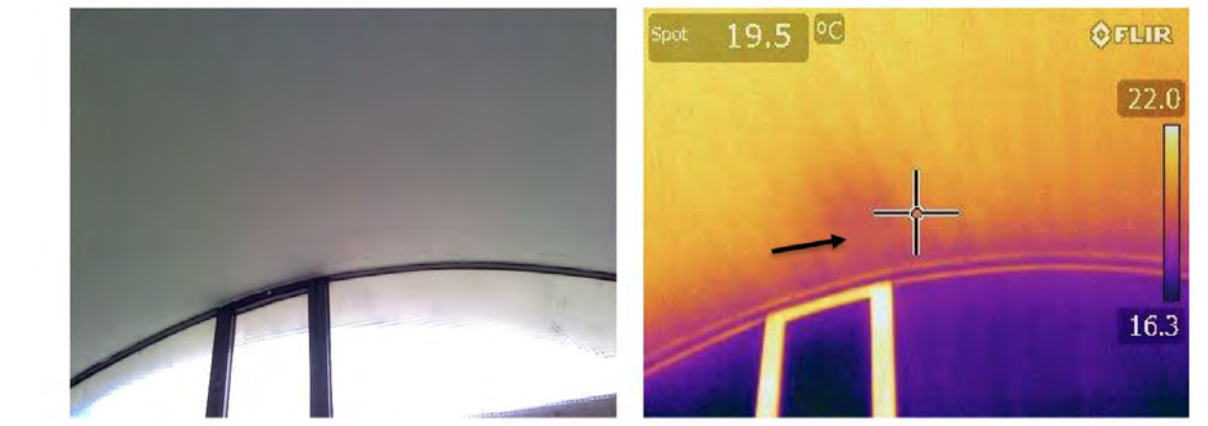
Figure 16: Thermal Image - front window roofline - heat loss highlighted Location THL8
