CRESCENT HOUSE

CRESCENT HOUSE PILOT PROJECT

TESTING OF THE PROPOSALS

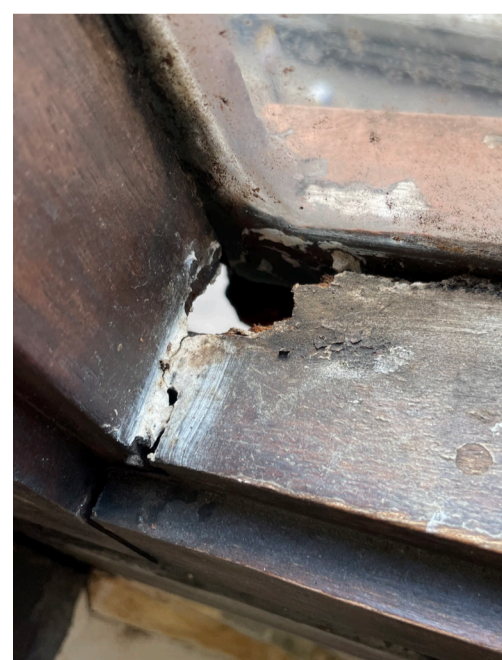
Deterioration of the hardwood frame/cill on the west façade where the glass pane has become exposed to the elements. Evidence of mould growth.

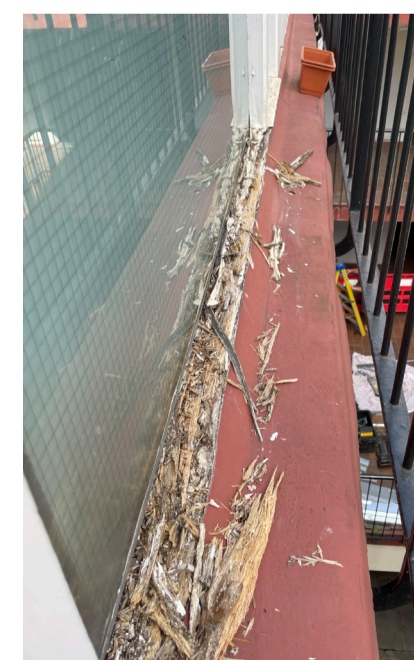
Deterioration of the softwood frame/cill on the kitchen window facing the internal lightwells.

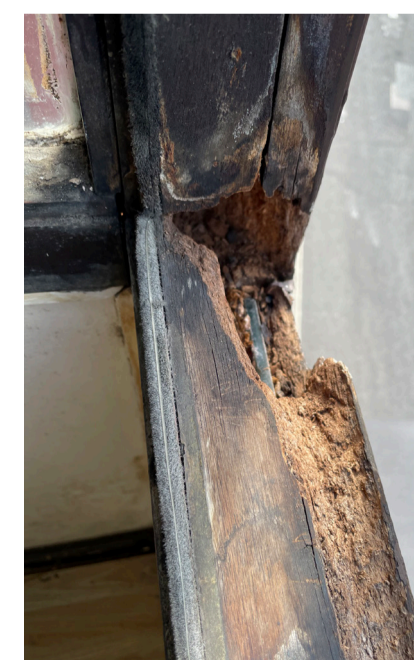
Deterioration of the hardwood frame on the west façade (oriel window).

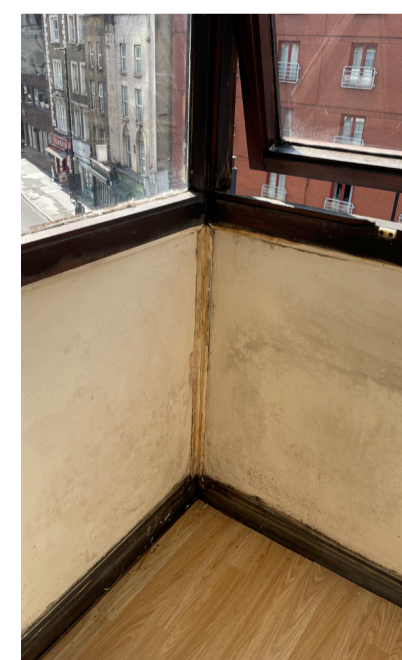
Paintwork deteriorating on timber frame and the spandrel panel. Evidence of mould growth.

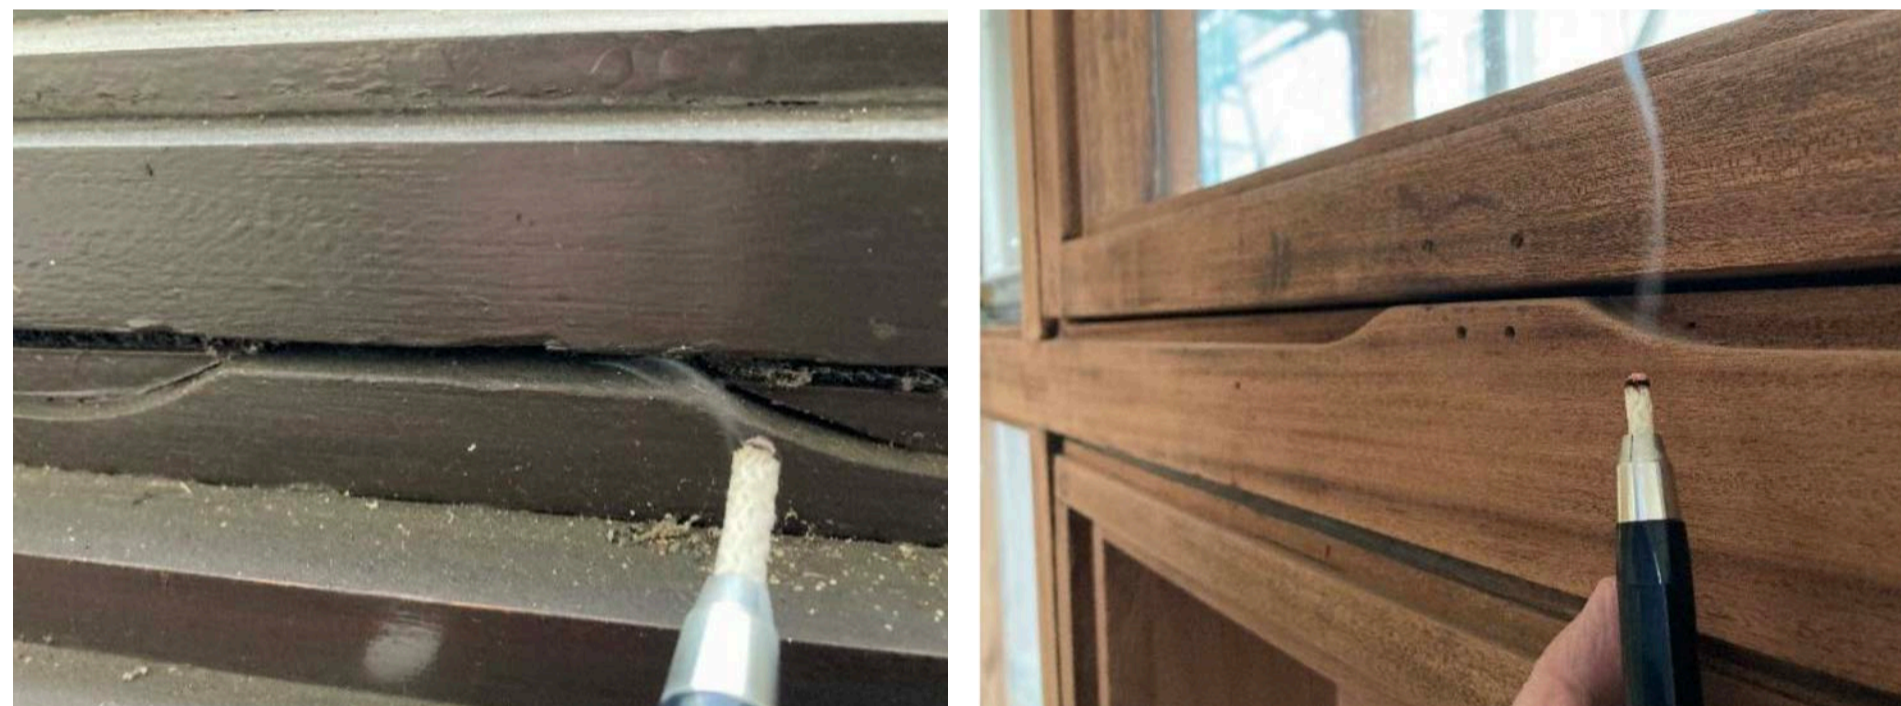
Before refurbishment: air (some) leakage visible through junction between frame and pivot window. After Refurbishment: minimal air (smoke) leakage at same junction between frame and pivot window.

Whole home average airtightness - before: $8.13 \text{ m}^3.\text{hr}^{-1}.\text{m}^{-2}@50\text{Pa}$
 Whole home average airtightness - after: $4.82 \text{ m}^3.\text{hr}^{-1}.\text{m}^{-2}@50\text{Pa}$

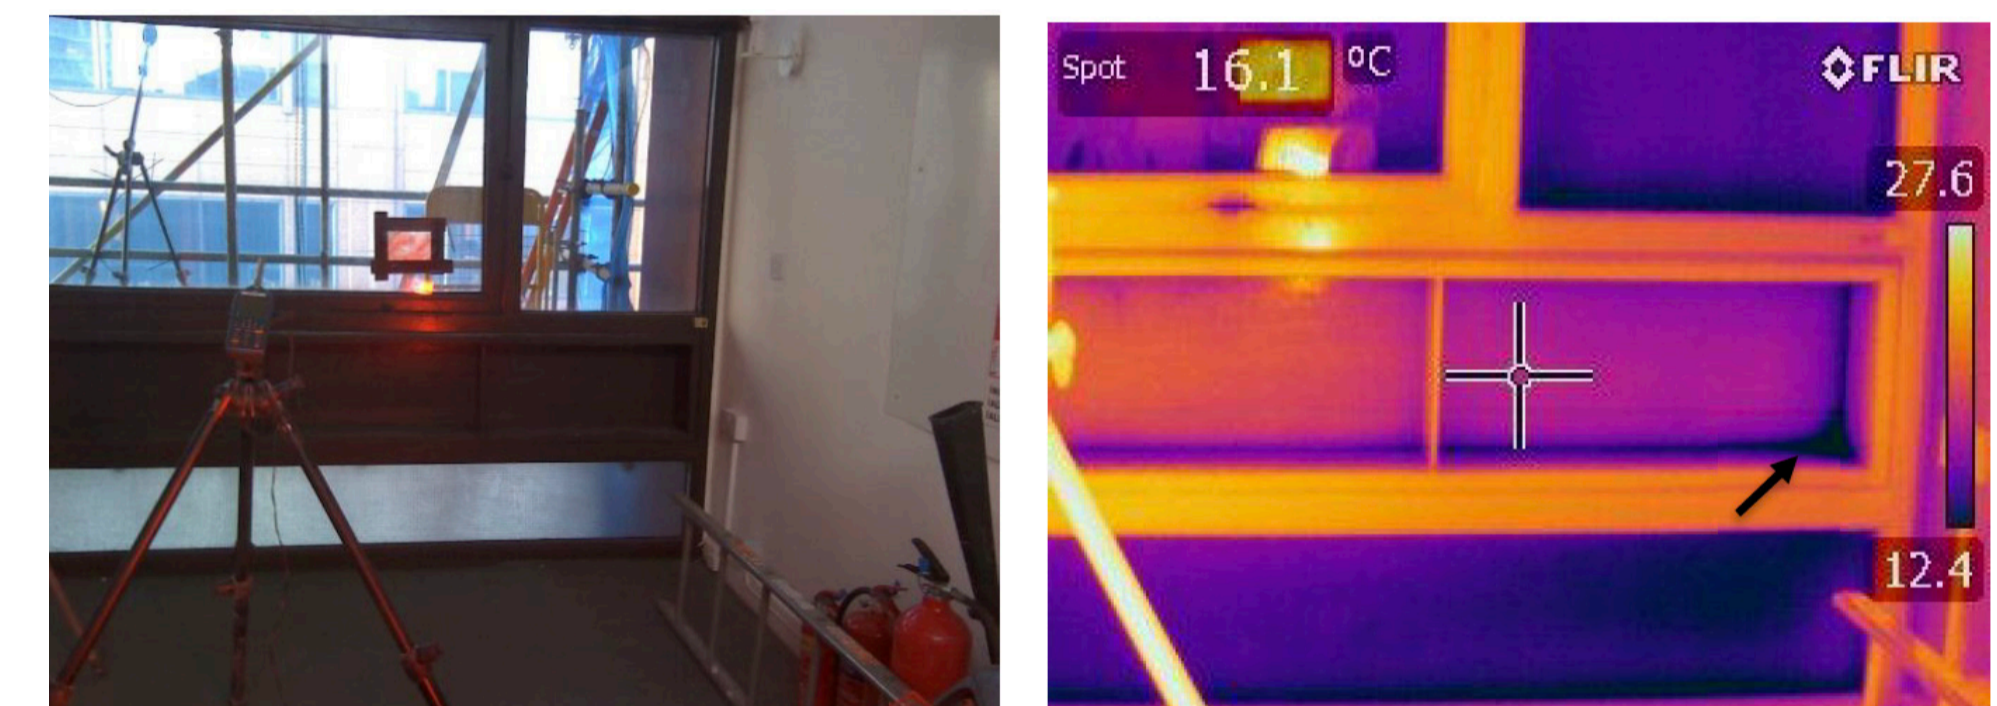
Figure 12: Thermal Image shelving - heat loss highlighted Location THL5 (see Figure 7)

An infrared camera was used to carry out a thermographic survey of the windows to determine where conductive heat loss, structural defects, air leakage and thermal bridging occur. The survey of the existing windows showed localised heat loss around window frames, in the kitchen & oriel window roofs and the bookshelf on the external façade. After the work to the windows was complete the areas where heat loss had been identified were re-photographed to determine any change. The results of the thermographic survey are indicative at this stage as on the day the survey was carried out the difference between the internal and external temperature was less than 10°C .

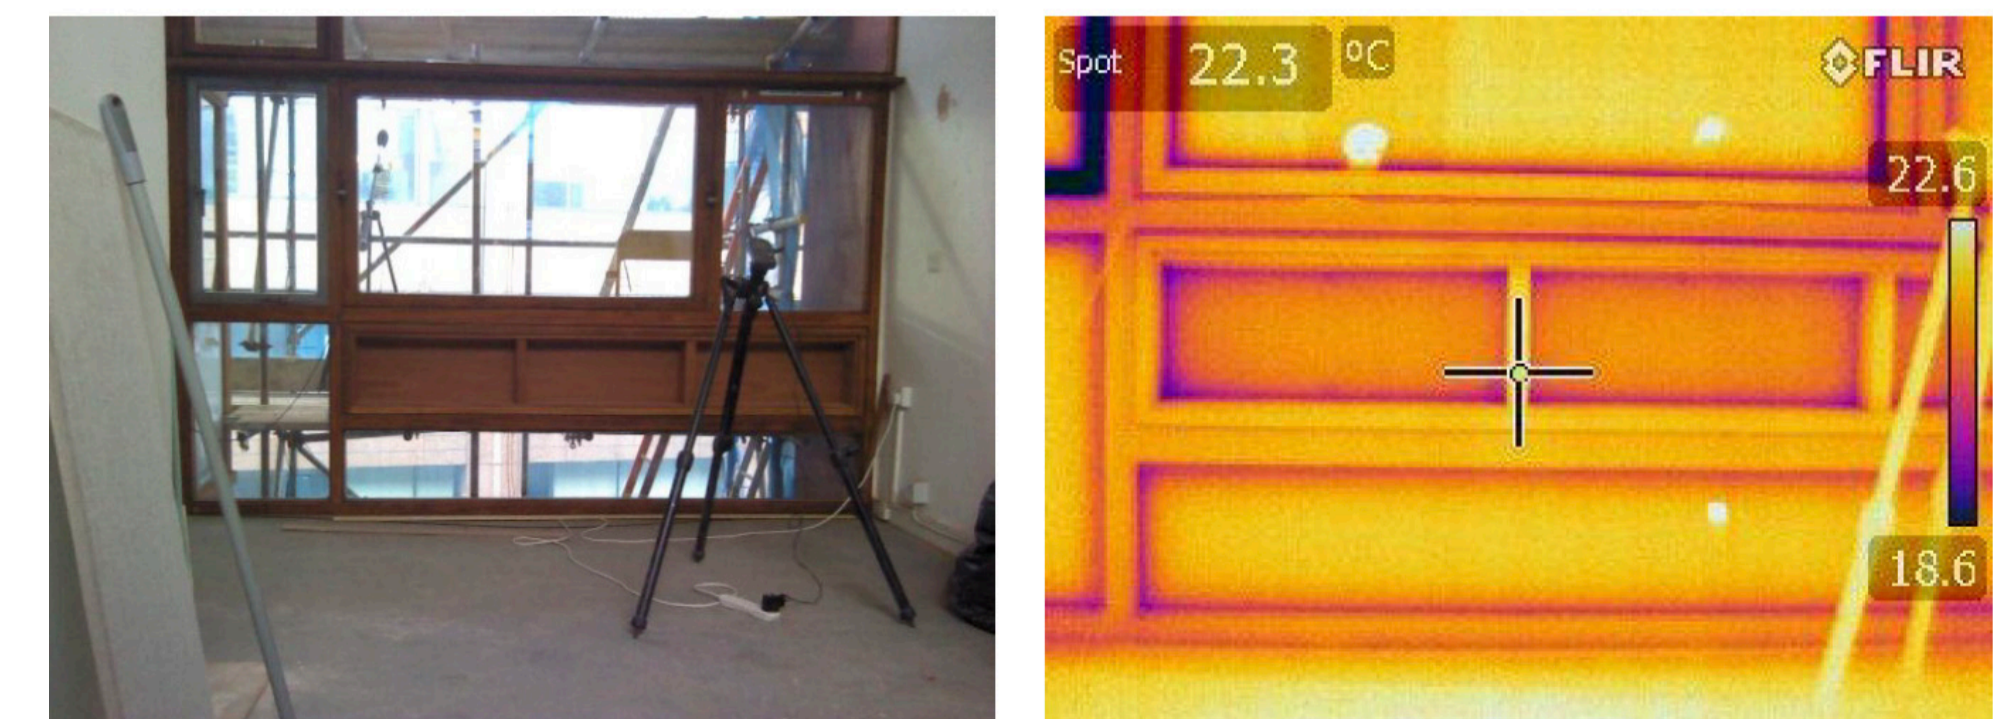
Figure 21: Thermal Image shelving minimal heat loss highlighted Location THL5 (see figure 7)

The images above highlight a reduced heat loss through the bookshelf. A third set of thermal images will be taken in November when it will be easier to maintain a temperature difference of 10°C .

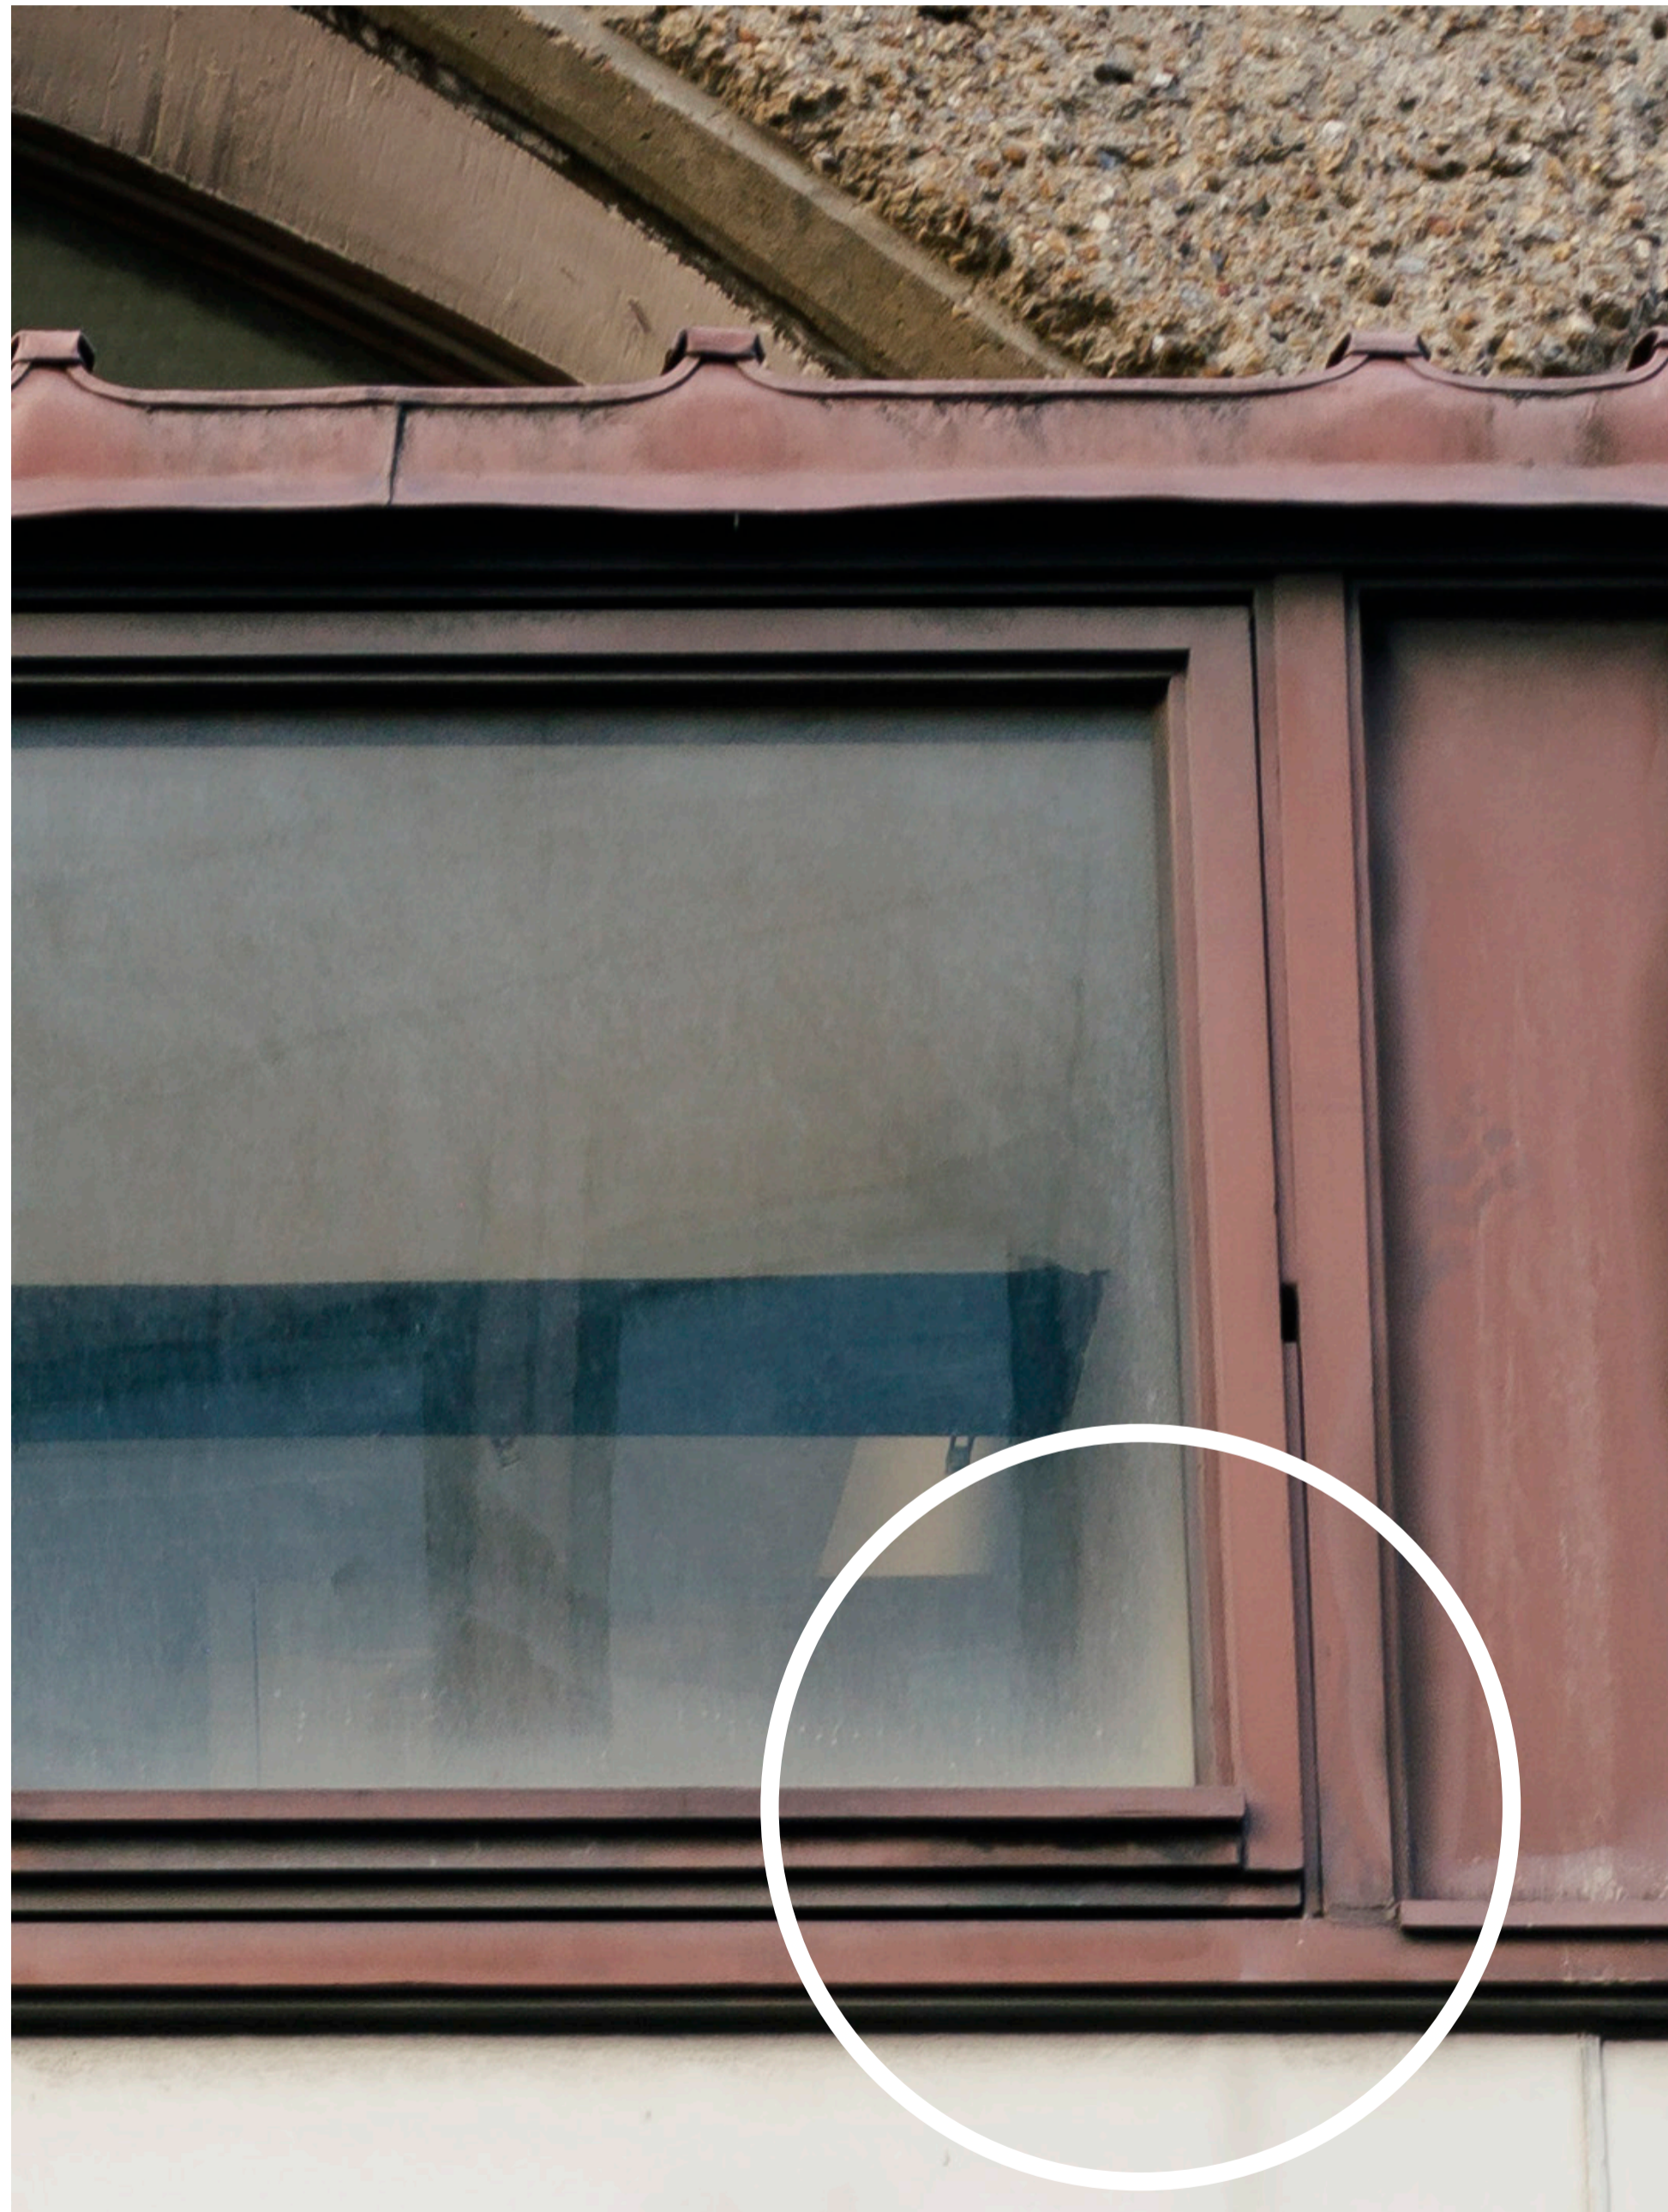
The same corner joint is shown in each of these three photographs.
This photo shows the window frame prior to starting the Pilot Project and there is no obvious visible rotten timber.

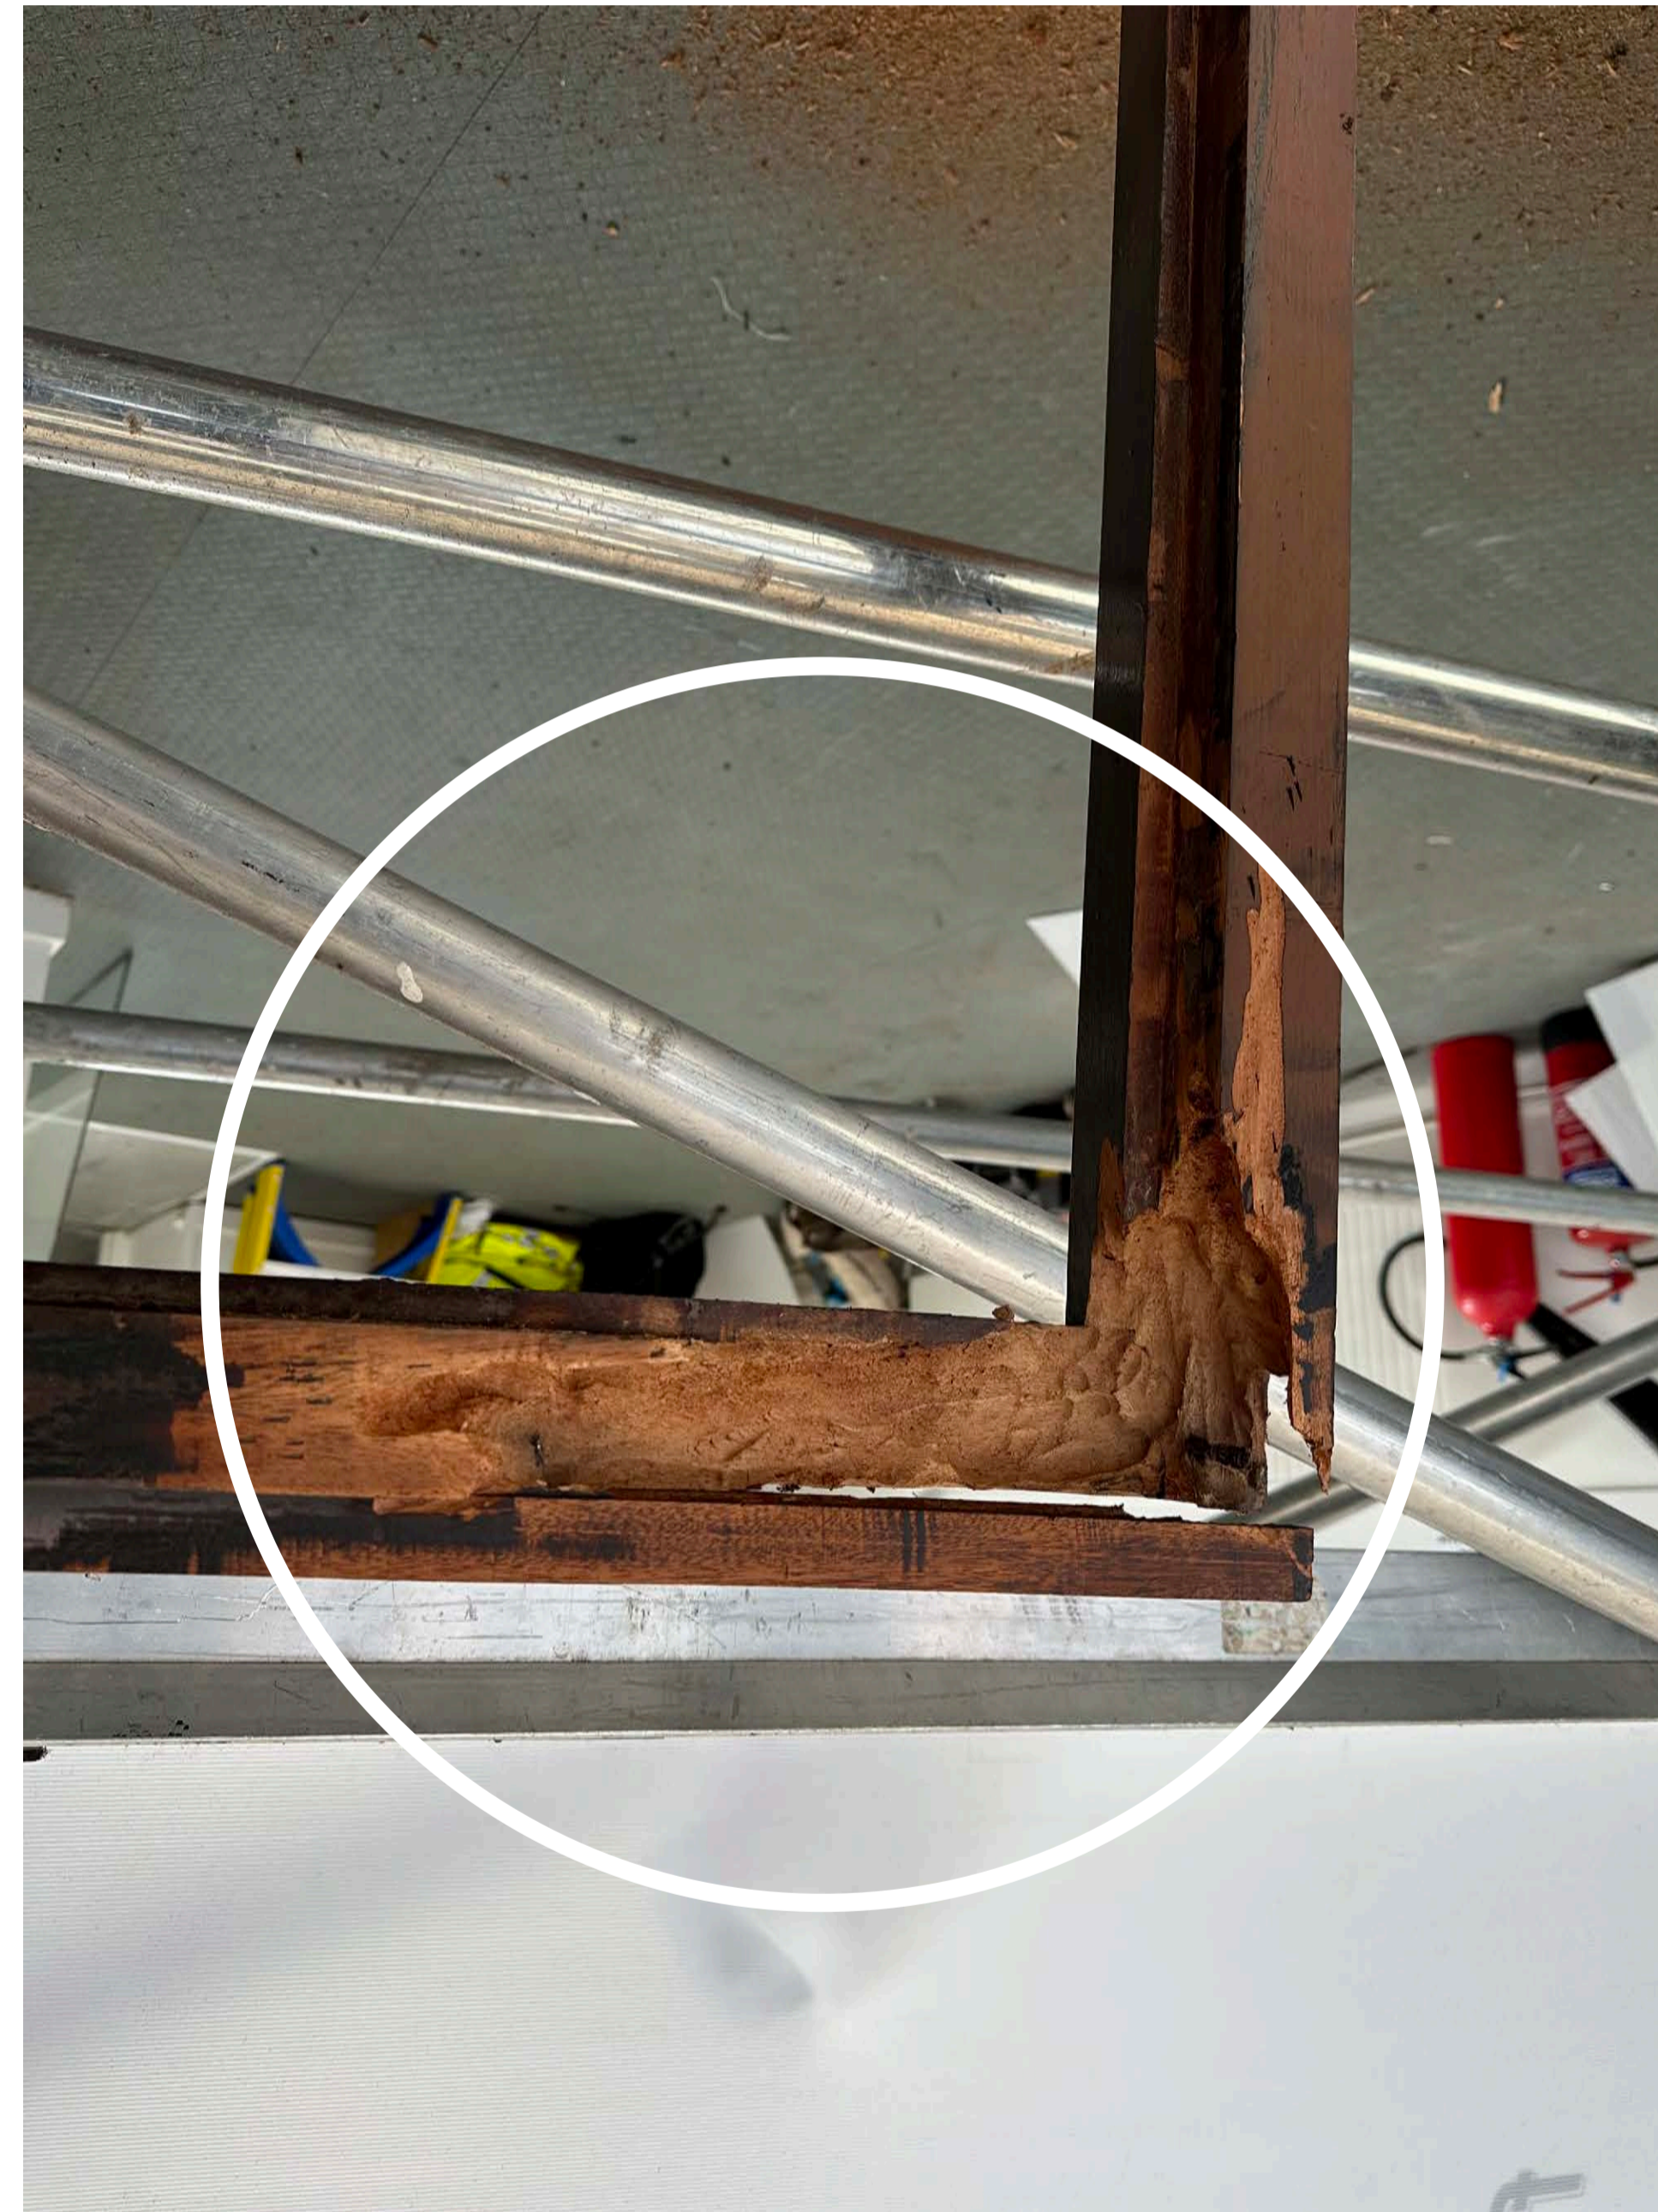
This photos shows the corner junction after the rotten timber has been removed.

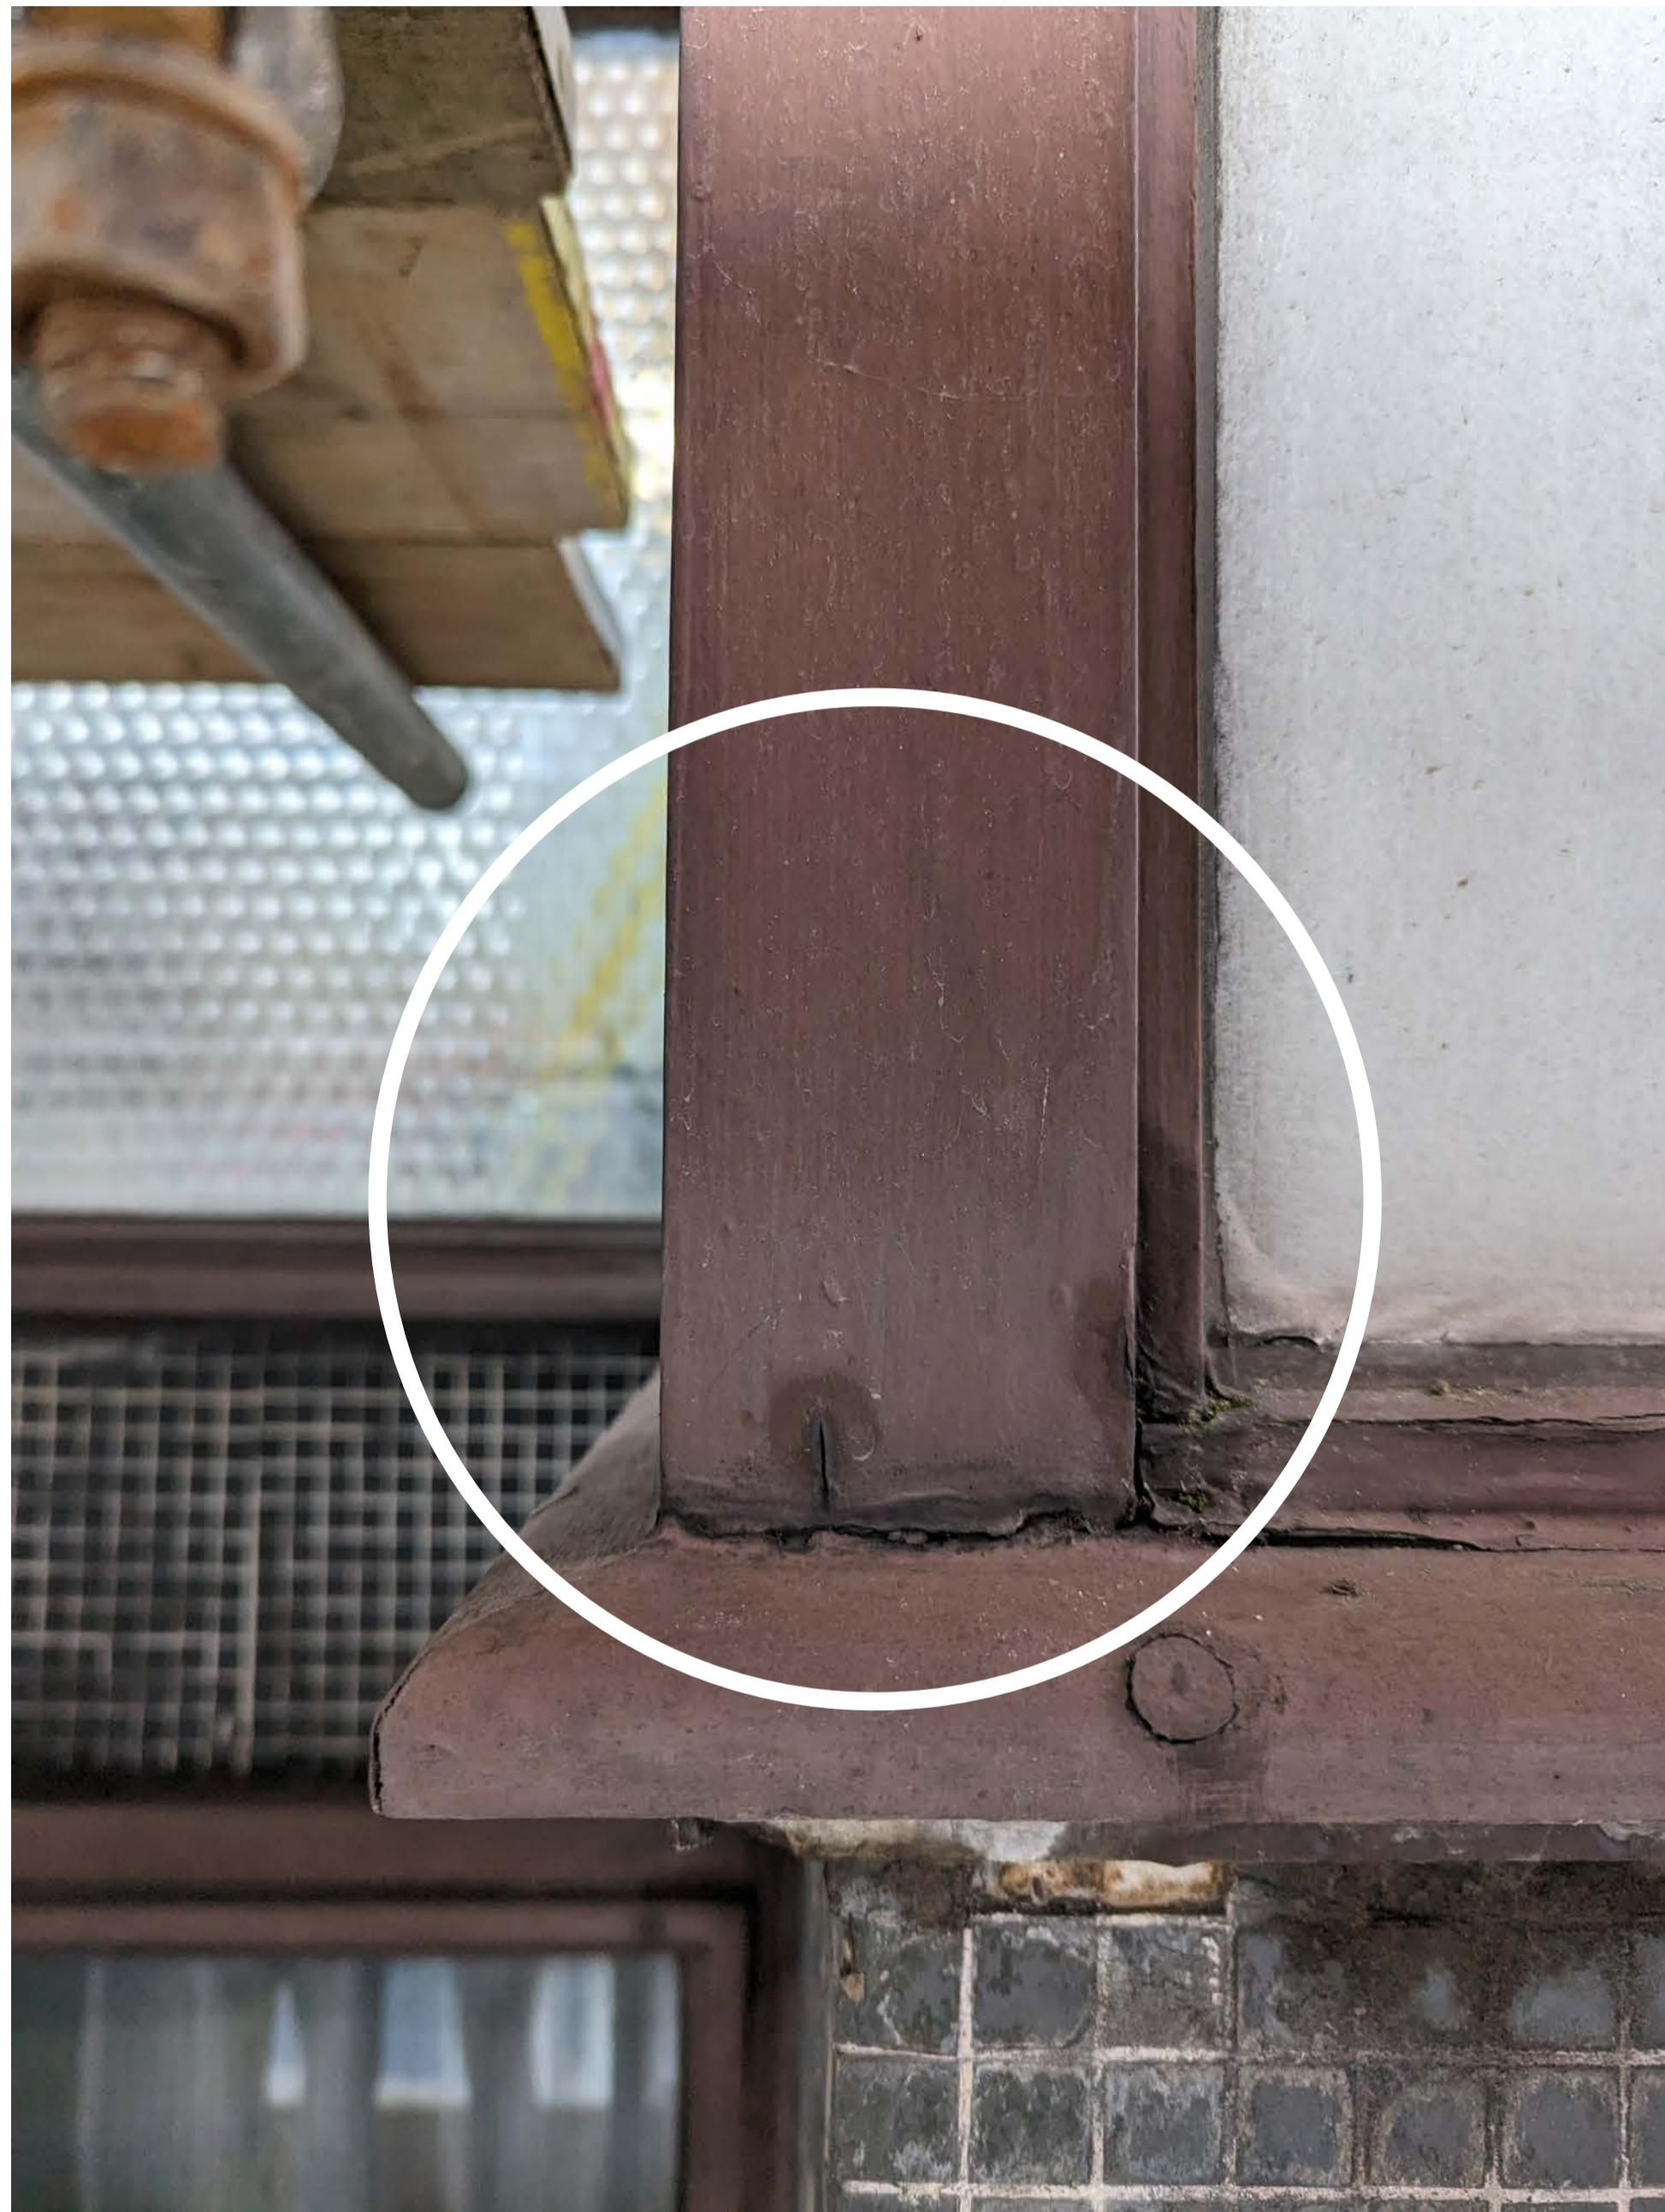
The same frame joint is shown in each of these three photographs. This photo shows the corner post of the window frame prior to starting the Pilot Project and there is no obvious visible rotten timber.

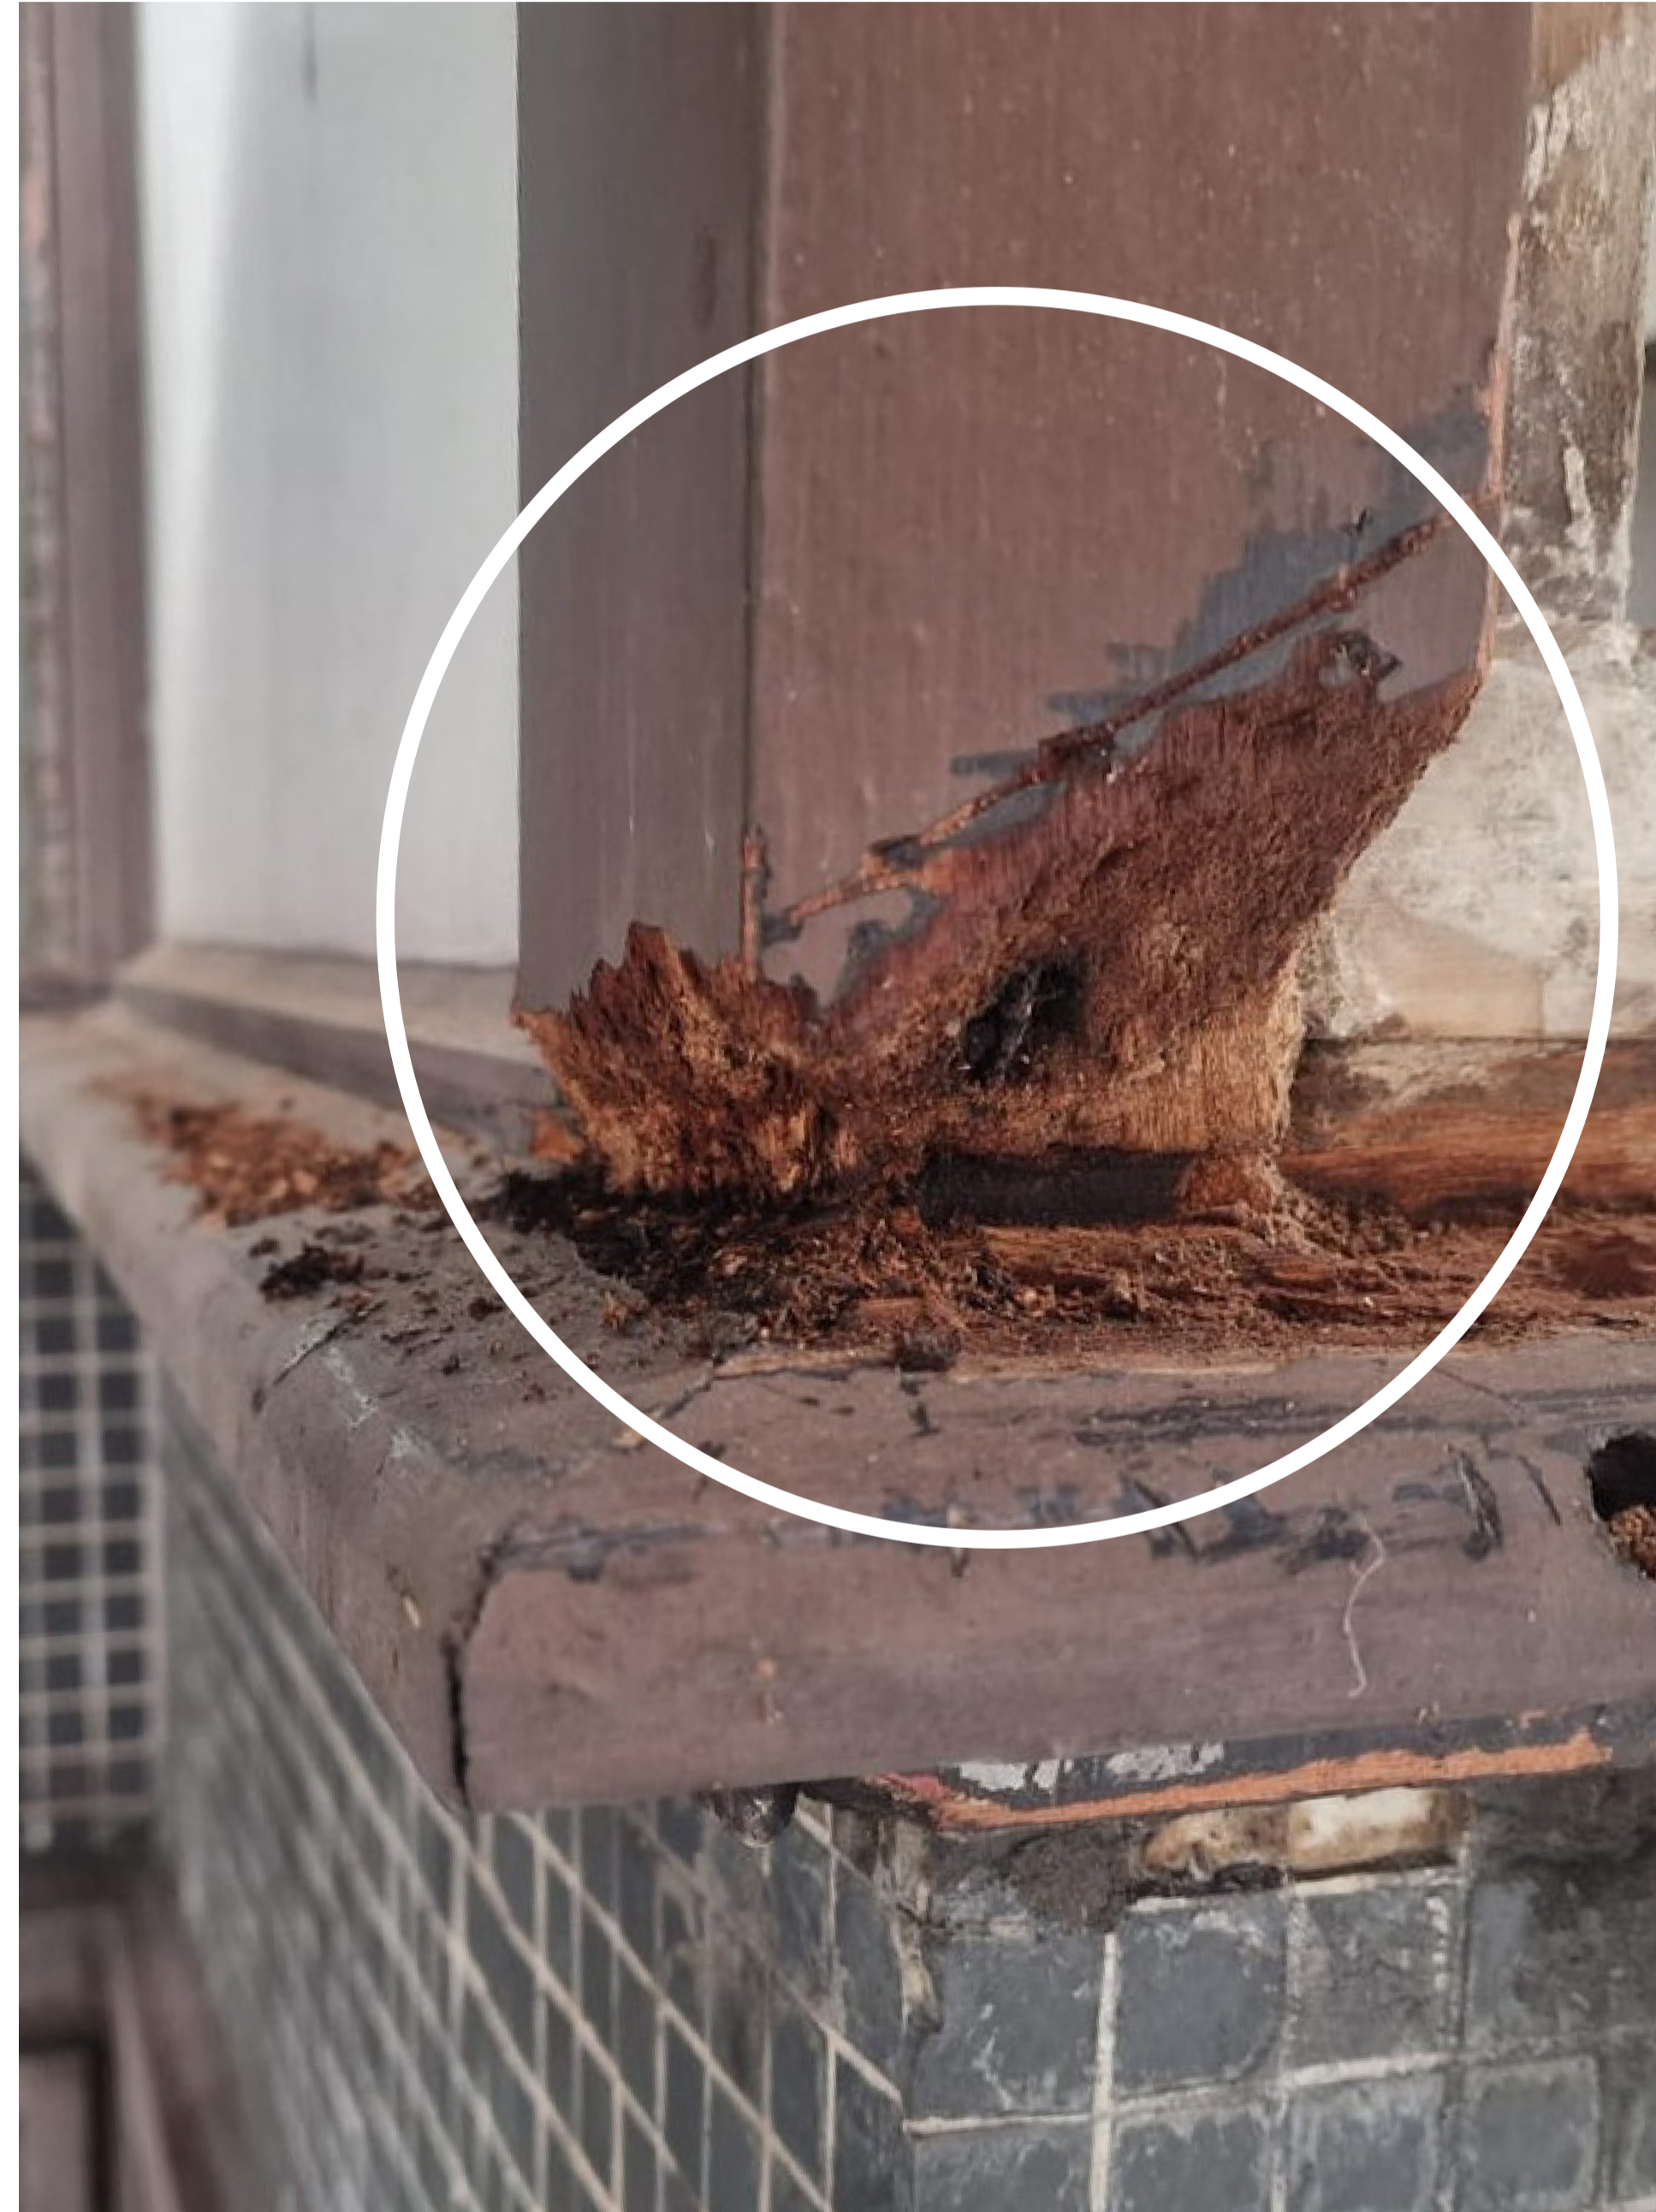
This photos shows the corner post after the rotten timber has been removed.
