# CRESCENT HOUSE

# CRESCENT HOUSE PILOT PROJECT

## TESTING OF EXISTING BUILDING FABRIC

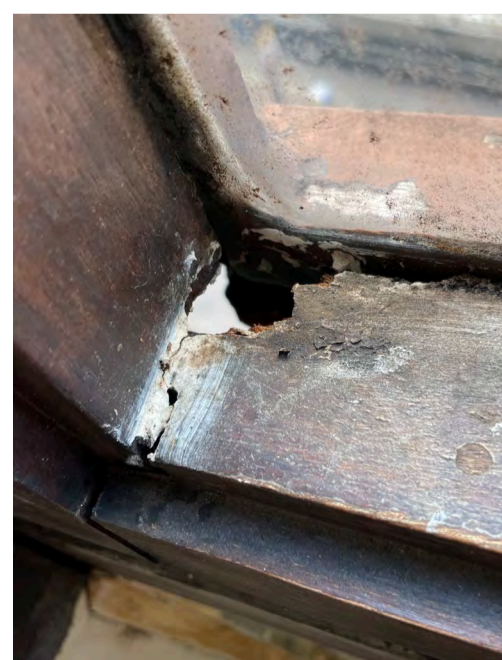
Deterioration of the hardwood frame/cill on the west façade where the glass pane has become exposed to the elements. Evidence of mould growth.

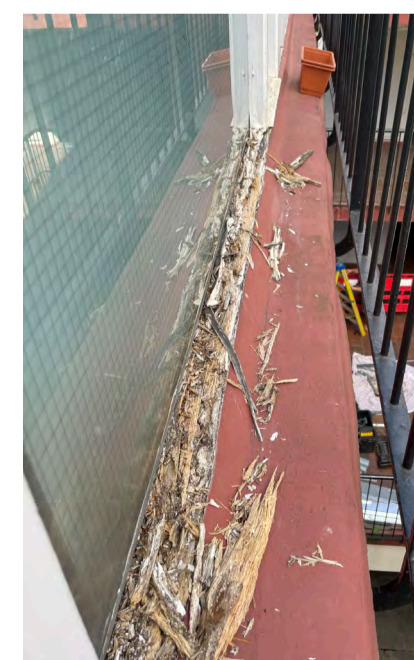
Deterioration of the softwood frame/cill on the kitchen window facing the internal lightwells.

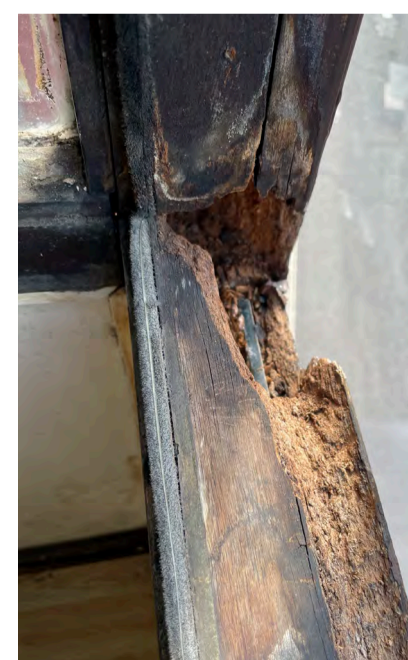
Deterioration of the hardwood frame/vv on the west façade (oriel window).

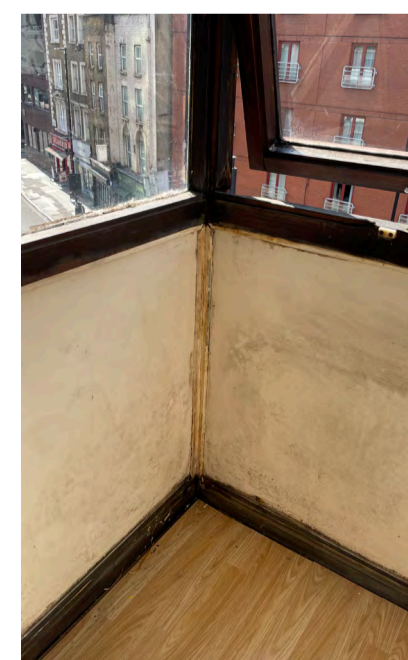
Paintwork deteriorating on timber frame and the spandrel panel. Evidence of mould growth.

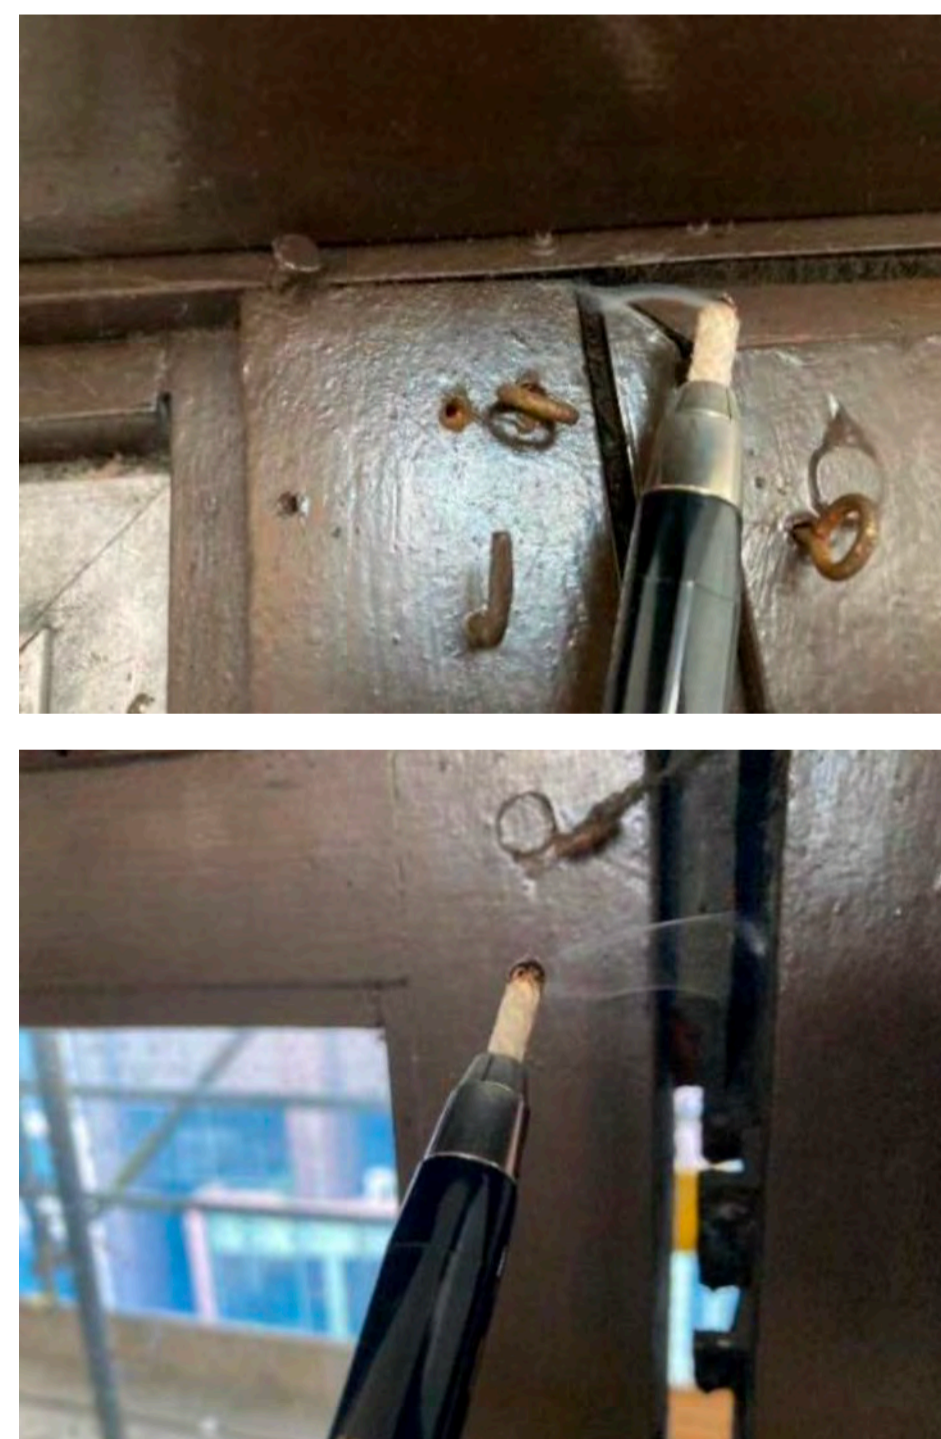
The airtightness of the external façades was tested using a blower door to pressurise the apartment, and smoke pens to show air leakage paths. This showed significant air leakage paths around window frames. The test will be re-run following refurbishment of the window frames & installation of the vacuum glazing to measure the reduction of air leakage.

Above: air leakage paths through/around the window frames demonstrated using a smoke pen

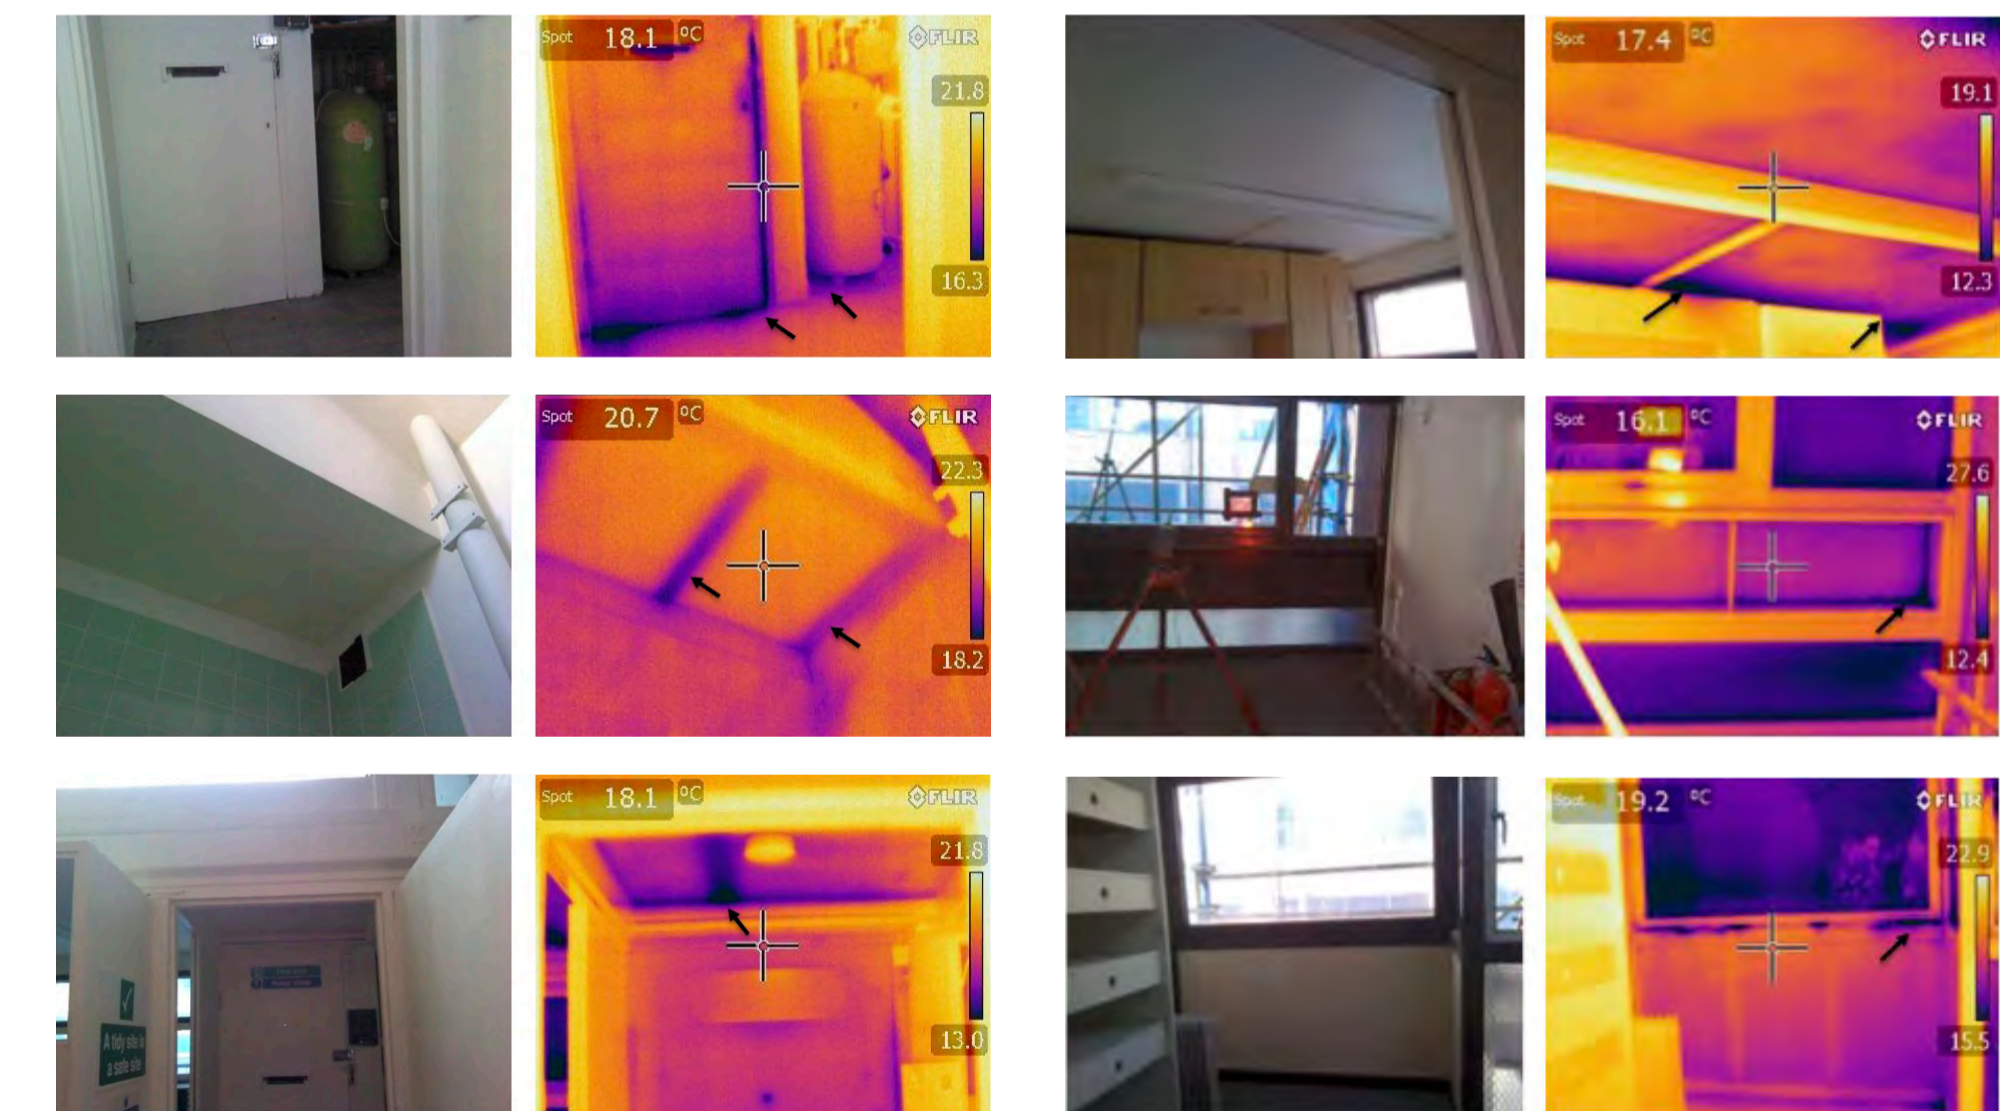
An infrared camera was used to carry out a thermographic survey and determine where conductive heat loss, structural defects, air leakage and thermal bridging within the building fabric occur. This showed localised heat loss around door penetrations, pipe work and window frames, as well as in the kitchen & oriel window roofs and the bookshelf on the external façade. The test will be re-run following refurbishment of the window frames & installation of the vacuum glazing and insulation to the main concrete vaulted roofs, first floor concrete soffit & bookshelf, to determine the reduction in heat loss.

Above: infrared photographs showing key heat loss junctions around the flat. A darker colour indicates higher levels of heat loss, which may lead to condensation and mould developing in that area.
