# Executive Summary

This document has been prepared by Studio Partington on behalf of the City of London Corporation. It explores several possible approaches for improvements to the condition and performance of windows in Stanley Cohen House.

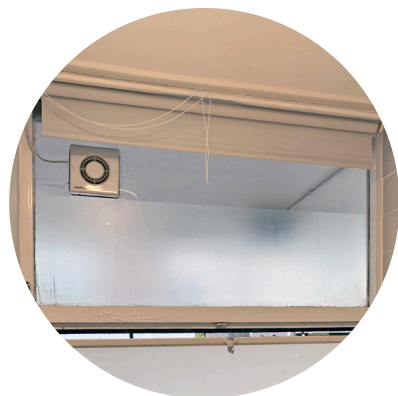
*Fixed lights*

*(this photo includes an example of obscuring film and an extract fan which have been added retrospectively. Note that none of the windows have built-in trickle ventilators).*

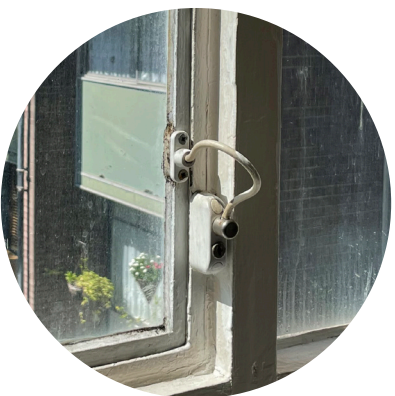
*Restrictors*

*Metal/cable restrictors fitted retrospectively to side-hung casement window (fitted for safety).*

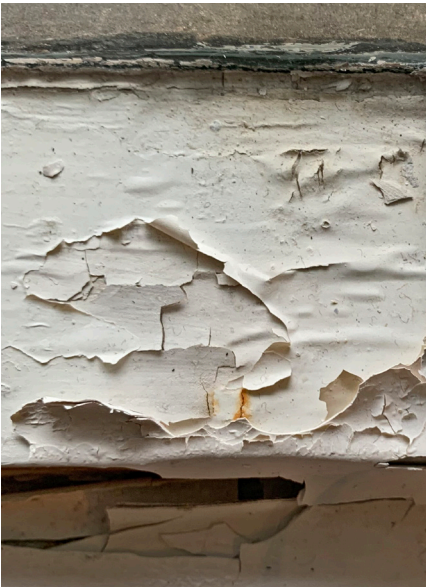
Studio Partington has undertaken a visual survey of a selection of windows at Stanley Cohen House. After over sixty years of use, the condition of the windows across the estate has deteriorated. The painted finish on the timber frames is visibly deteriorated, implying possible deterioration of the softwood timber frames beneath. Likewise, the finish on the steel-framed opening lights has deteriorated over time, leaving the steel-frame exposed and vulnerable.

It is worth noting that significant deterioration has occurred in the interior side of the windows, suggesting that the damage has been caused by condensation, rather than exposure to the elements externally.

Paintwork deteriorating on timber frame/sill (internal). Evidence of mould growth.

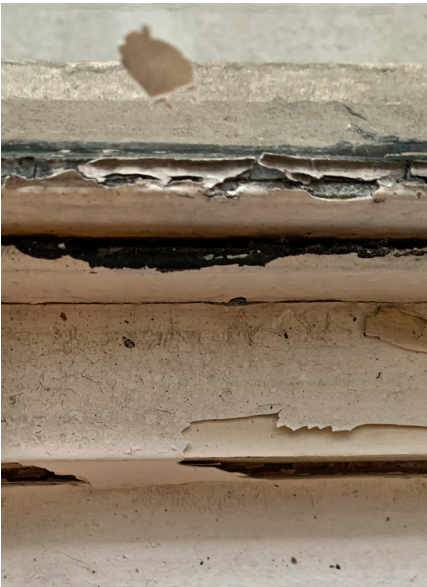
Paintwork deteriorating on timber frame/sill and steel opening lights (internal).

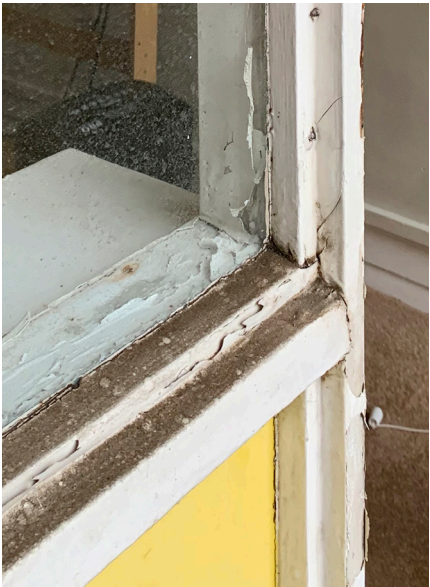
Paintwork deteriorating on timber frame/sill (internal and external).

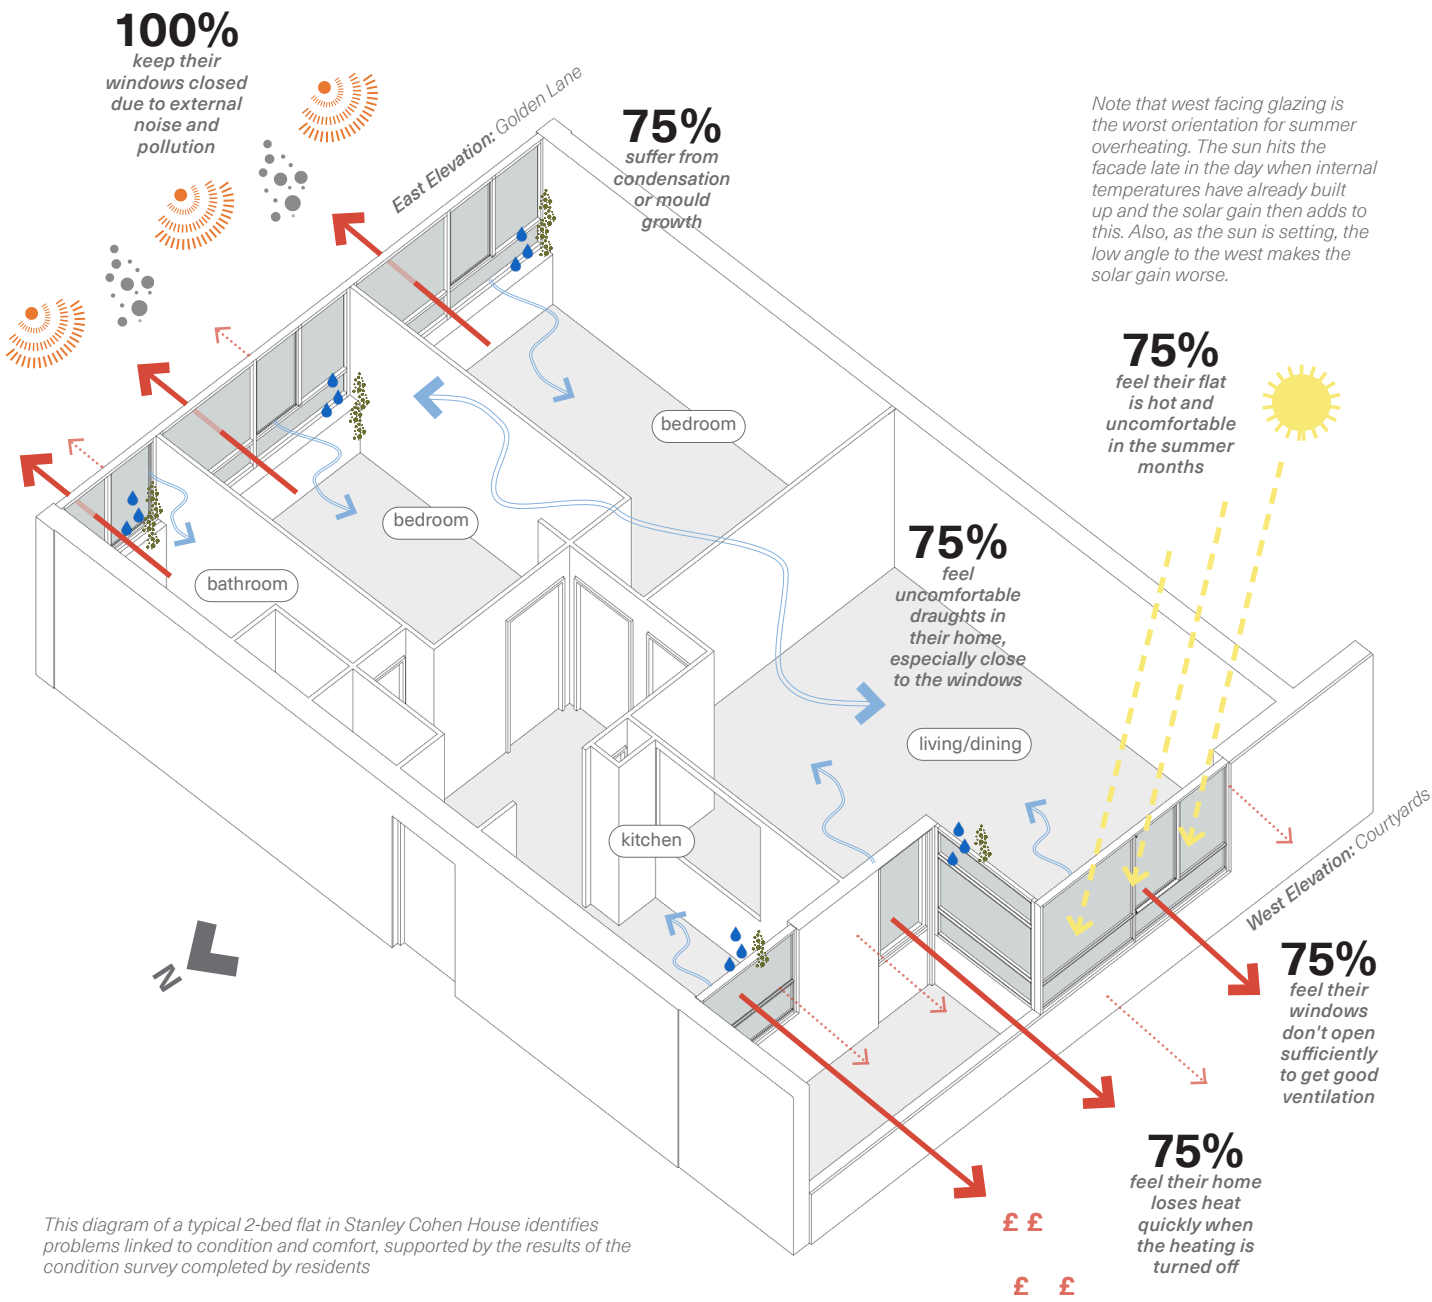
This diagram of a typical 2-bed flat in Stanley Cohen House identifies problems linked to condition and comfort, supported by the results of the condition survey completed by residents
