Crescent House

Windows Appraisal Report

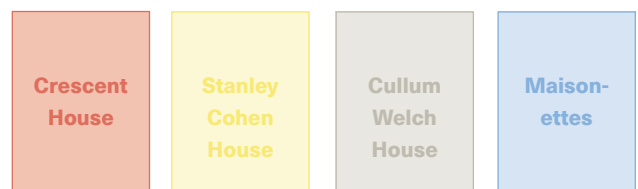
1.4 Heritage Context

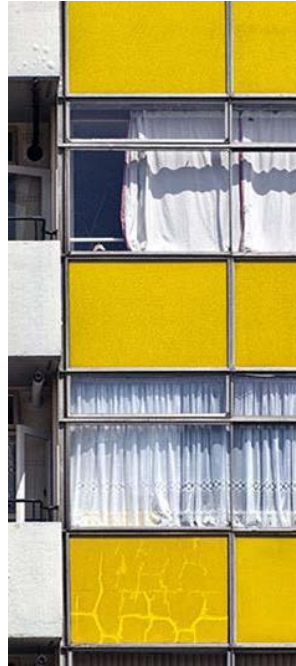
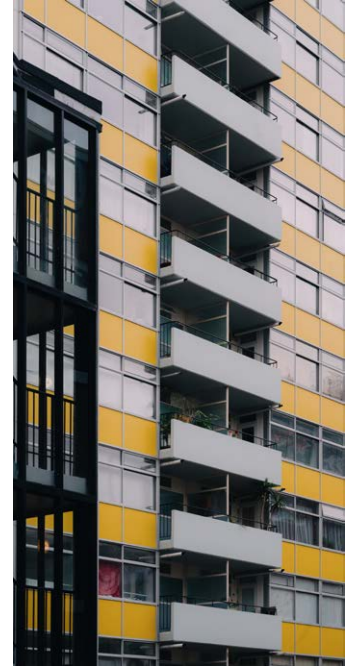
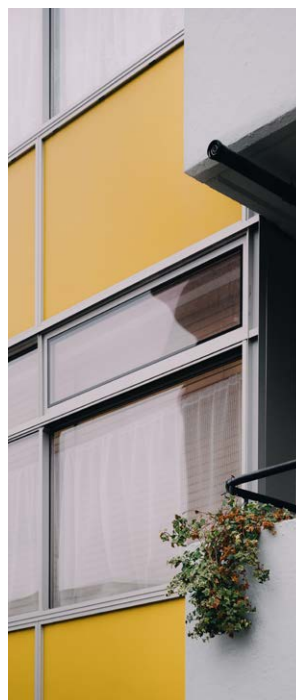
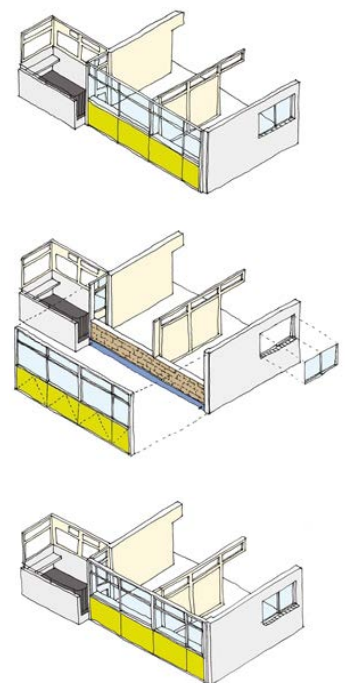
1. Great Arthur House

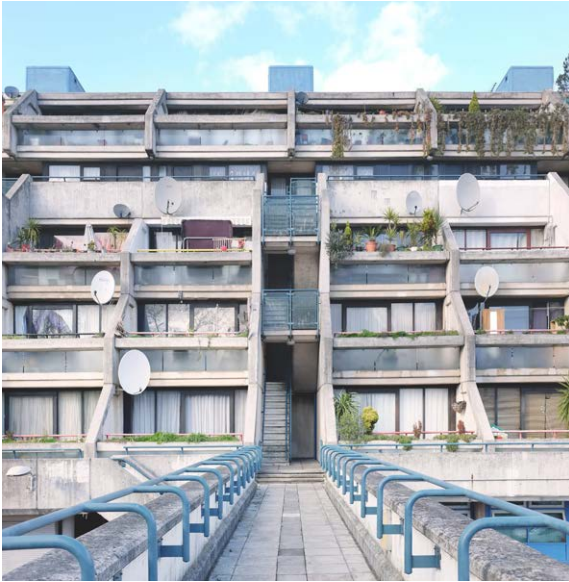
Alexandra Road Estate ahead of glazing replacement works.

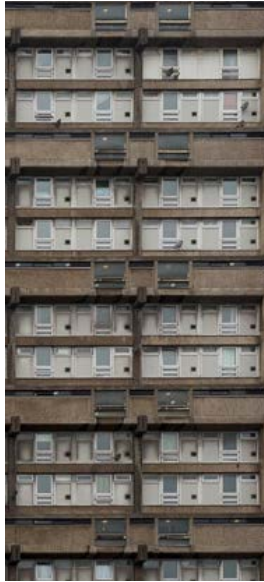
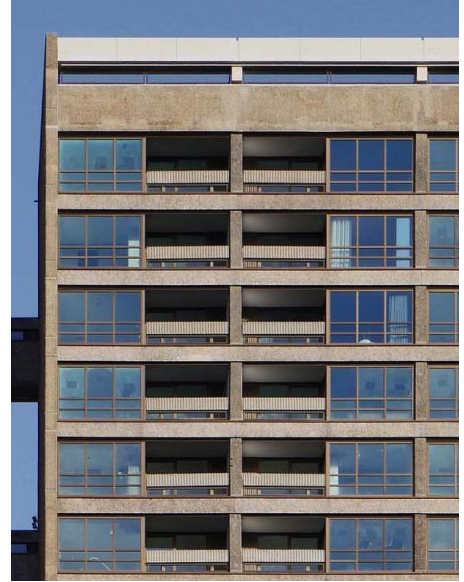
Balfour Tower (Tower Hamlets): Existing window/façade treatment (left) and new, replacement windows/façade (right).

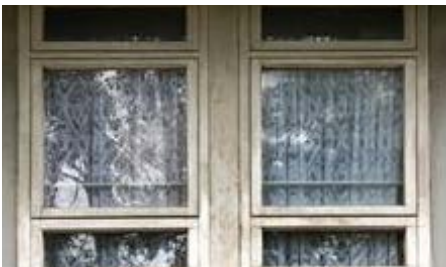
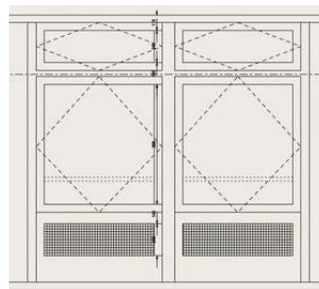
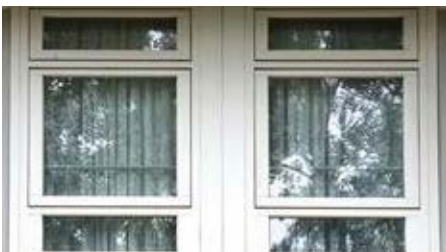
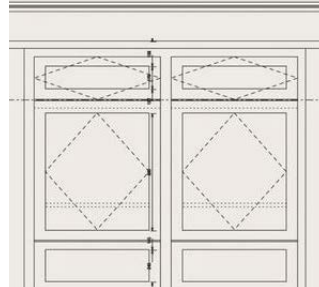
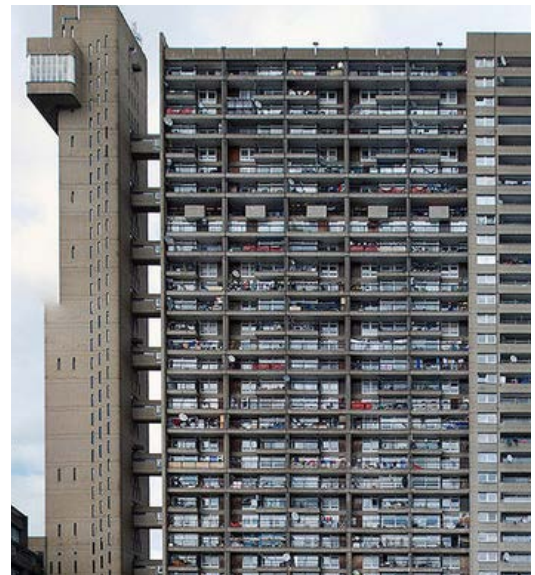
Trellick Tower (Notting Hill): The whole building (right); drawings of existing and proposed typical window, with the move from georgian wire glass to clear at low level (middle); before and after photos of window replacement (left).

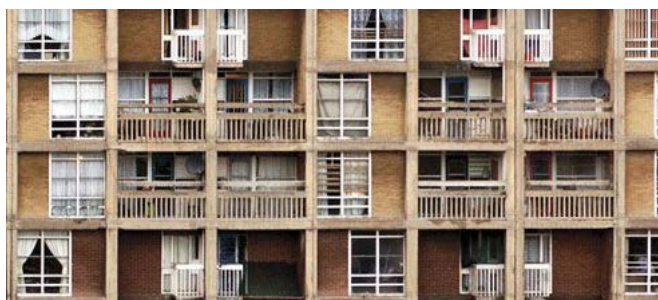
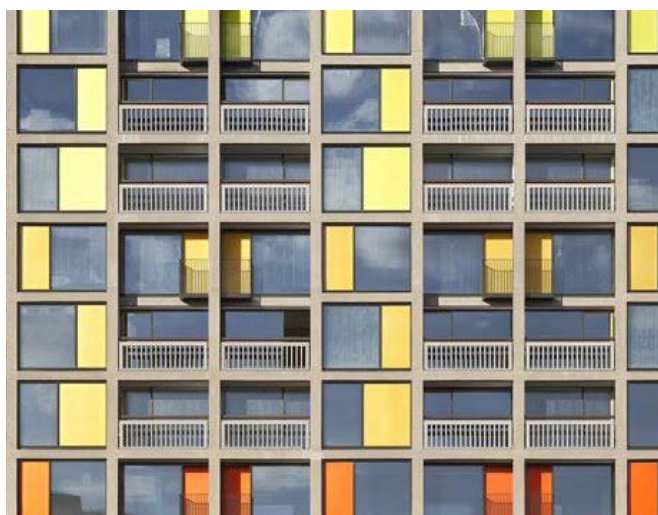
Park Hill Phase 1 (Sheffield): Existing window/façade treatment (top) and new, replacement windows/façade as part of phase 1 refurbishment works (bottom).

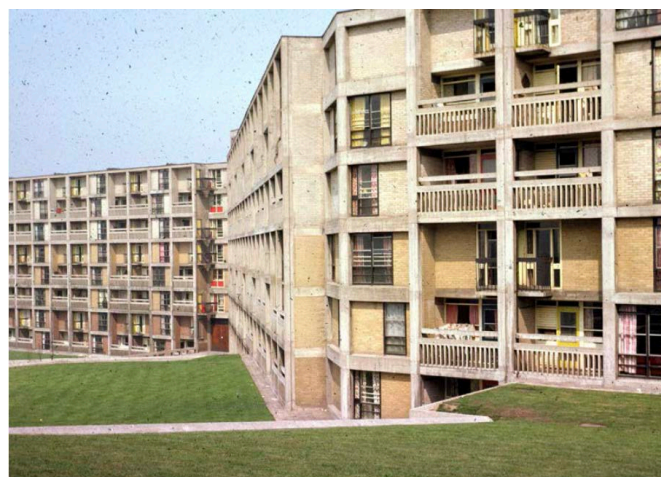
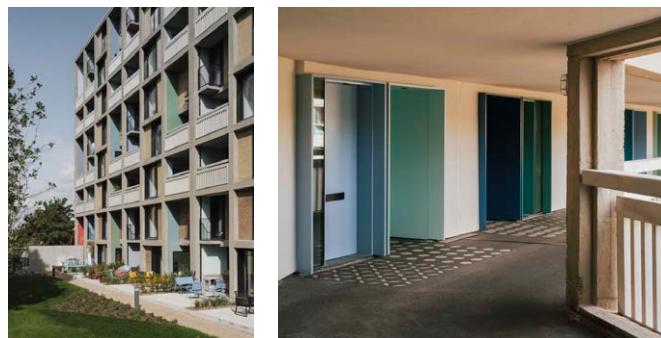
Park Hill Phase 2 (Sheffield): Existing window/façade treatment (top) and new, replacement windows/façade as part of phase 2 refurbishment works (bottom).

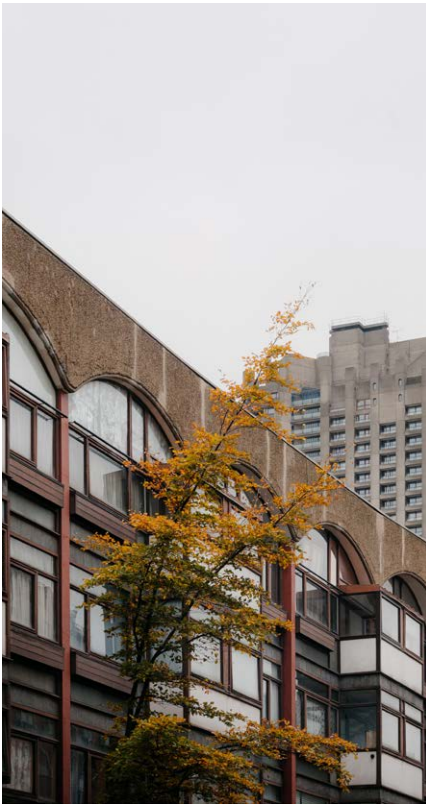
Crescent House West elevation, facing Goswell Road, highlighting the barrel vaulted in situ concrete and dark wood window frames.

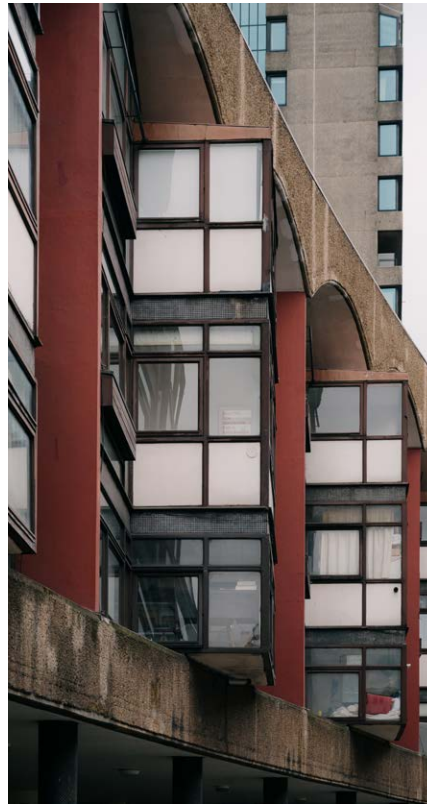
Crescent House highlighting the projecting oriel windows and the rust-red painted rendered concrete cross walls, progressively projecting further forward towards the North and South.

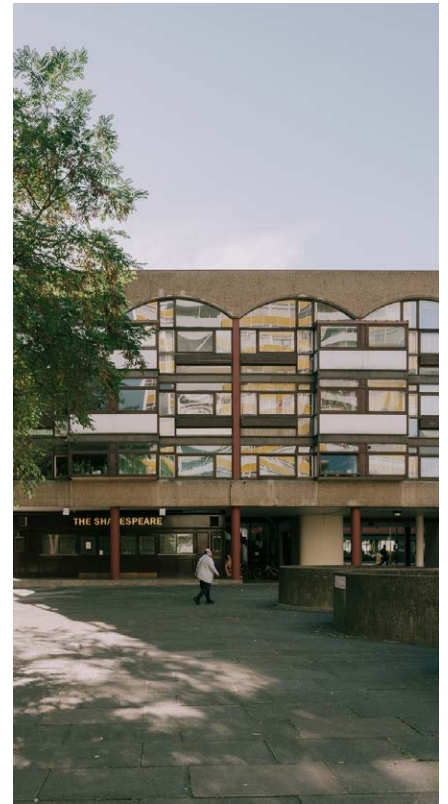
Crescent House East elevation, facing the courtyards and Great Arthur House, highlighting the three different window configurations on the first, second and third floor.

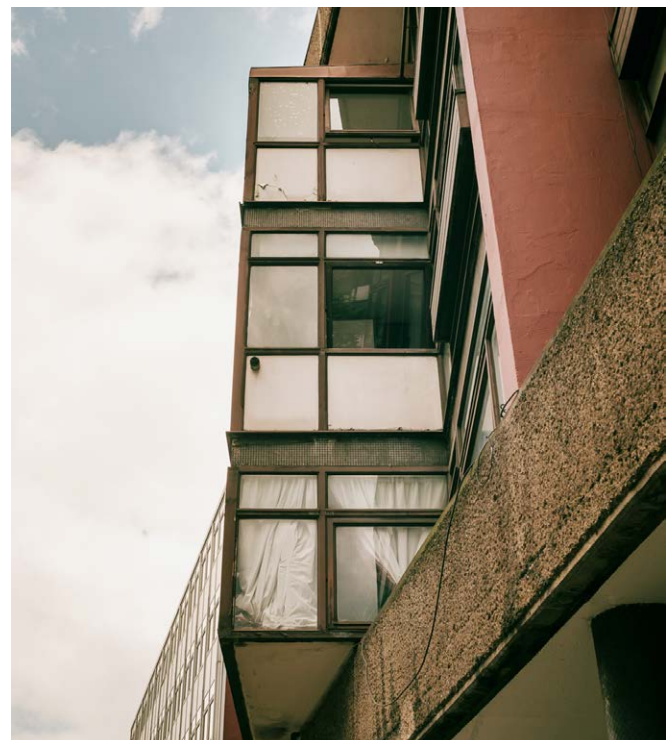
The west elevation projecting oriel windows, facing Goswell Road.

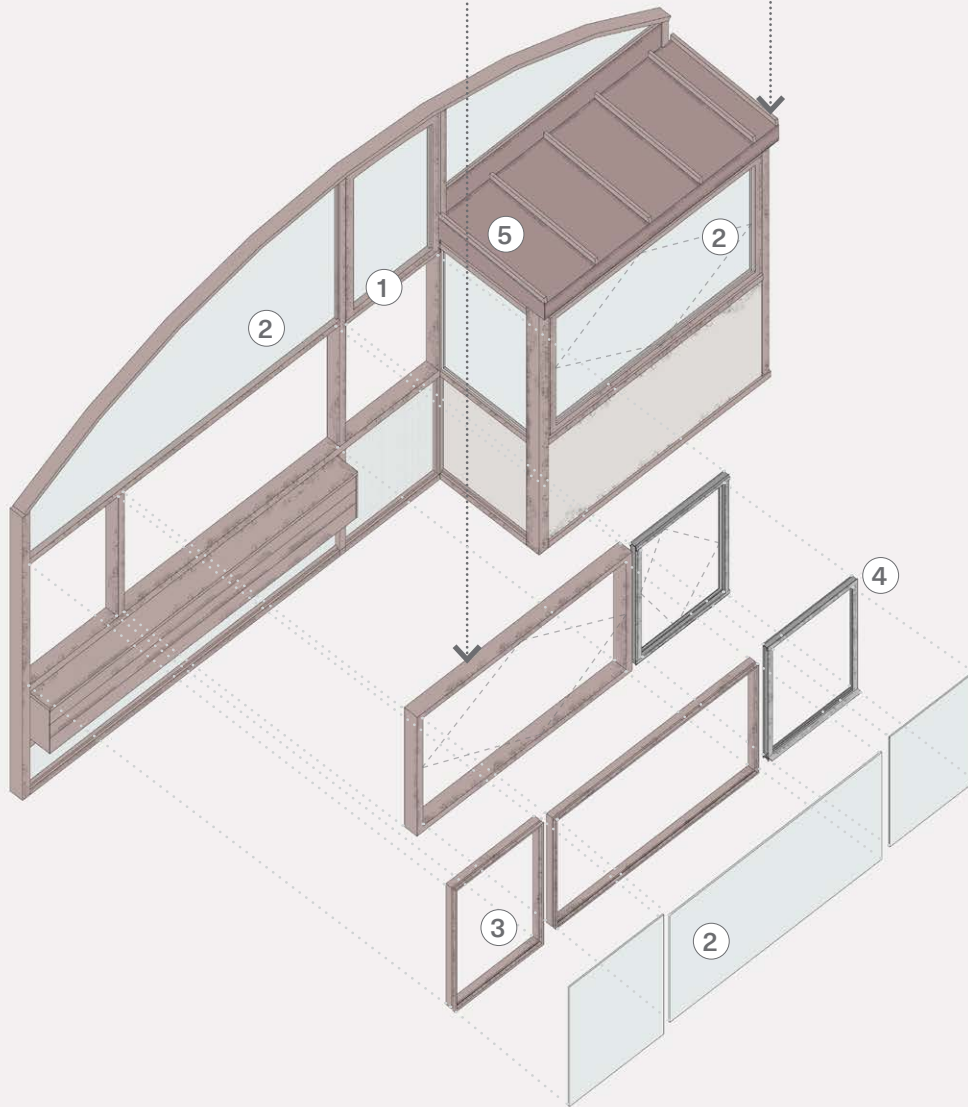
The existing oriel roof presents some design issues and does not provide adequate draining which over time has damaged the timber corner posts.

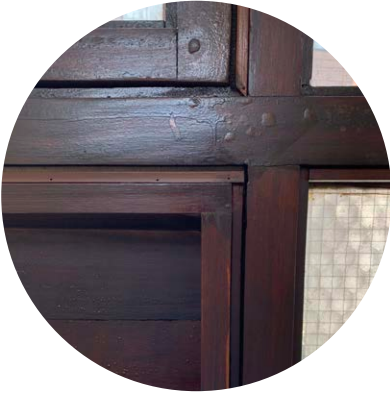
Hardwood timber window frame

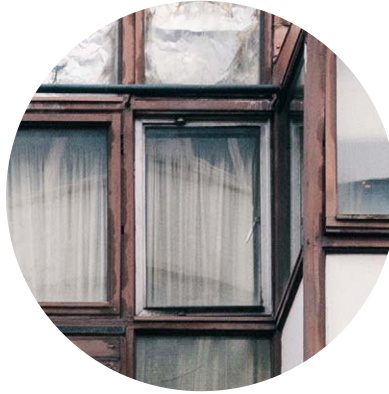
Aluminium window frame

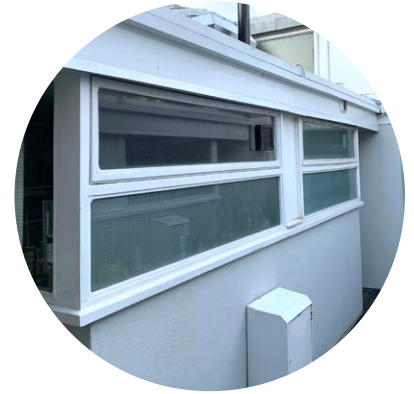
Softwood timber window frame

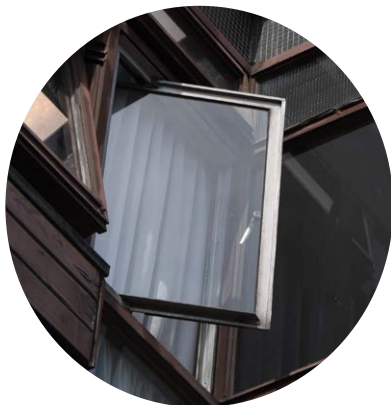
Vertical, central pivot opening light

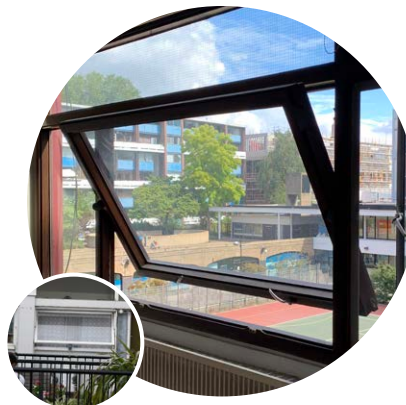
Horizontal, central pivot opening light

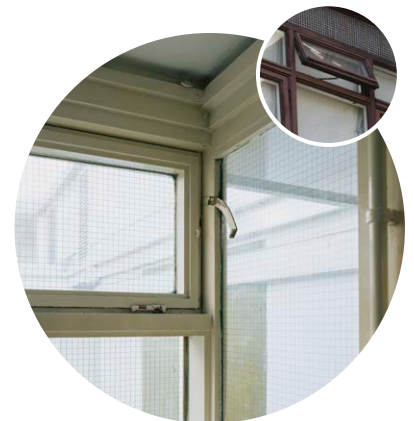
Bottom and top hung opening light

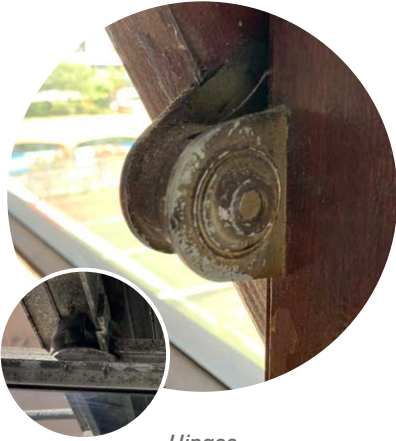
OPERATION & IRONMONGERY

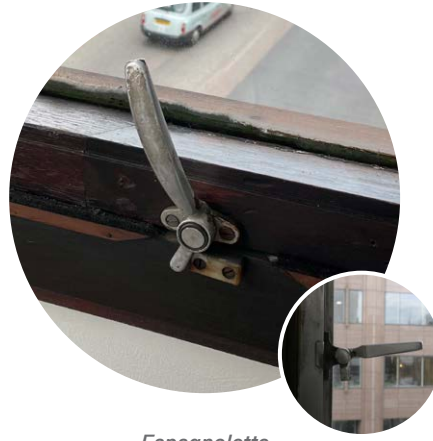
Original brass pivot hinges are found in most windows with this opening mechanism. Aluminium pivot hinges incorporated into aluminium frame (small image).

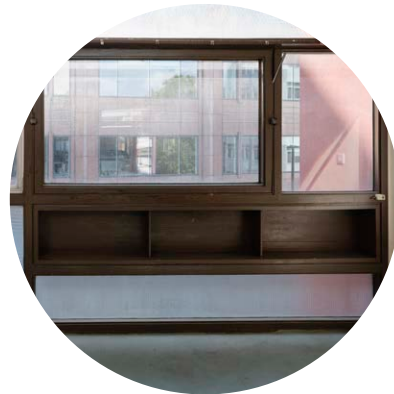
White, Muroglass spandrel panels found beneath the windows on the projecting oriel windows and under windows on the western façade at the far northern end.

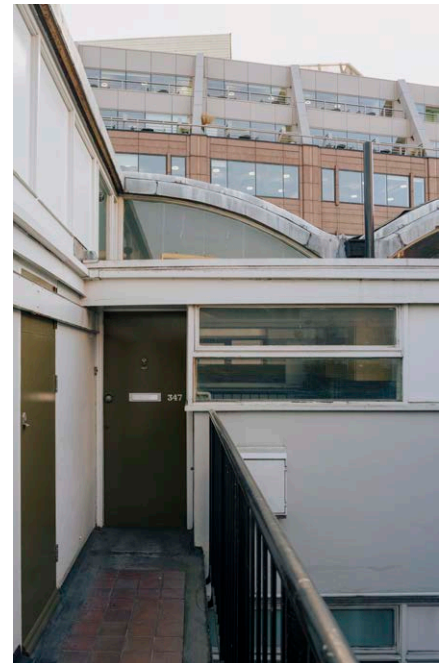
A section of the internal lightwell elevation, showing the kitchen and bathroom. Note that these elevations vary more from flat to flat than the external elevations.

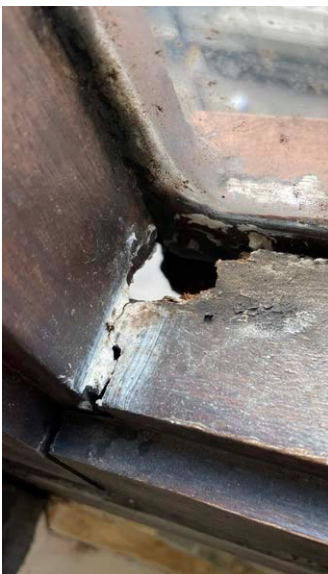
Deterioration of the hardwood frame/sill on the west façade where the glass pane has become exposed to the elements. Evidence of mould growth.

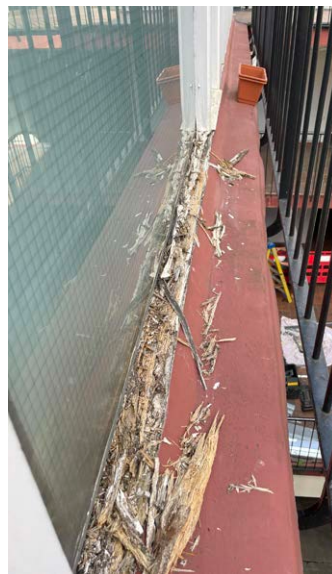
Deterioration of the softwood frame/sill on the kitchen window facing the internal lightwells.

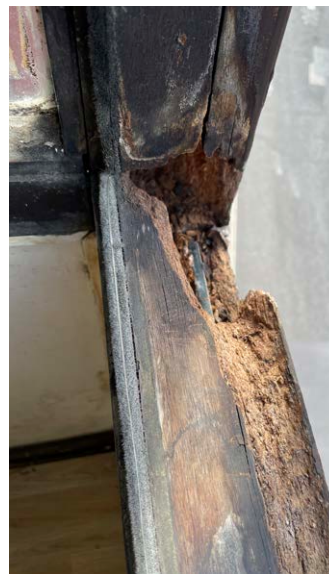
Deterioration of the hardwood frame/sill on the west façade (oriel window).

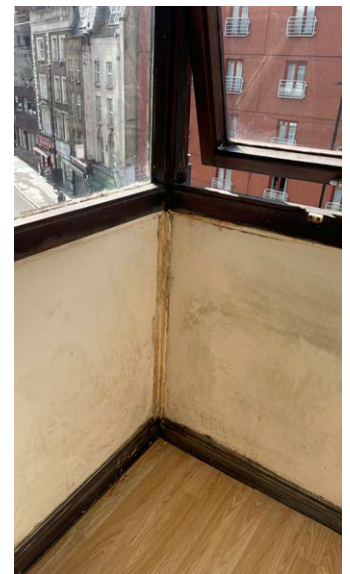
Paintwork deteriorating on timber frame and the spandrel panel. Evidence of mould growth.

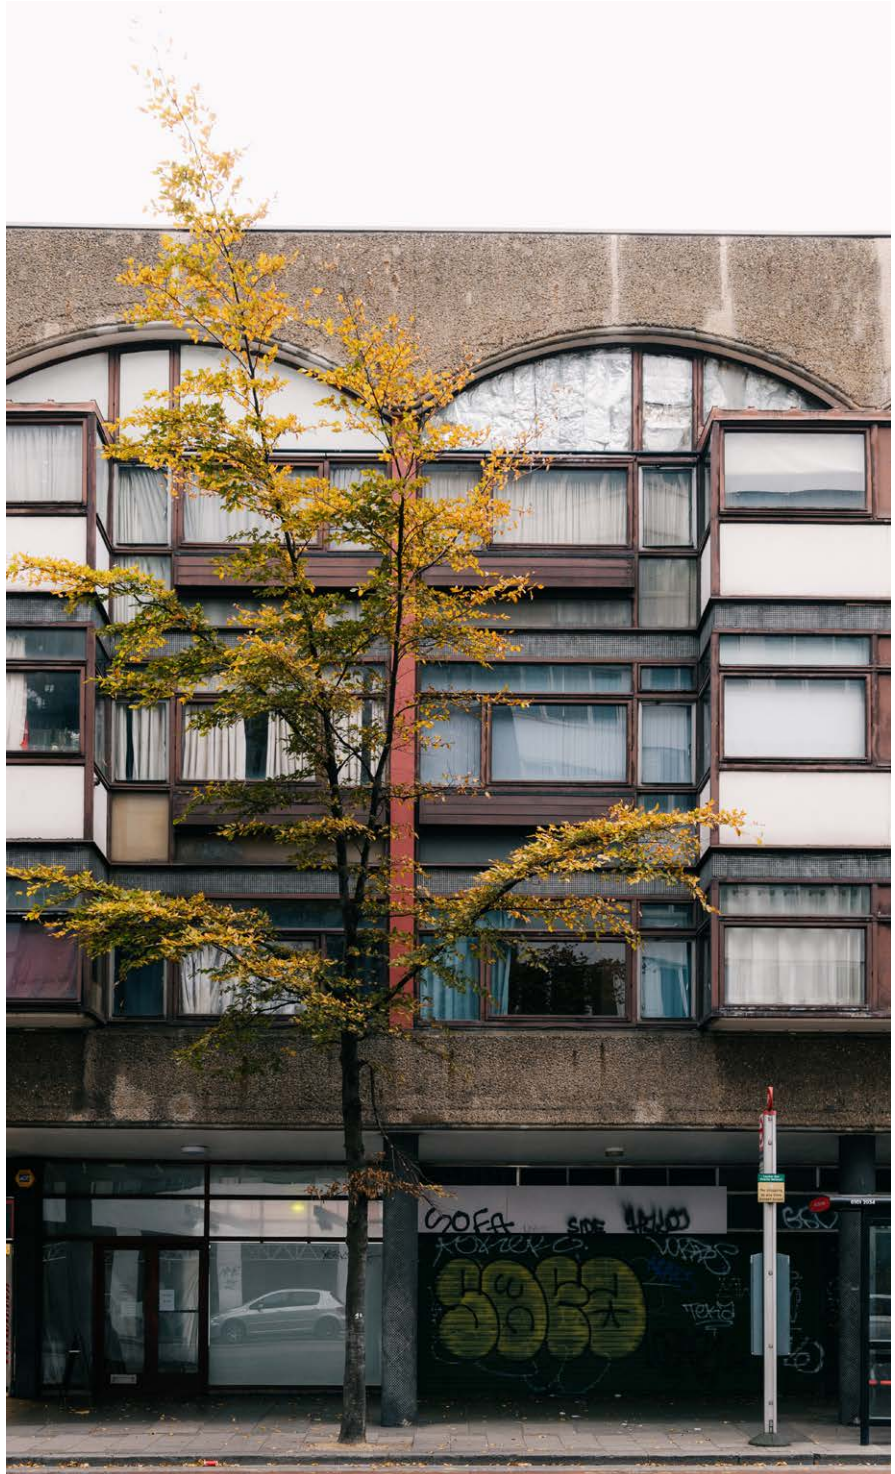
Crescent House West elevation, highlighting the three different types of windows across the three floors and their relationship with the ground floor retail units.

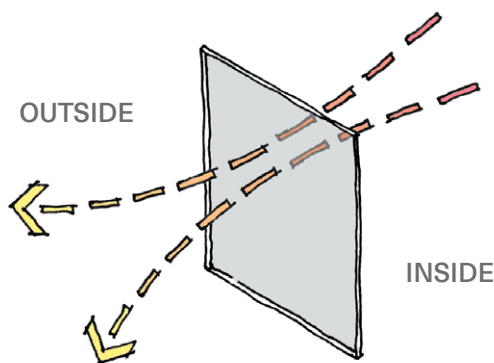
Heat loss through single glazing is significant as the glass has a high thermal transmittance - it is a very good transferer of heat (not good for heat retention in homes!). Glass is better at retaining heat when it is high performance (vacuum/double/triple) and in an insulated (thermally broken) frame. A standard single glazed unit has a U-value of up to $5.8 \text{ W}/(\text{m}^2\text{K})$.

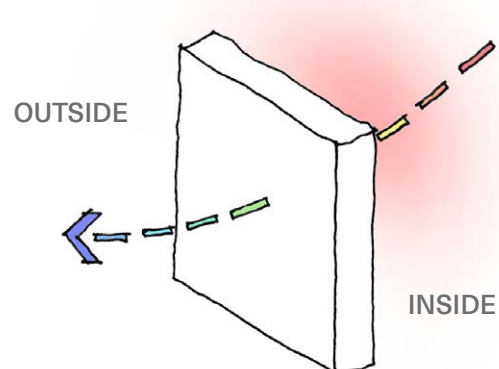
Heat loss through external walls is less significant as a typical wall build up does not have a thermal transmittance rate as high as glass - it is better at retaining heat. A standard solid brick wall has a U-value of $2 \text{ W}/(\text{m}^2\text{K})$.

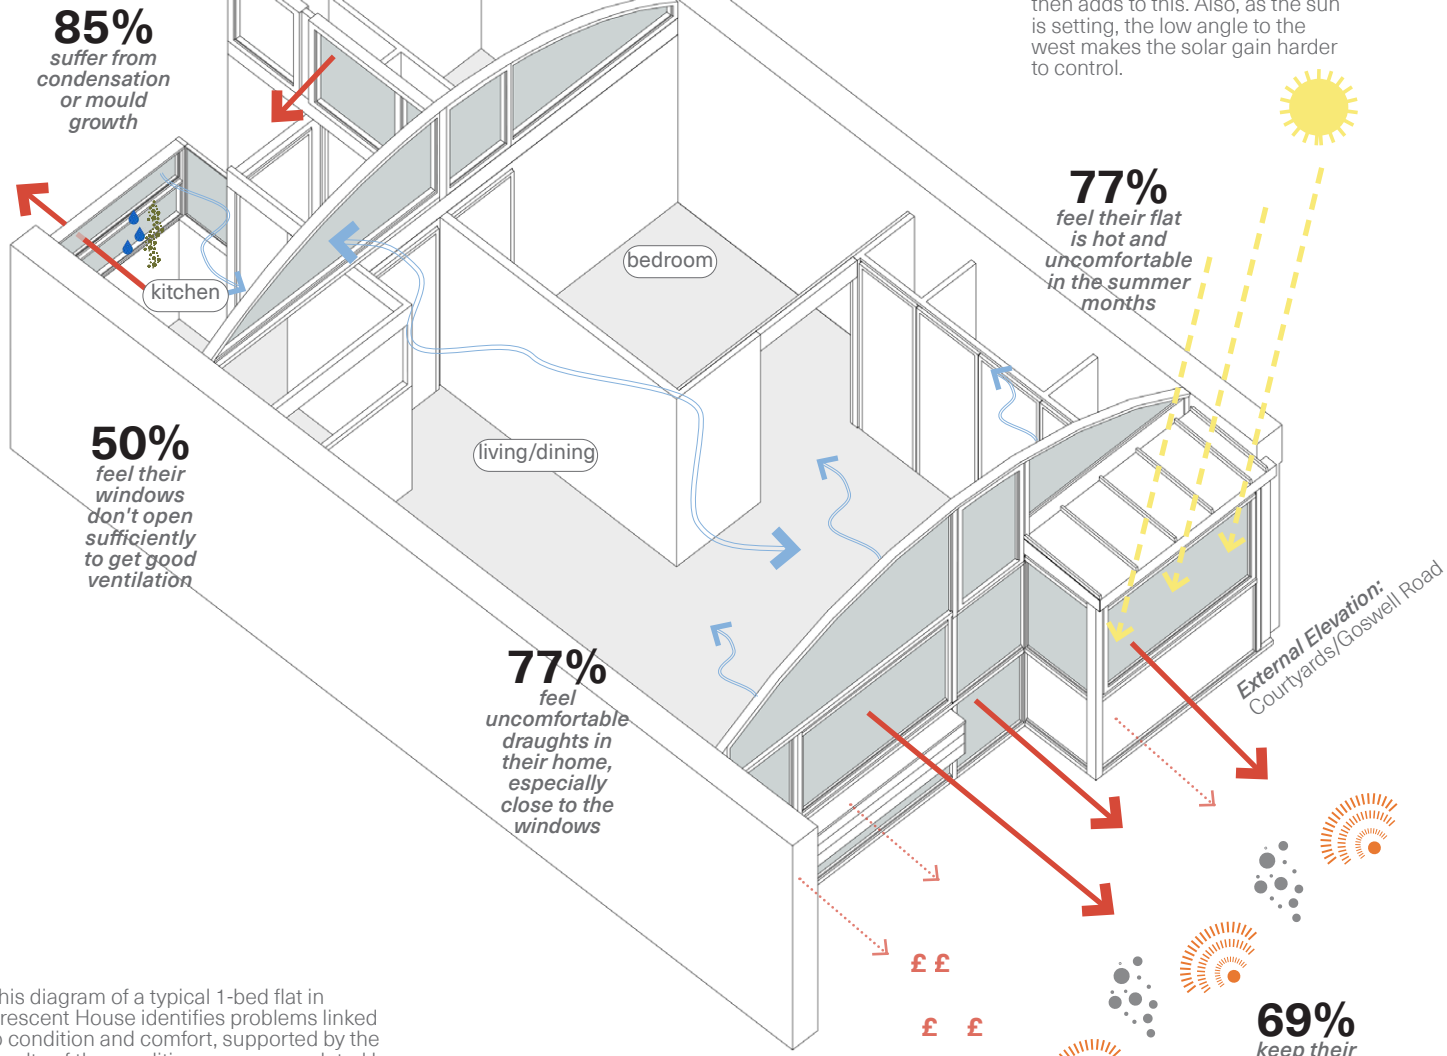
This diagram of a typical 1-bed flat in Crescent House identifies problems linked to condition and comfort, supported by the results of the condition survey completed by residents

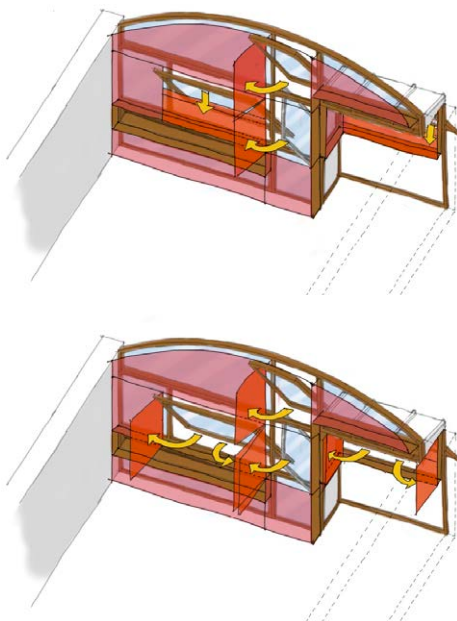
Exploration of a secondary glazing option which highlights the difficulties with operating the opening horizontally pivoting windows.

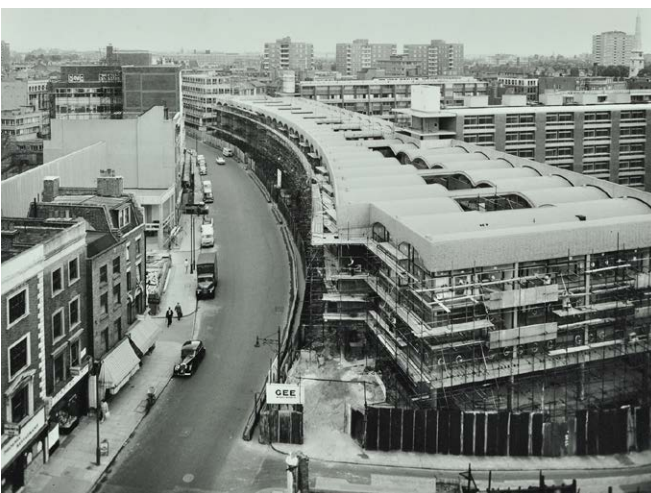
Certain parts of Crescent House were made off site whilst others were jointed on site. The frames and the concrete structure meet with no obvious details to accommodate tolerances, suggesting that a high level of custom sized joinery exists in the façade of Crescent House.

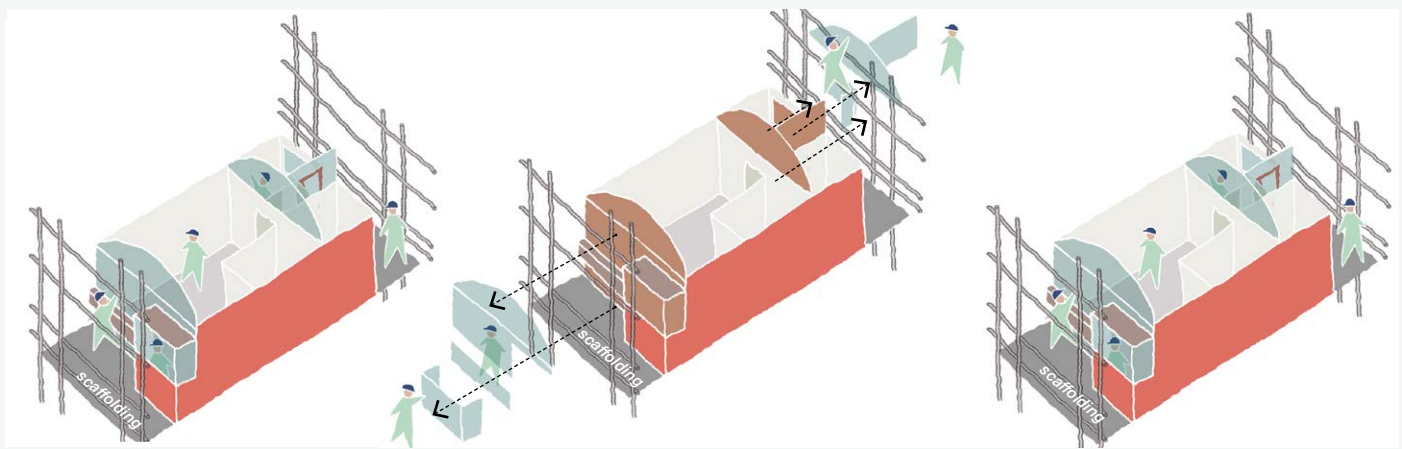
Step One: Install scaffold. Temporarily remove existing glass to template for new vacuum glazing. Measure glass and place order (min 12 weeks from order to delivery). Strip decorations on existing window frames. Establish extent of repair needed for the frames and estimate programme for the repair works. Put existing glass back in. (1 week)

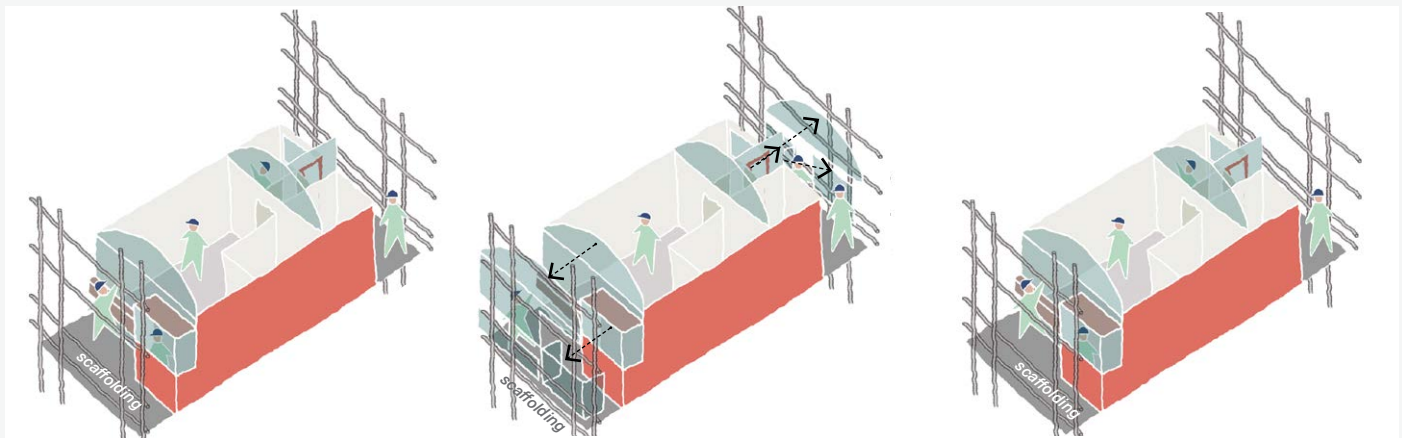
Step One: Install scaffold. Measure existing frames and openings to place order for new frames (8 weeks from order to delivery).

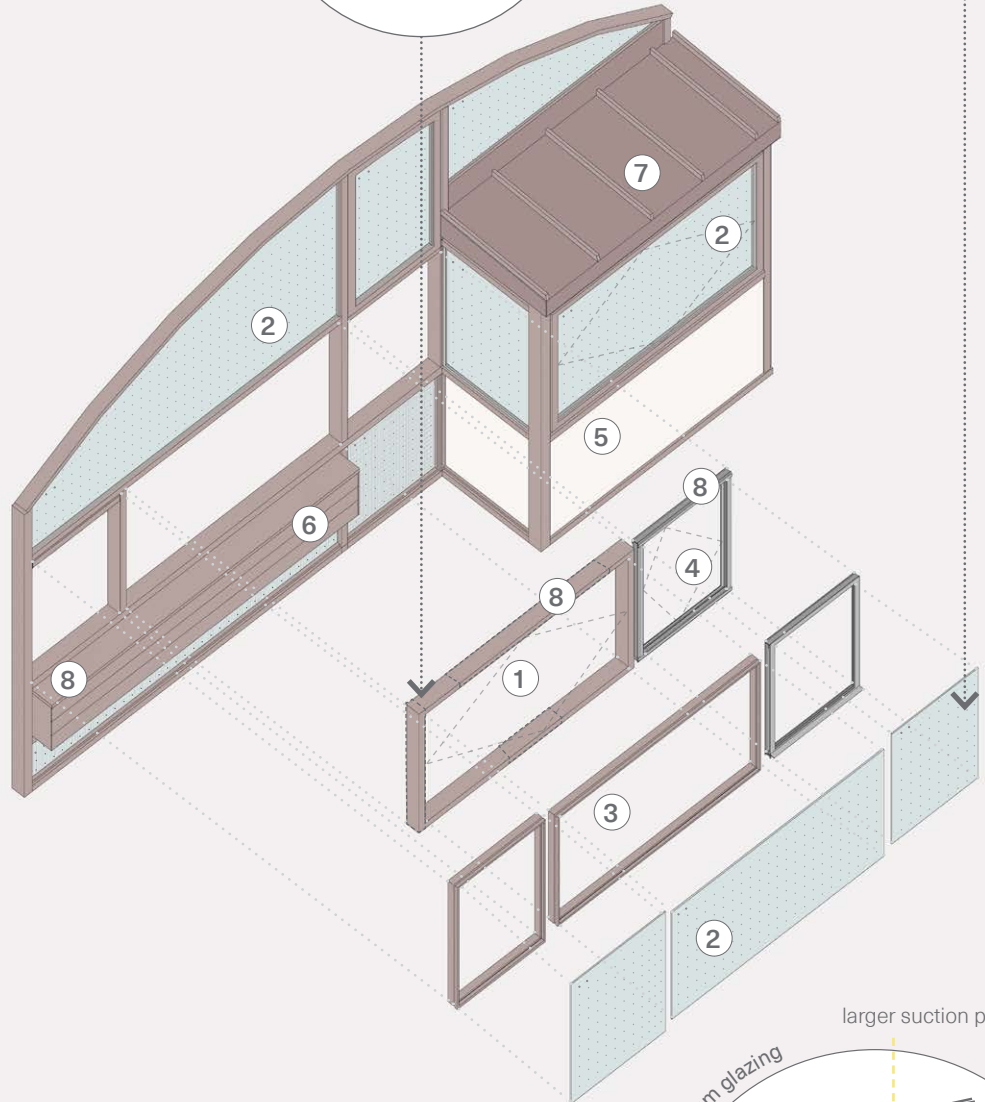
Increasing the thickness of the glass will likely mean that the glass is very slightly darker. Microspacers/plugs/getters are indicative

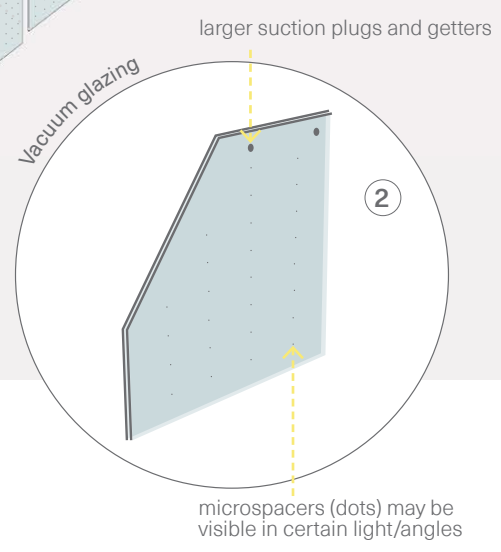
This drawing highlights the different elements of a typical, **refurbished** window at Crescent House. The principles can be applied to all windows in the block, apart from the internal lightwell facing softwood windows (these are not described as significant in heritage terms). Principally, the vast majority of the frames are hardwood and open by pivoting centrally horizontally, vertically or top hung.

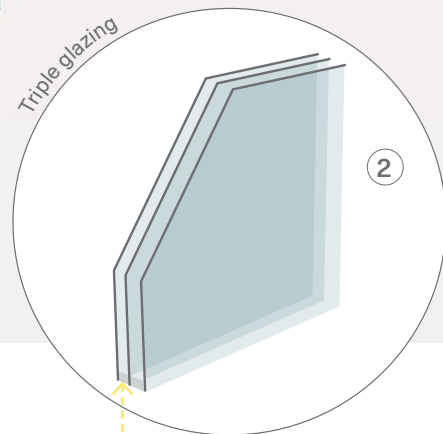
This drawing highlights the different elements of a typical, **replacement** window at Crescent House. The principles can be applied to all windows in the block, apart from the internal lightwell facing softwood windows (these are not described as significant in heritage terms). The majority of the frames are hardwood and open by pivoting centrally horizontally, vertically or top hung. All to match existing. High performance glazing could be vacuum, double or triple, however, triple glazing is shown as this would have the maximum thermal and acoustic improvement.

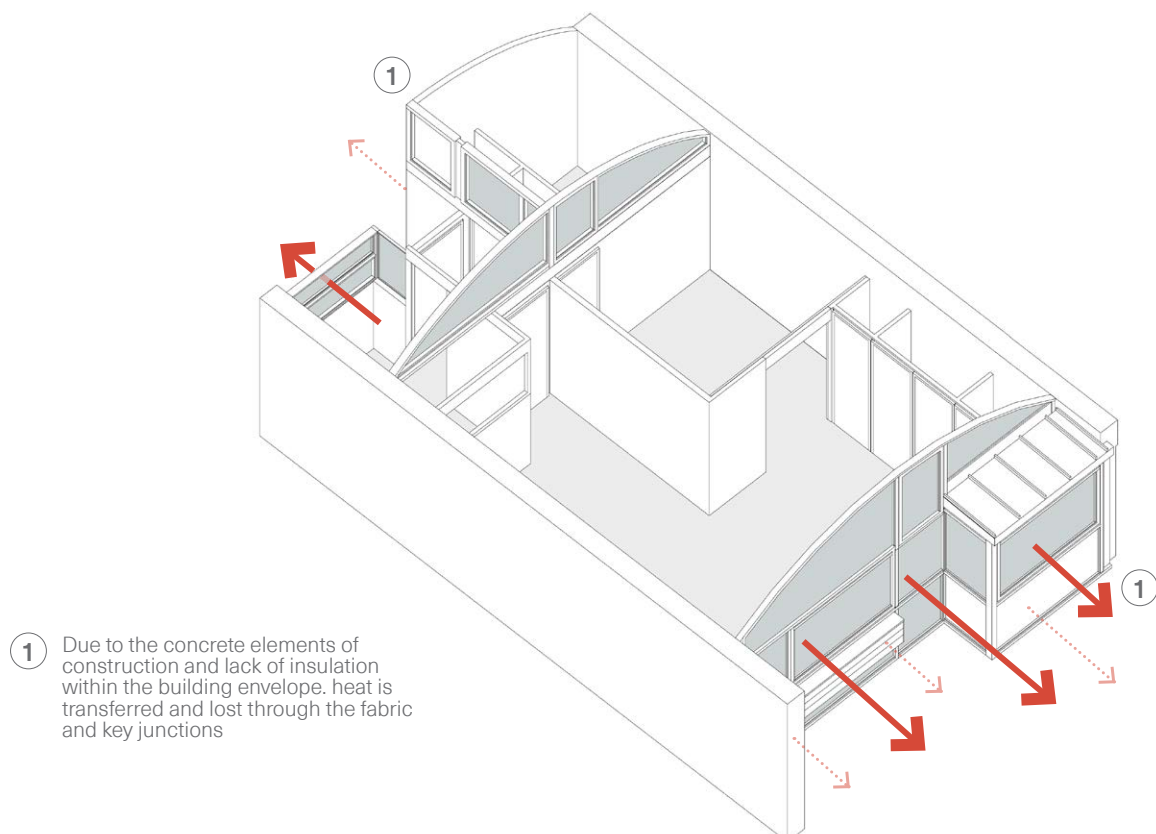
7.3 Air Infiltration

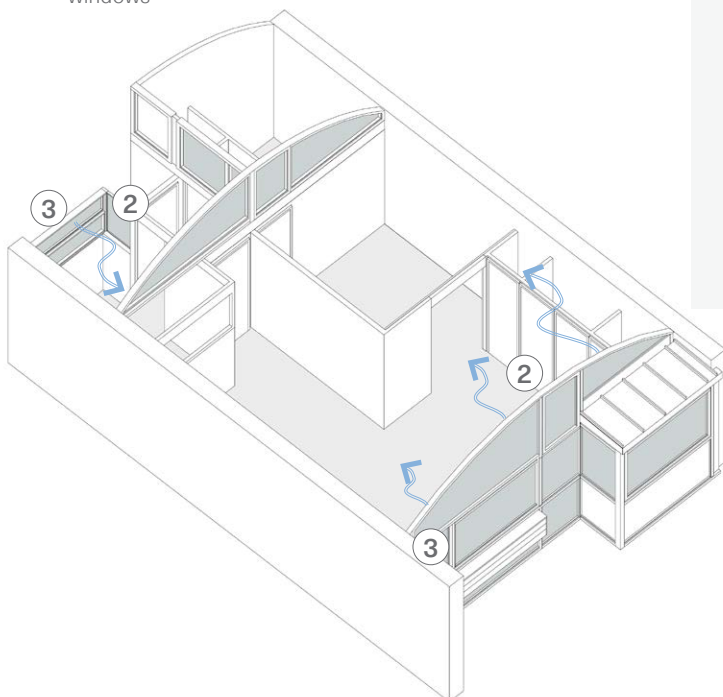
② Excess air infiltration is experienced as cold draughts, particularly near windows

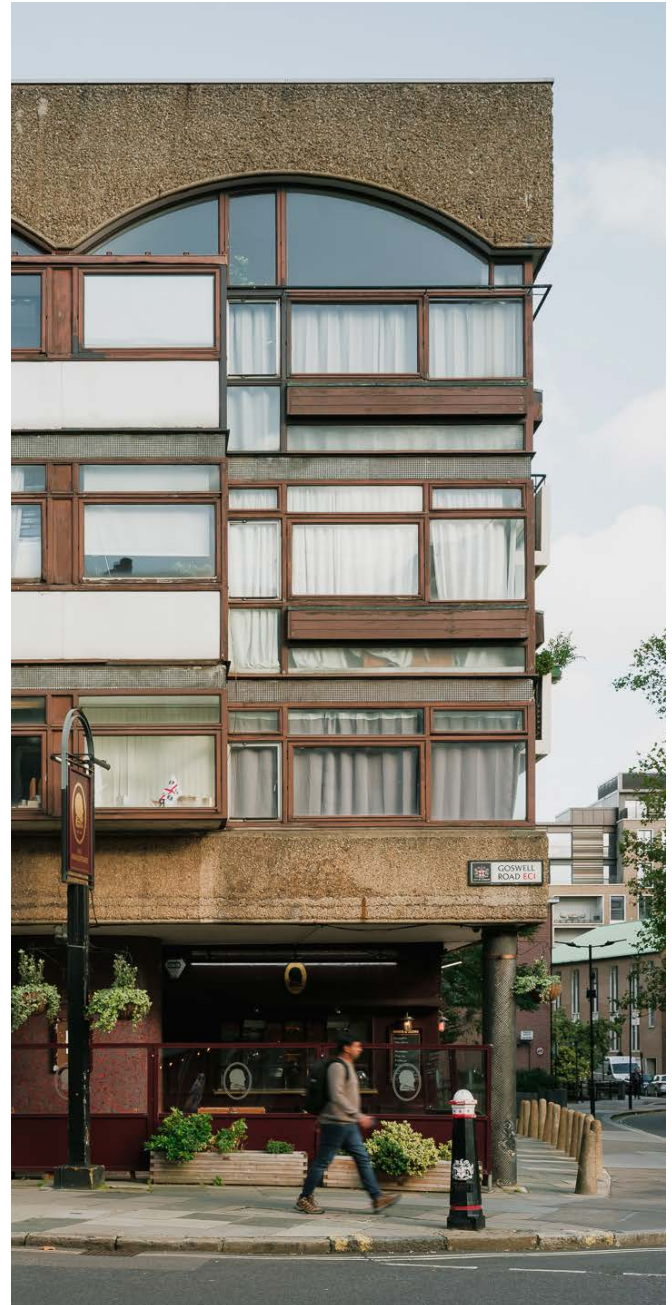
The south western corner of Crescent House on Goswell Road, highlighting the building's position as a boundary to the wider estate and The Shakespeare pub on the ground level.
