Beinneun 2 Wind Farm

Technical Appendix A6.5: Fish

Document prepared by the Ness District Salmon Fisheries Board for Beinneun 2 Ltd

# Beinneun 2 Windfarm Habitat and Fish Population Survey

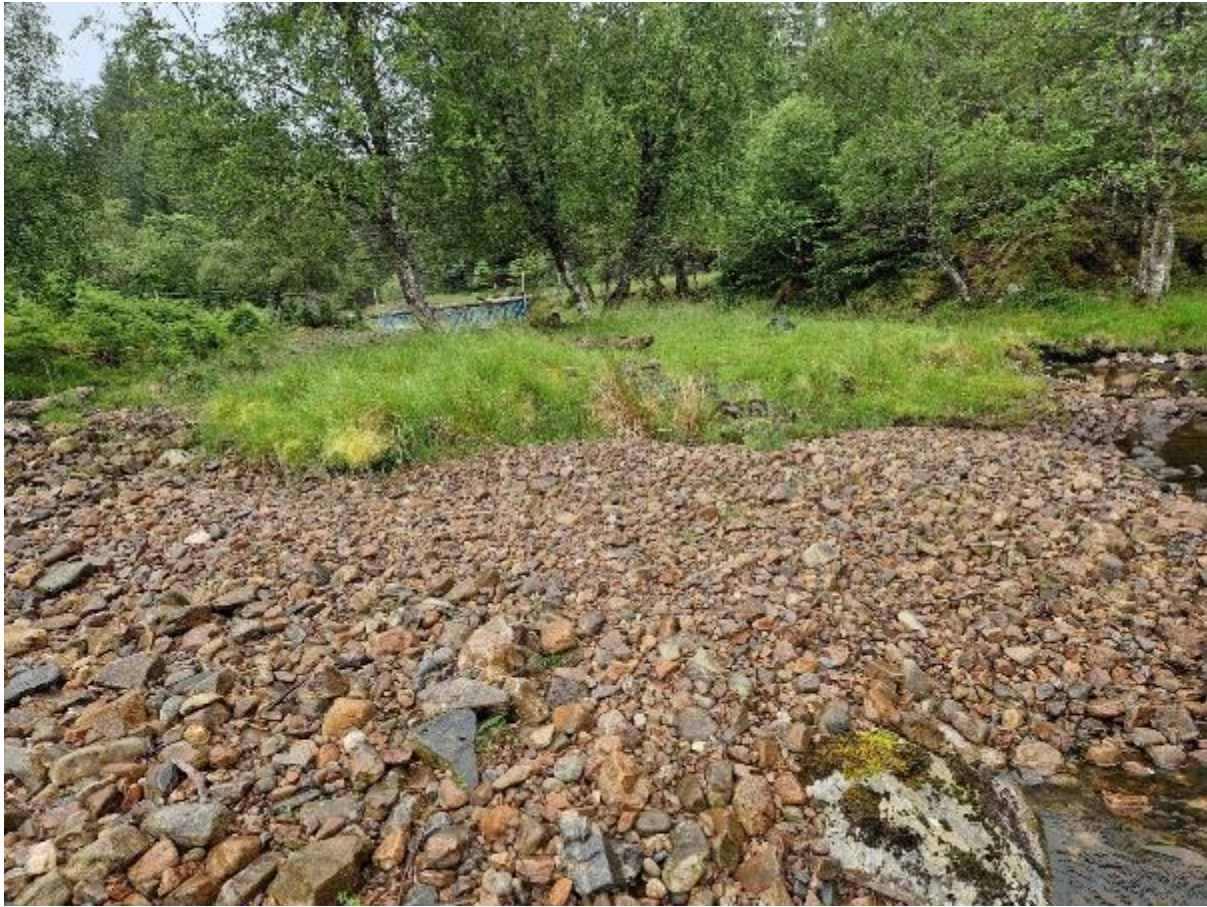
Bealach Odhar is an important tributary in terms of the addition of sediments within the River Moriston. A photograph of this feature is shown below in **Figure 4**.

*Figure 4: Gravel Cone at the confluence with River Moriston*

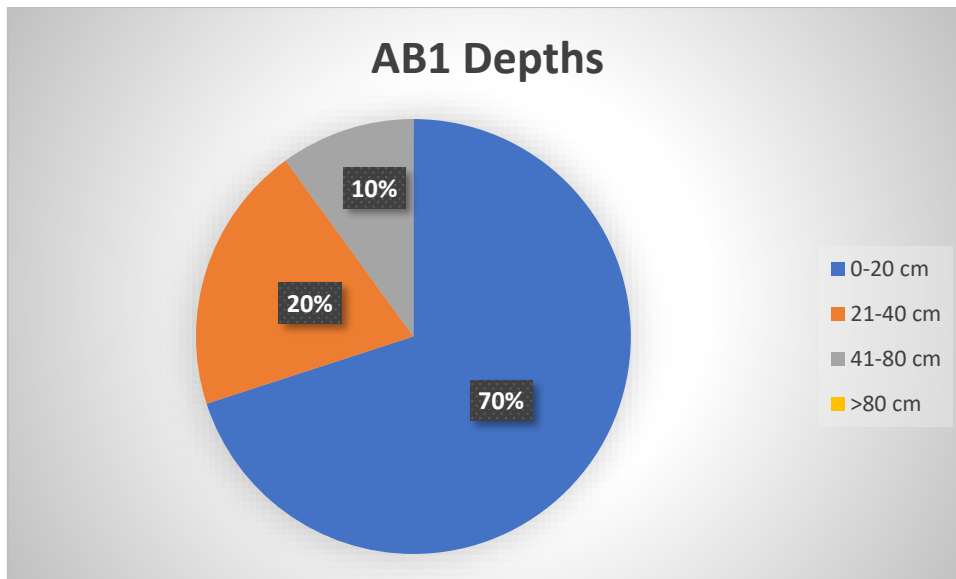
Depths throughout the transect length were relatively shallow with the majority being in the <20cm and 21cm-40cm range although occasional pockets of slightly deeper areas were observed both at the start and at the upstream extremity. These depths were recorded as a percentage of the whole transect and are shown below in **Figure 5**.

**Figure 5: Depths recorded as a percentage for Transect AB1**

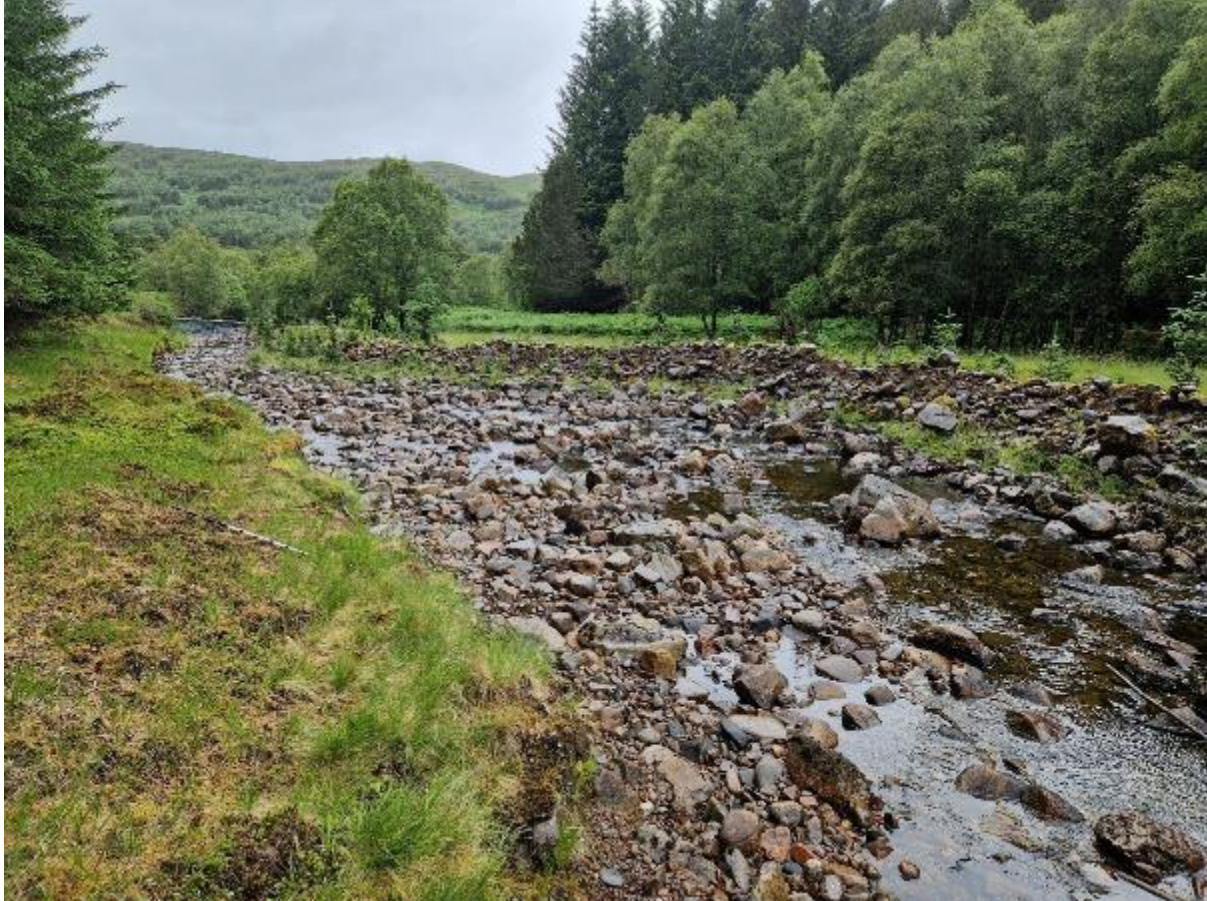
It was noted that instream substrate has historically been utilised for bank reinforcement/flood prevention on the right bank. The photograph below in **Figure 7** shows a downstream view of the transect with the flood bank and instream habitat shown.

*Figure 7: Downstream view of transect AB1 showing instream habitat and flood bank.*

Overall Transect AB1 offered good to excellent juvenile salmonid habitat with a good mixture of substrates providing plenty of cover for juvenile salmonids. Spawning areas were patchy but likely to be utilised by salmon with access unhindered to this area. Juvenile salmonids were observed during the survey although it was difficult to ascertain species. The area where dredging had occurred presents a potential restoration opportunity.

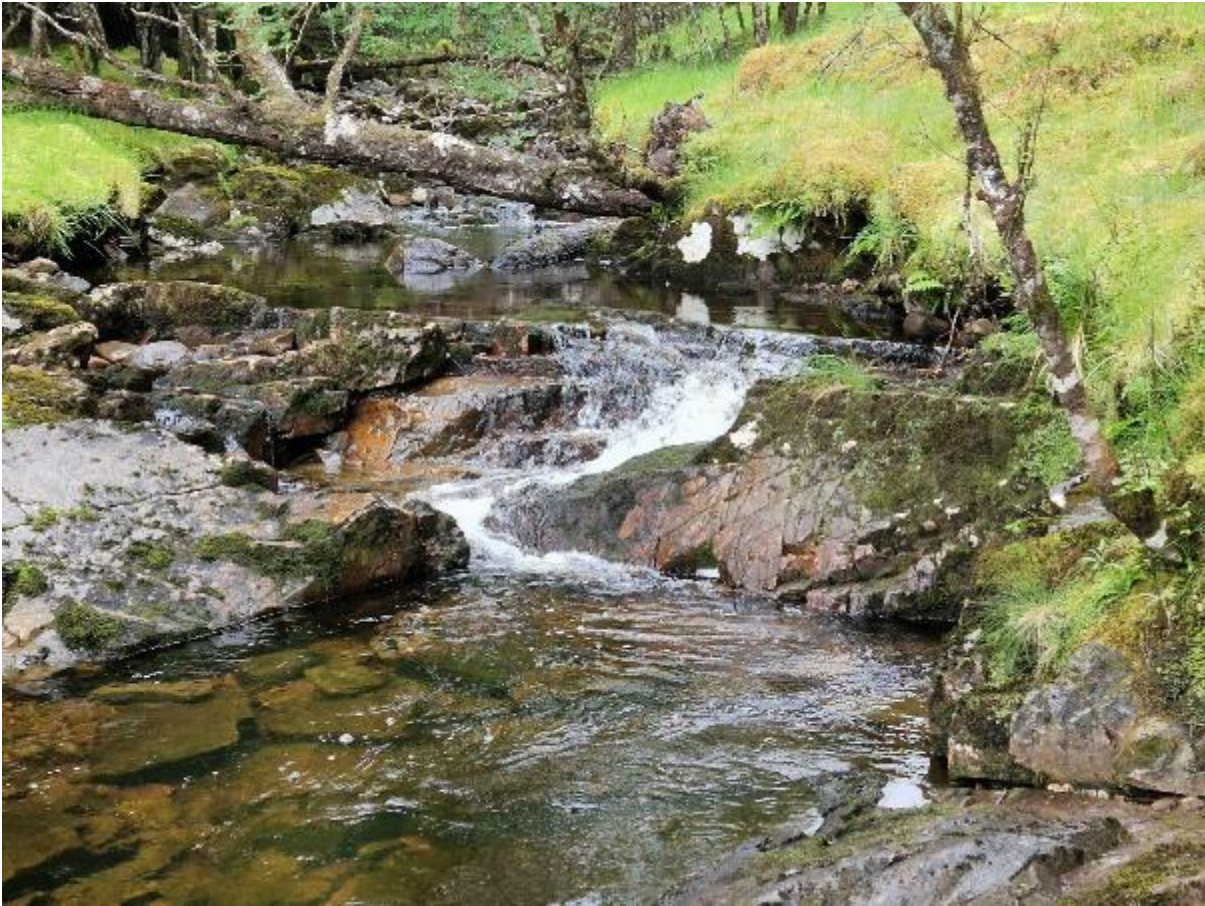
*Figure 9 The start of a series of waterfalls/cascades at the upper limit of Transect AB1*

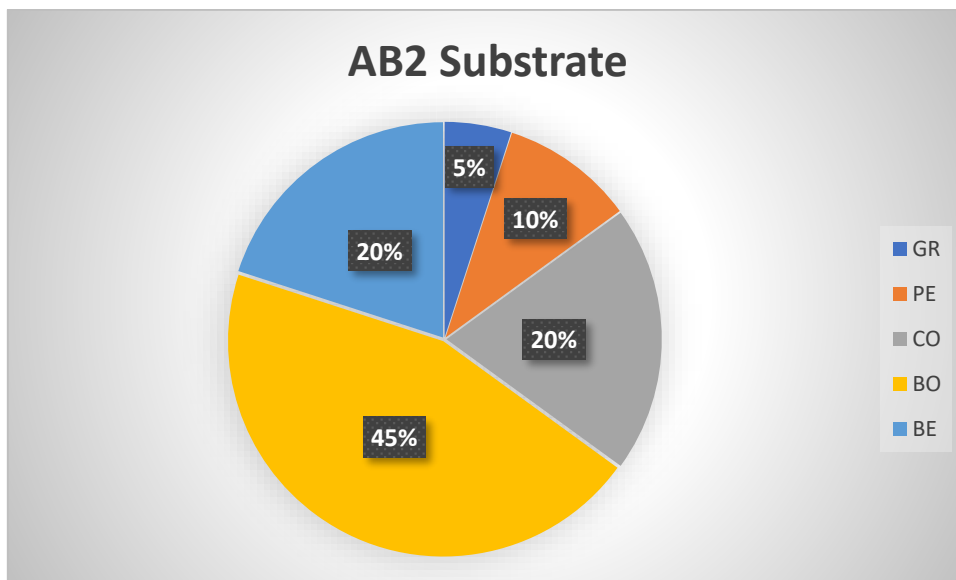
Substrate was much larger overall in transect AB2. Bedrock dominated with boulder and was minimal throughout the transect length. Transect AB2 offered very little spawning with approximately 80m<sup>2</sup> recorded, this was again spread throughout the transect with the majority found below the bridge at the top of the site. Substrate types are shown below in **Figure 11**.

*Figure 11: Substrate types shown as a percentage for Transect AB2*

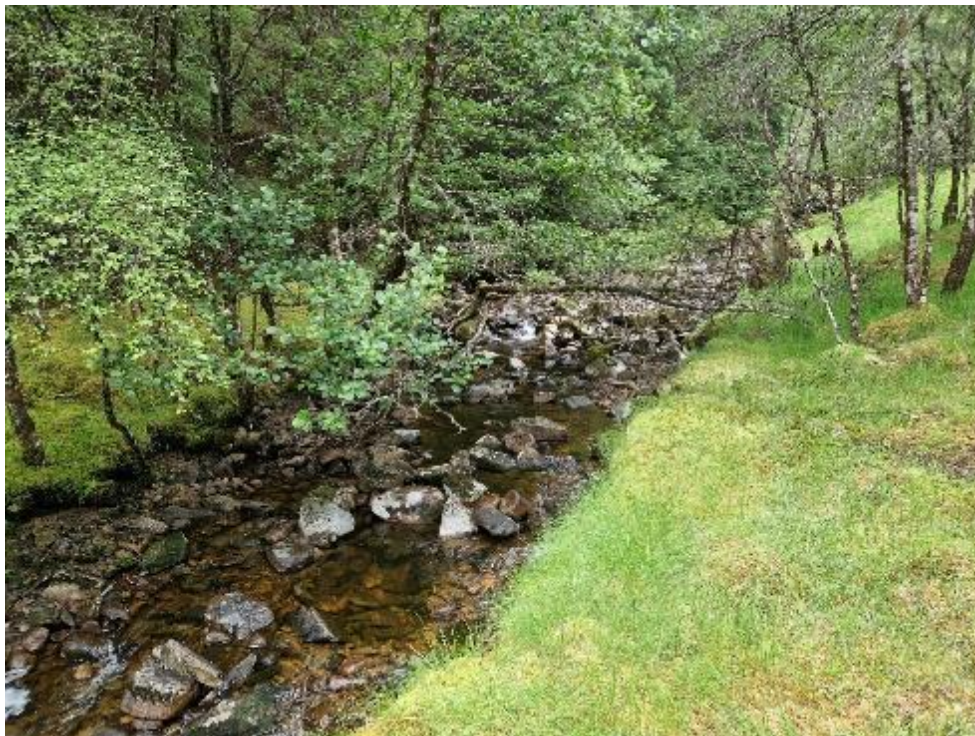
**Figure 13: Upstream view at the start of Transect AB2.**

There was no fish cover on both banks throughout the transect. The Riparian zone was predominantly ageing conifer with sporadic deciduous trees. The bank face vegetation on both banks was uniform in nature and both bank tops were complex. Canopy cover was recorded as 60% providing good shading.

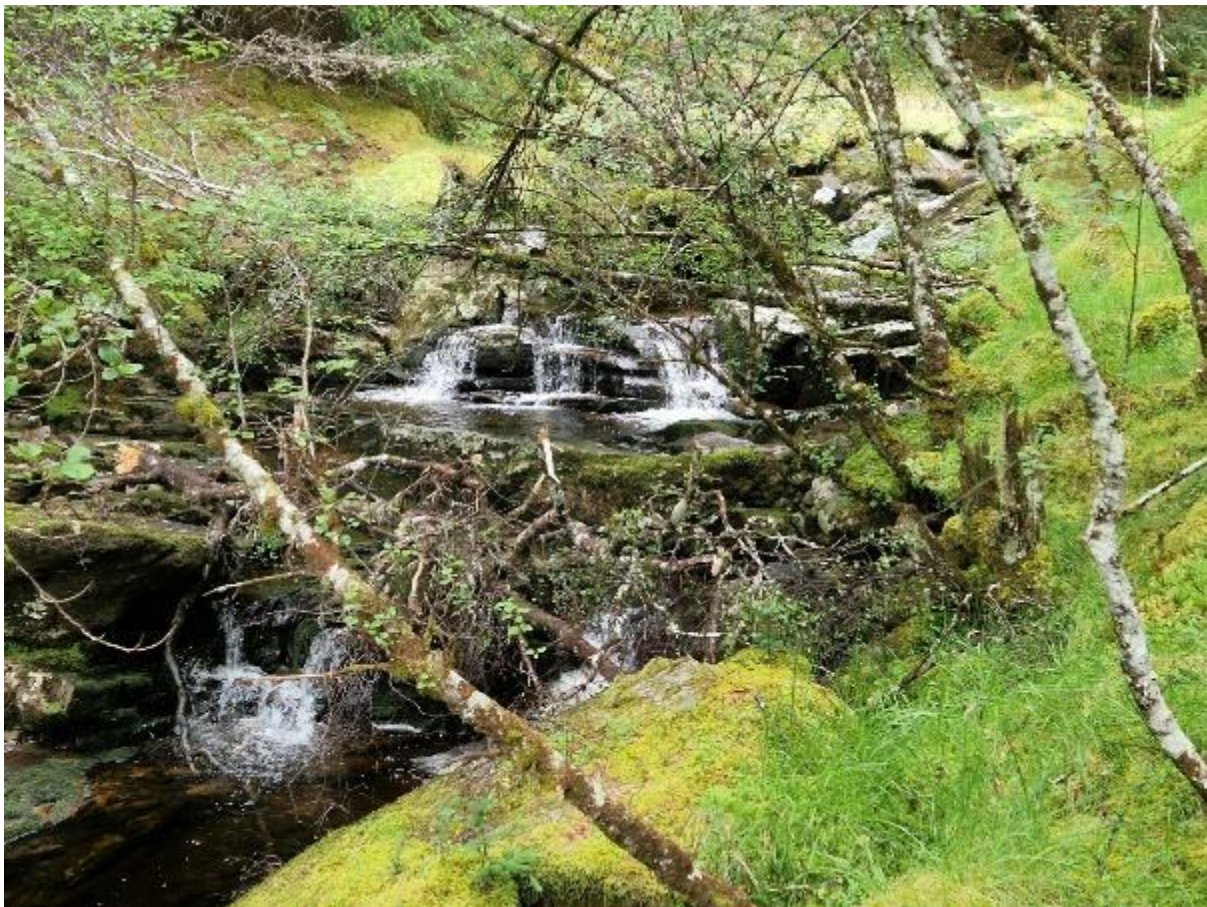
*Figure 14: Series of stepped falls/cascades in survey stretch AB2.*

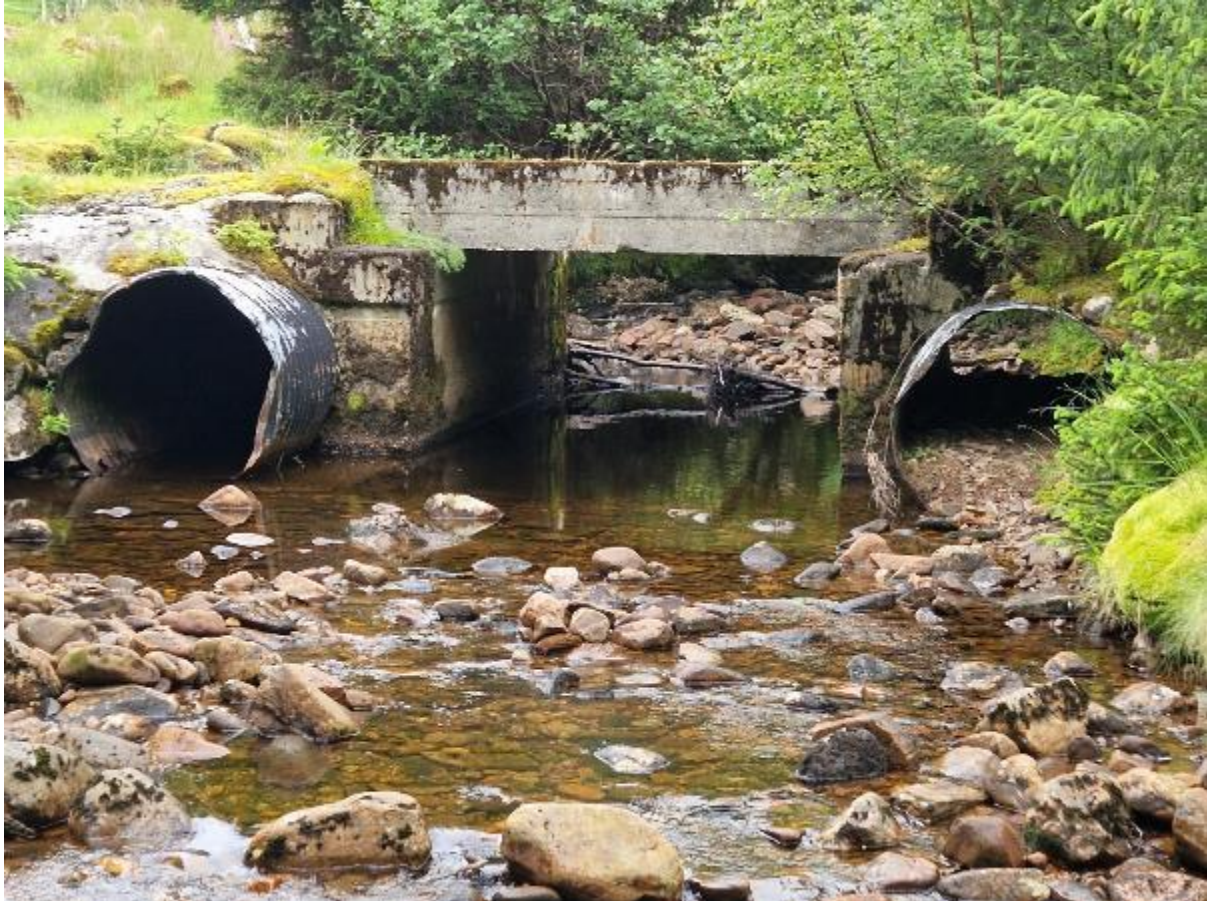
A photo of the bridge at the top of the transect is shown below in **Figure 15**.

*Figure 15: The bridge and culvert at the upper limit of Transect AB2. There was good mixed juvenile habitat in this part of the transect.*

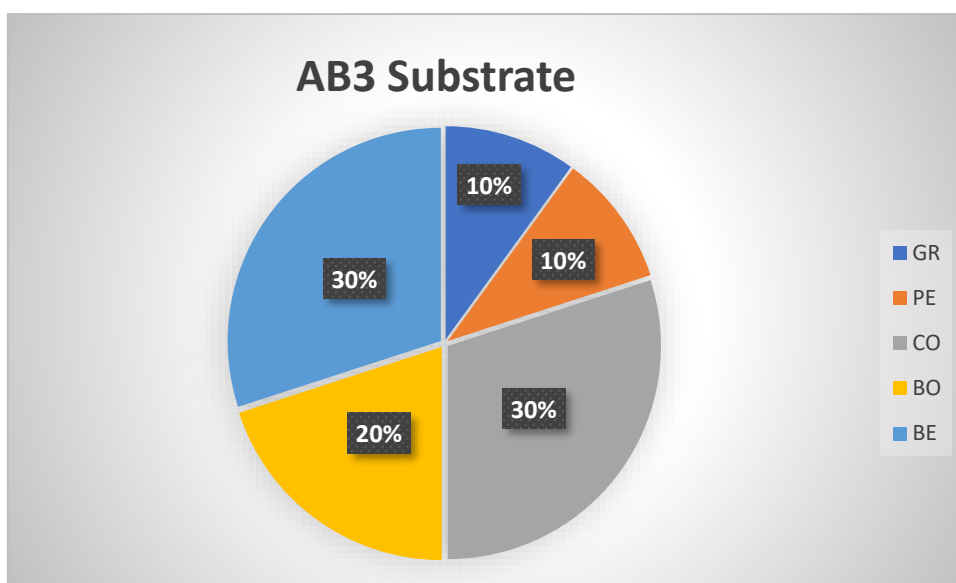
Substrate types at the start of Transect AB3 provided excellent instream habitat for juvenile salmonids and was made up of mainly cobble and boulder with some pebble and gravel. This changed markedly after approximately 20m where the river gradient steepened and bedrock dominated with a series of falls and cascades. The substrate breakdown is provided below in **Figure 17**.

**Figure 17: Substrate types shown as a percentage for Transect AB3**

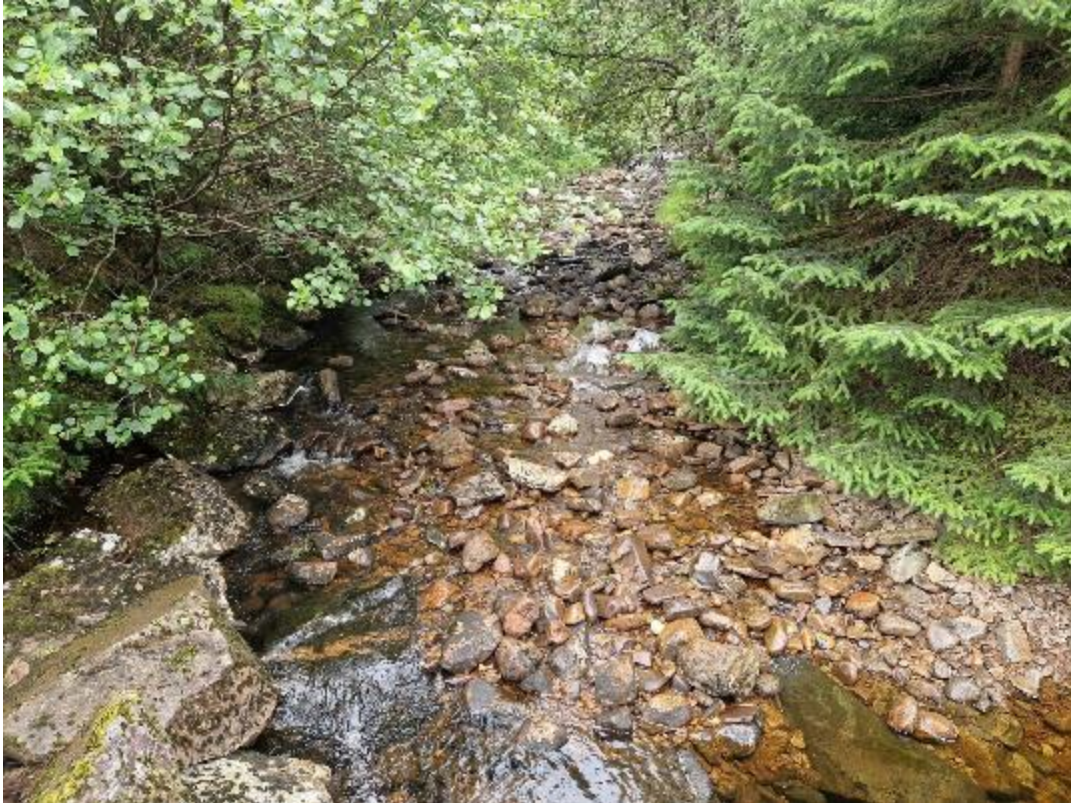
*Figure 19 Good habitat at the start of Transect AB3*

Spawning was limited to the downstream limits of the transect and spread throughout this area resulting in an area of approximately 50m<sup>2</sup>, however it is unlikely that this would be utilised by salmon due to the waterfalls downstream.

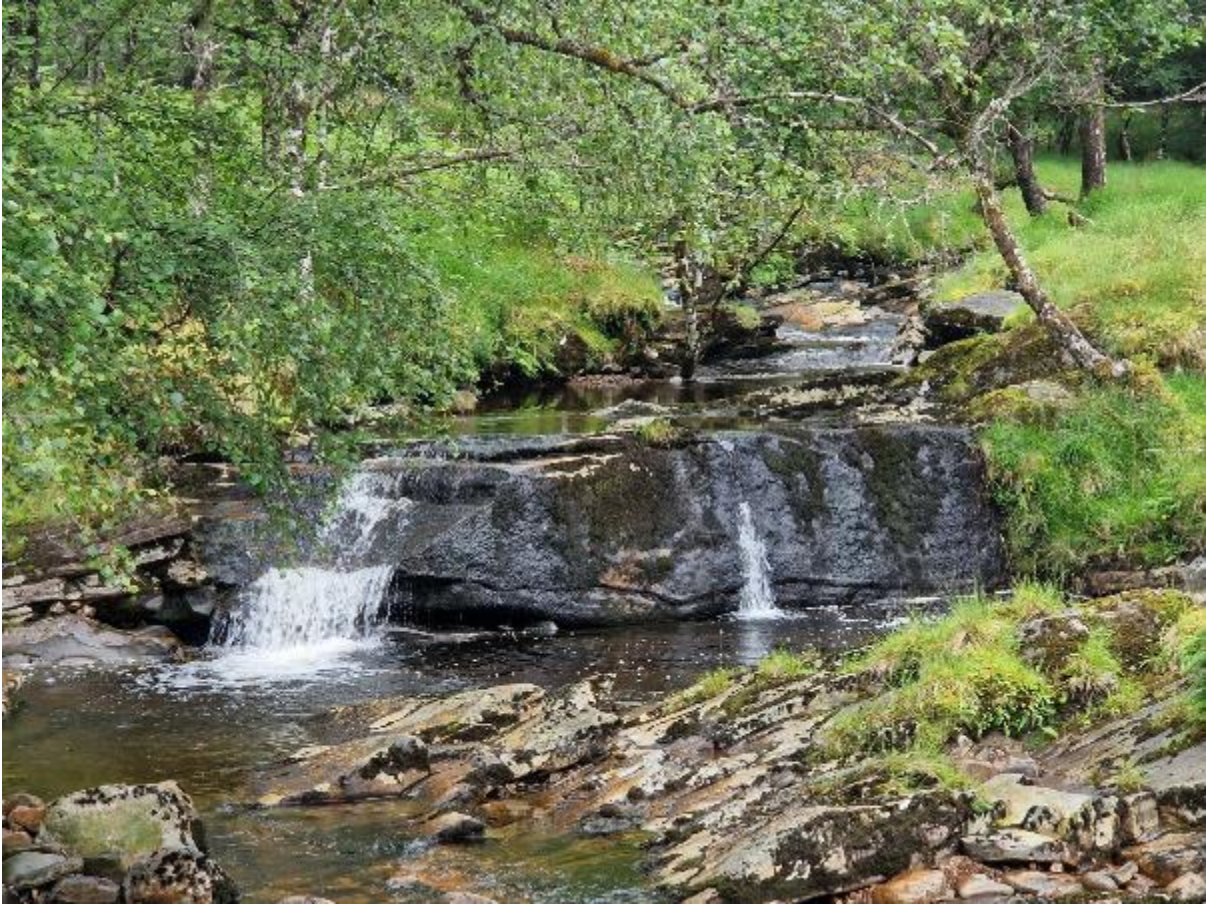
A number of waterfalls/cascades were recorded starting at Grid Reference **222308-809915** and extending to the end of the transect at Grid Reference **222286-809802** which was also marked by a waterfall. It is unlikely that these waterfalls are impassable to upstream migrations with downstream access highly likely.

*Figure 20: The start of a series of waterfalls at Transect AB3*

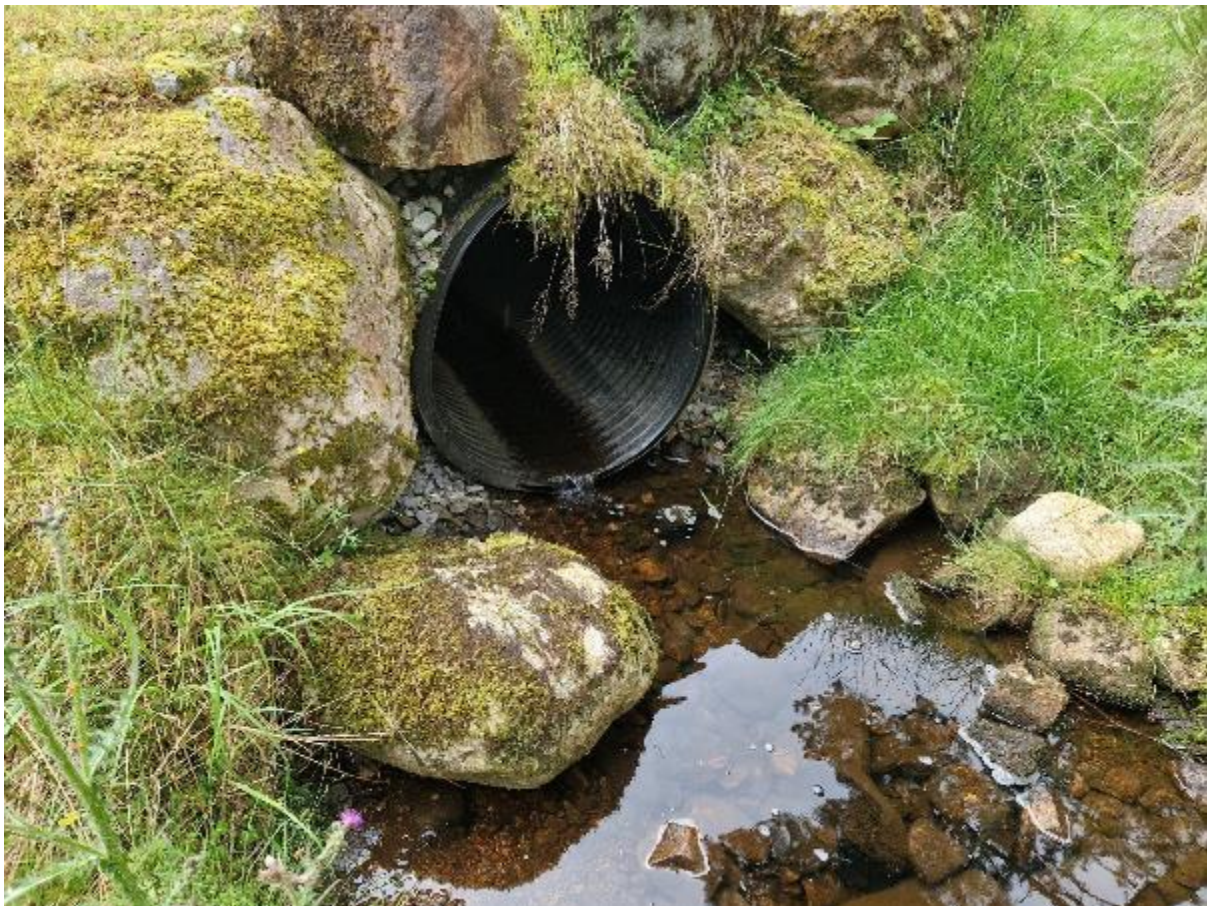
ACA1 was 149m in length and is the west tributary of the two streams that merge at grid reference **222371-810085**. The start of the survey stretch was marked by a culvert under the forest/wind farm track. This stream was small in nature with an average width of 0.6m and a bed width of 1.5m. At the time of survey water levels were very low with ponding occurring, suggesting this stream is likely to dry out during drought conditions. The culvert was considered impassable on the day of the survey due to low flows but it may be passable during higher flow conditions.

*Figure 22: Impassable Culvert (on the day of the survey) at the upper end of the survey stretch.*

Overall, this transect was deemed unsuitable for salmonids due to low water levels, it is highly likely that this stream dries out completely in dry years. In spite of this the instream habitat is excellent with lots of instream cover where water levels are sufficient. This was found at the downstream limits. The only obstacle was the culvert at the upper end of the transect.

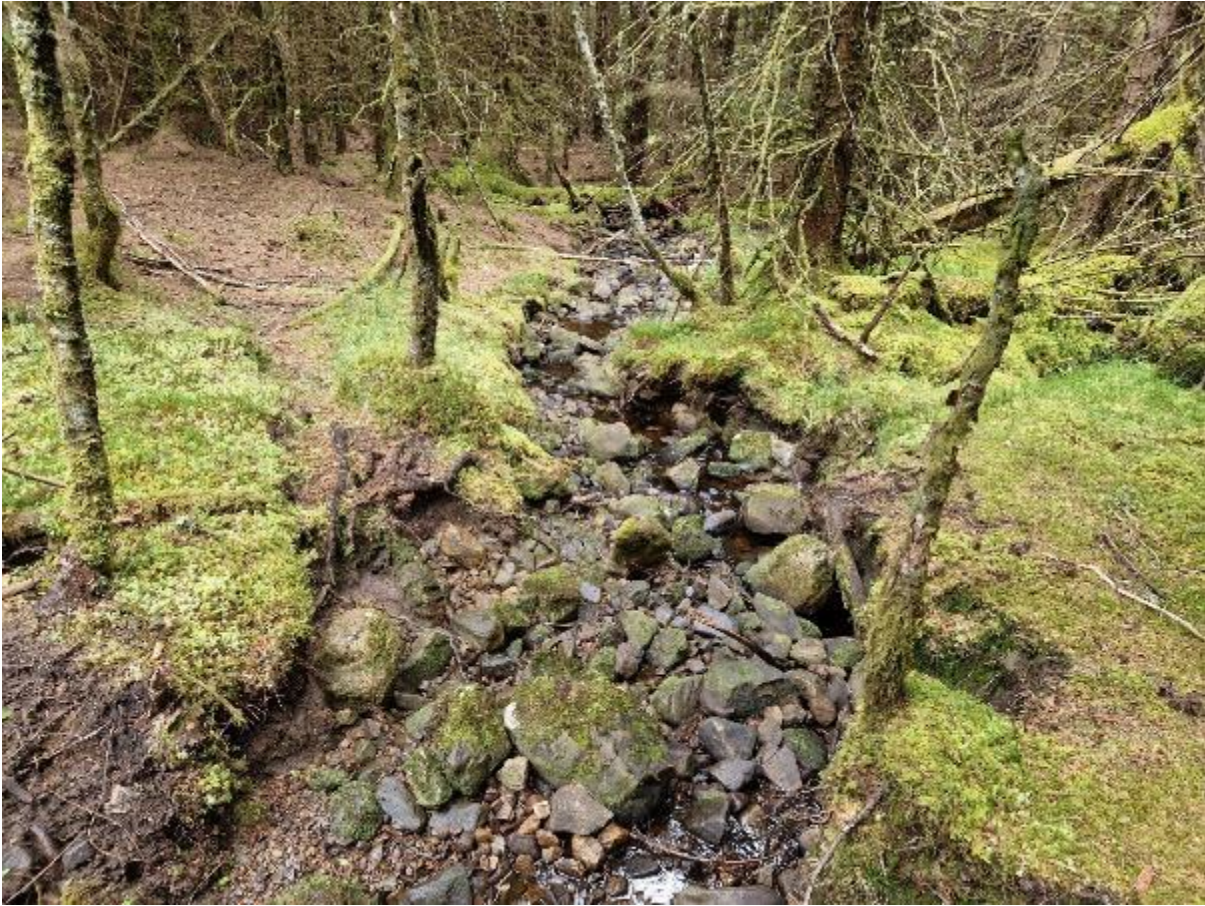
*Figure 23: Photo showing very low levels and ponded flow conditions.*

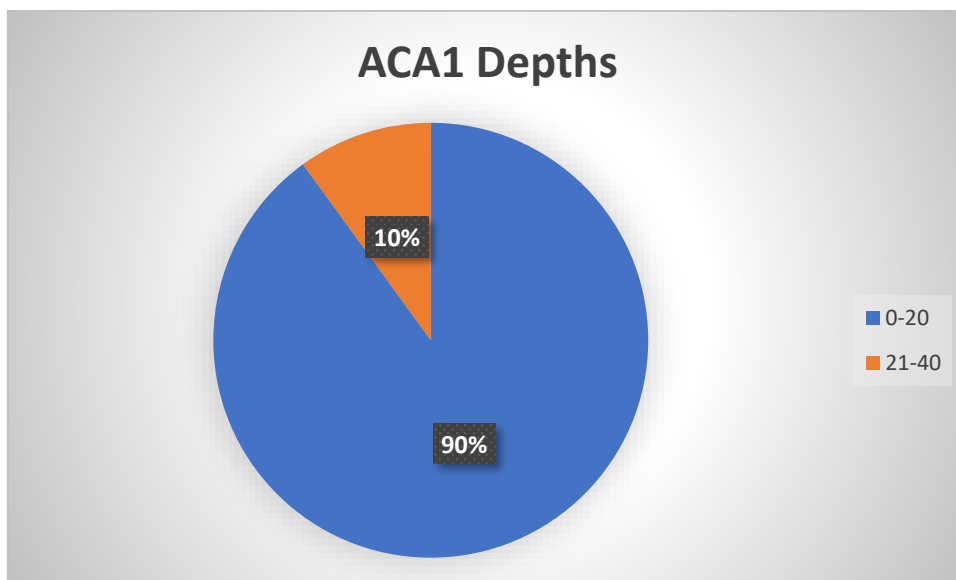
Depths were shallow with the 90% falling within the 0-20cm range with slightly deeper pockets in the 21-40cm range. **Figure 24** shows the breakdown of depths as percentage.

*Figure 24: Depths shown as a percentage for Transect ACA1*

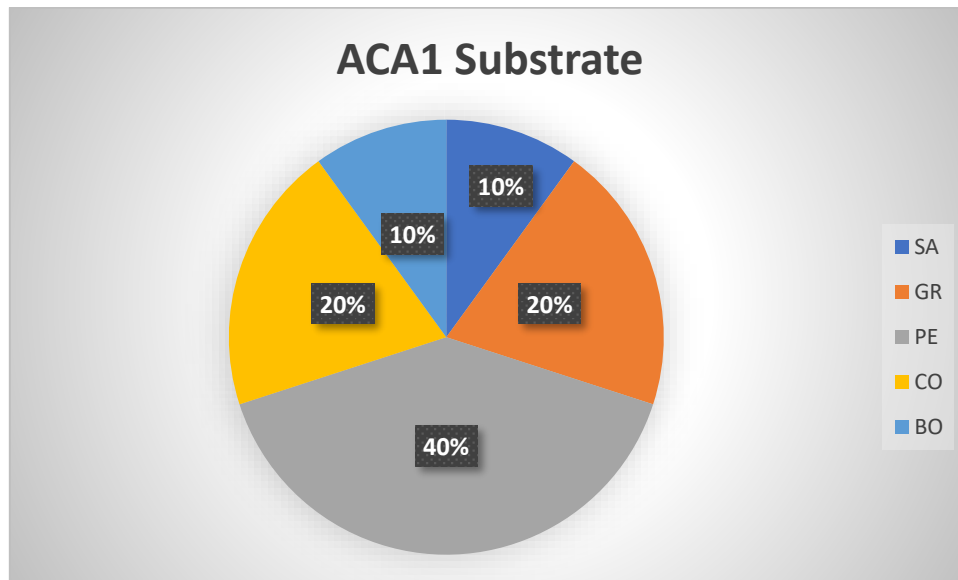
The substrate matrix was predominantly pebble and cobble although boulder and gravel were present along with pockets of sand. This instream habitat would offer good mixed juvenile habitat; however, the lack of flow was a limiting factor. **Figure 25** shows the breakdown of substrate types as a percentage.

*Figure 25: Substrate types shown as a percentage for Transect ACA1.*

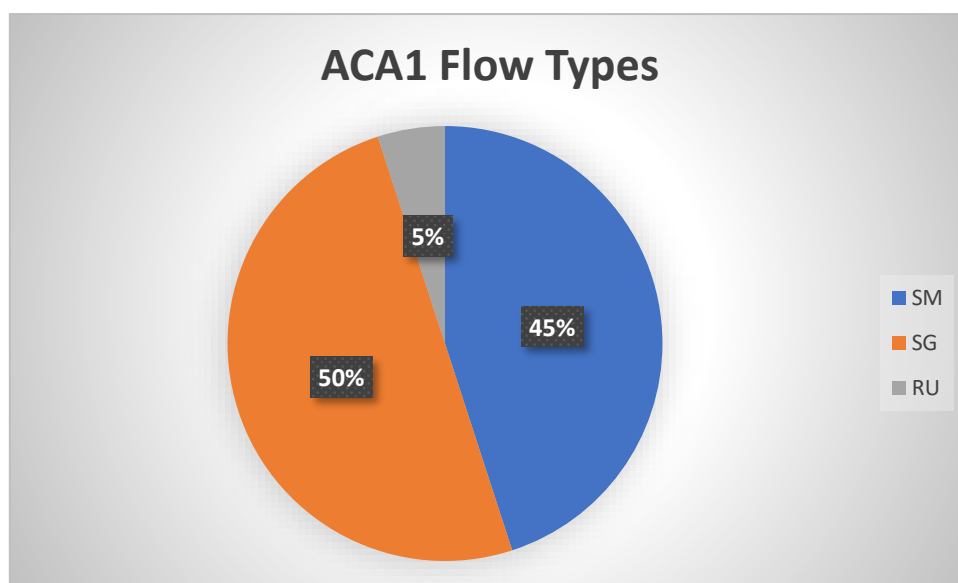
Greater flows were present towards the downstream limit where shallow glide and small areas of run dominated. Large areas of still marginal habitat occurred in the upper reaches. These areas took the form of isolated pockets of still, very shallow water in between areas of dried out substrate. A breakdown of these flow types is shown as a percentage in **Figure 26**.

*Figure 26: Flow Types shown as a percentage for Transect ACA1*

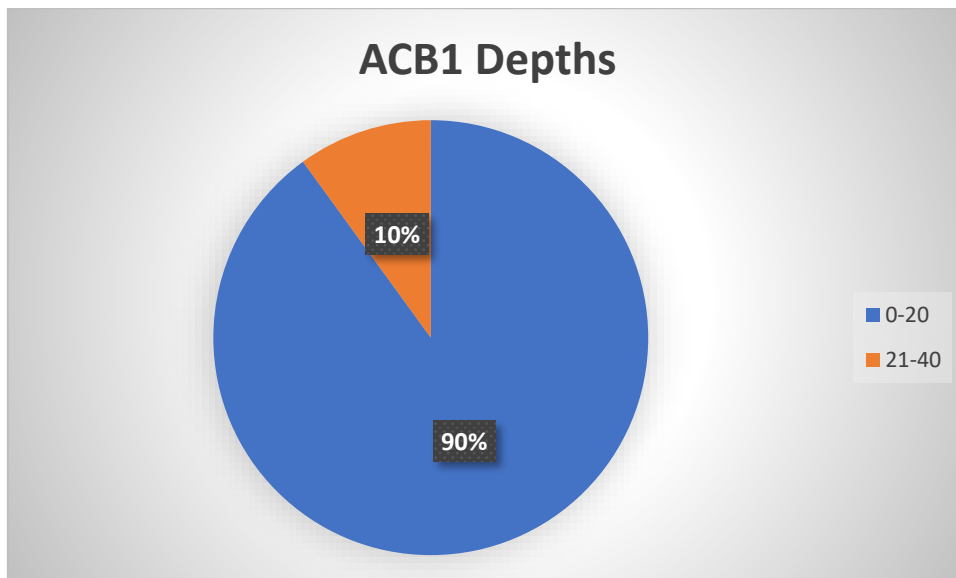
Depths were very shallow, with the majority falling into the 0-20cm range with small pockets of slightly deeper water, although this was still shallow. A breakdown of depths recorded as a percentage are shown in **Figure 28**.

*Figure 28: Depths shown as a percentage for Transect ACB1*

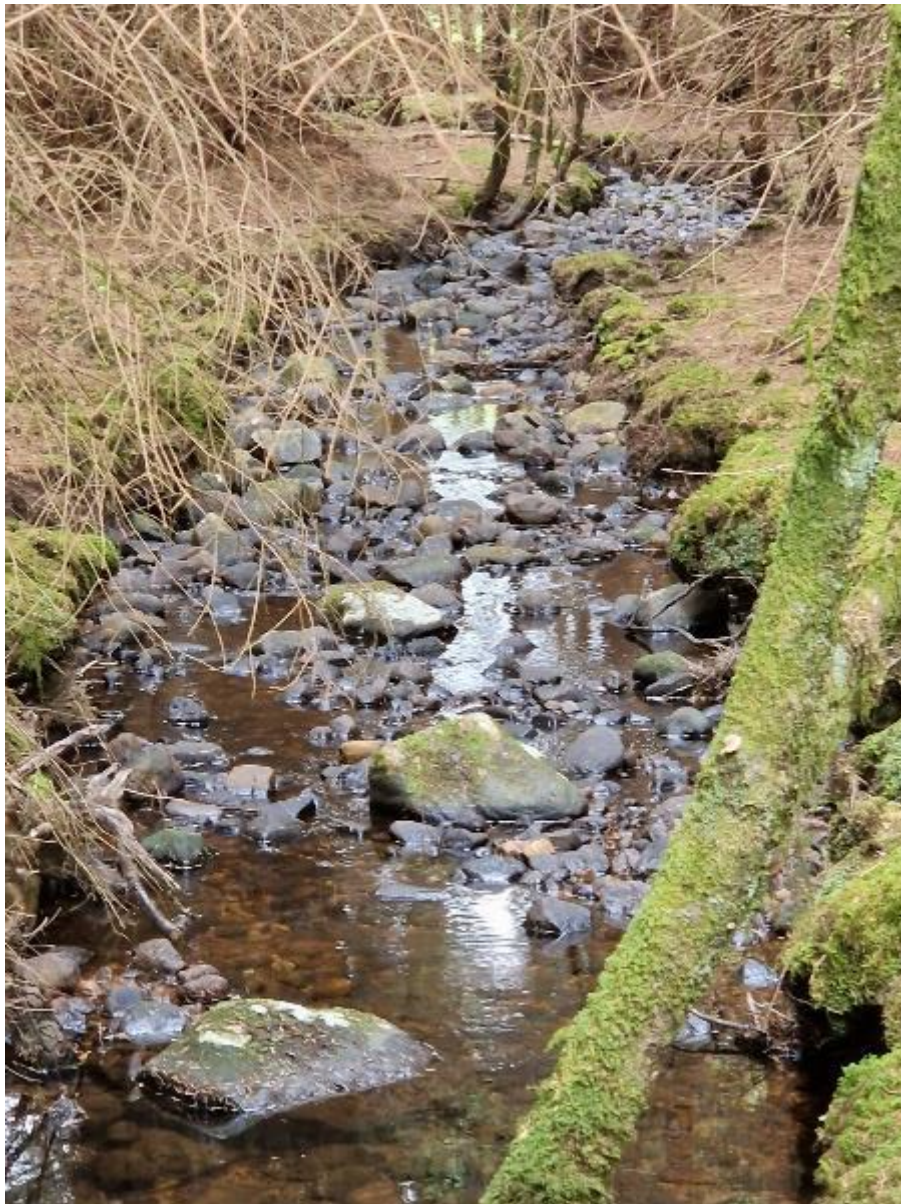
*Figure 31: Area of excellent habitat at the downstream limits of Transect ACB1. Note the heavy conifer shading and the lack of any ground cover*

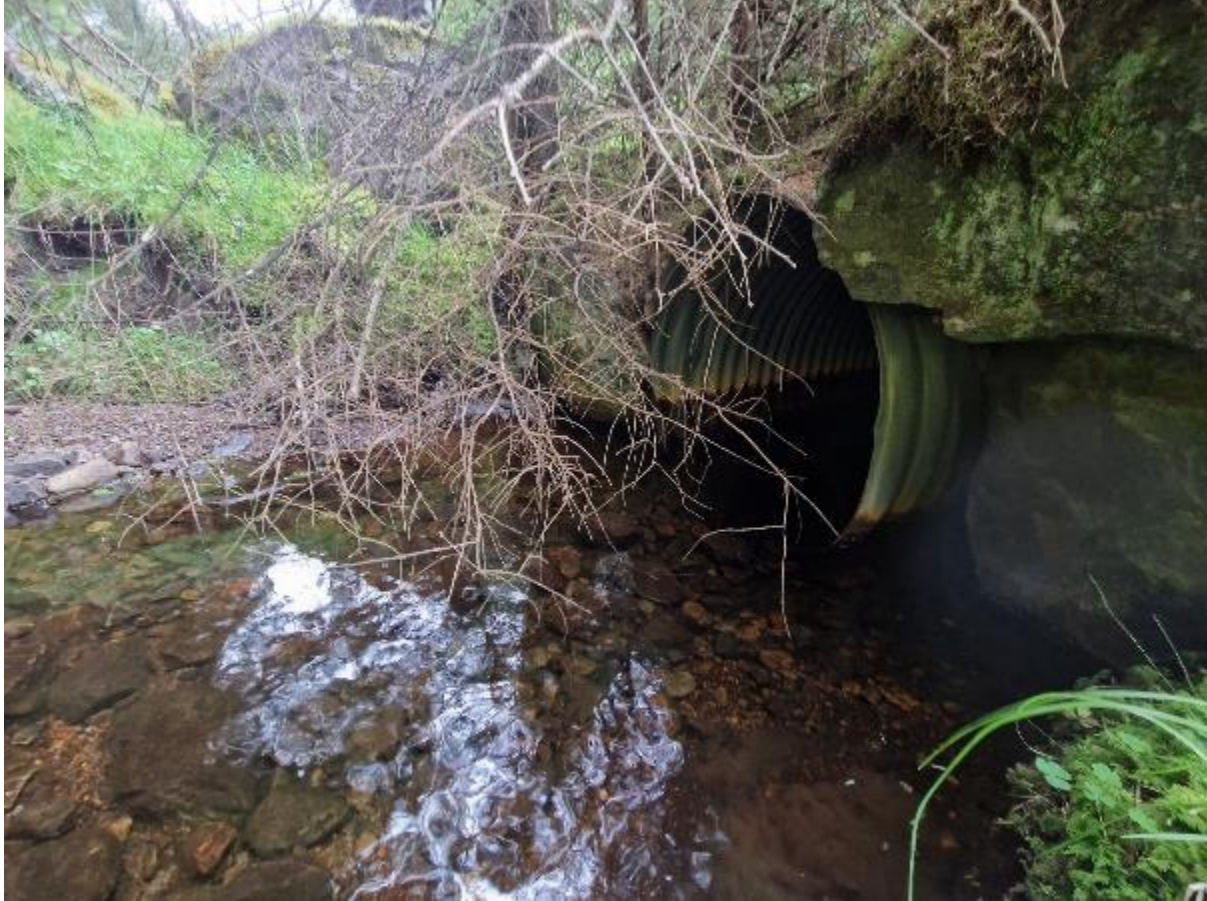
*Figure 32: Passable culvert at the upper end of Transect ACB1*

Transect ACB1 offered good instream habitat for juvenile salmonids where flows were sufficient, however it is possible that this stream may dry completely during periods of dry weather. There was a single potential obstacle at the upper end of the transect and this was recorded as passable, however this may be restricted in periods of extreme low flows.

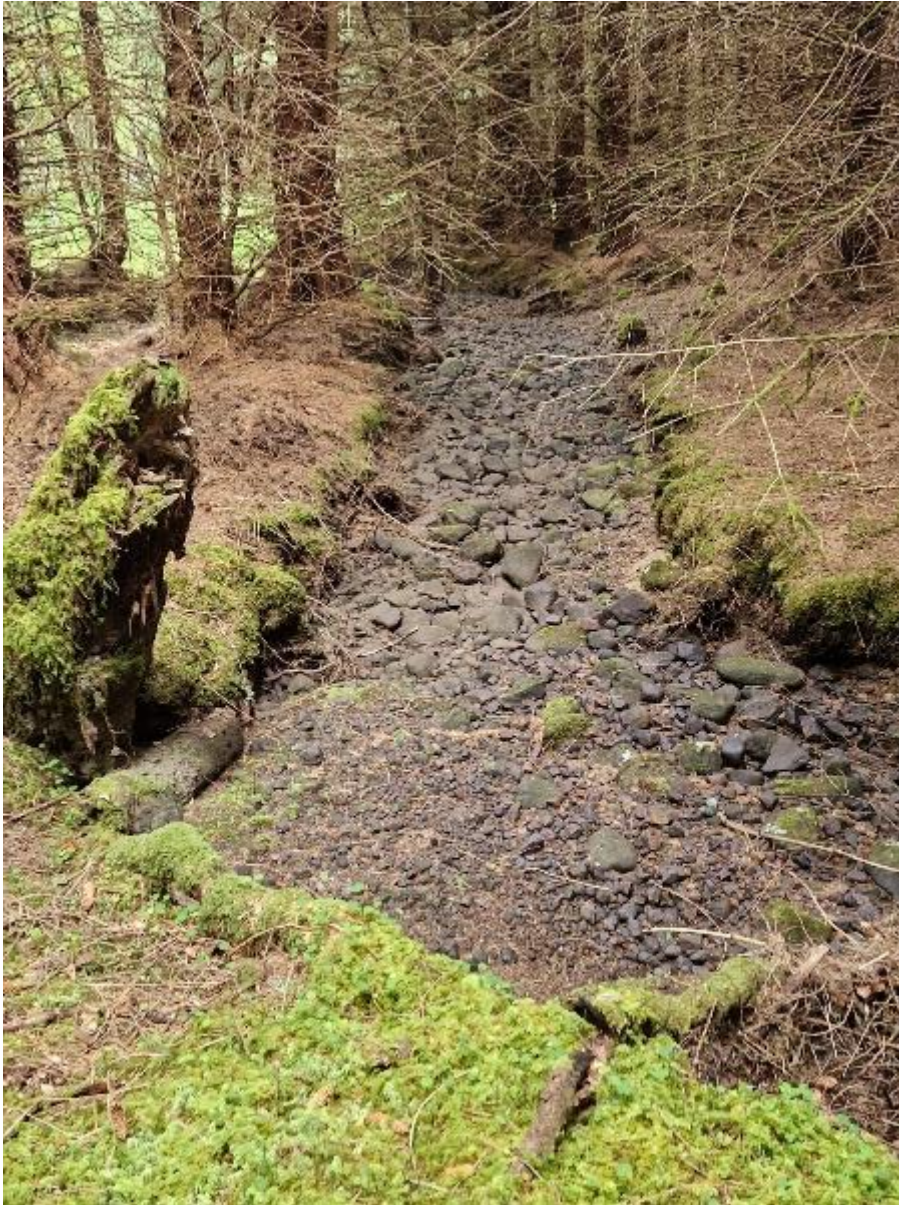
*Figure 33: Dry left channel at island.*

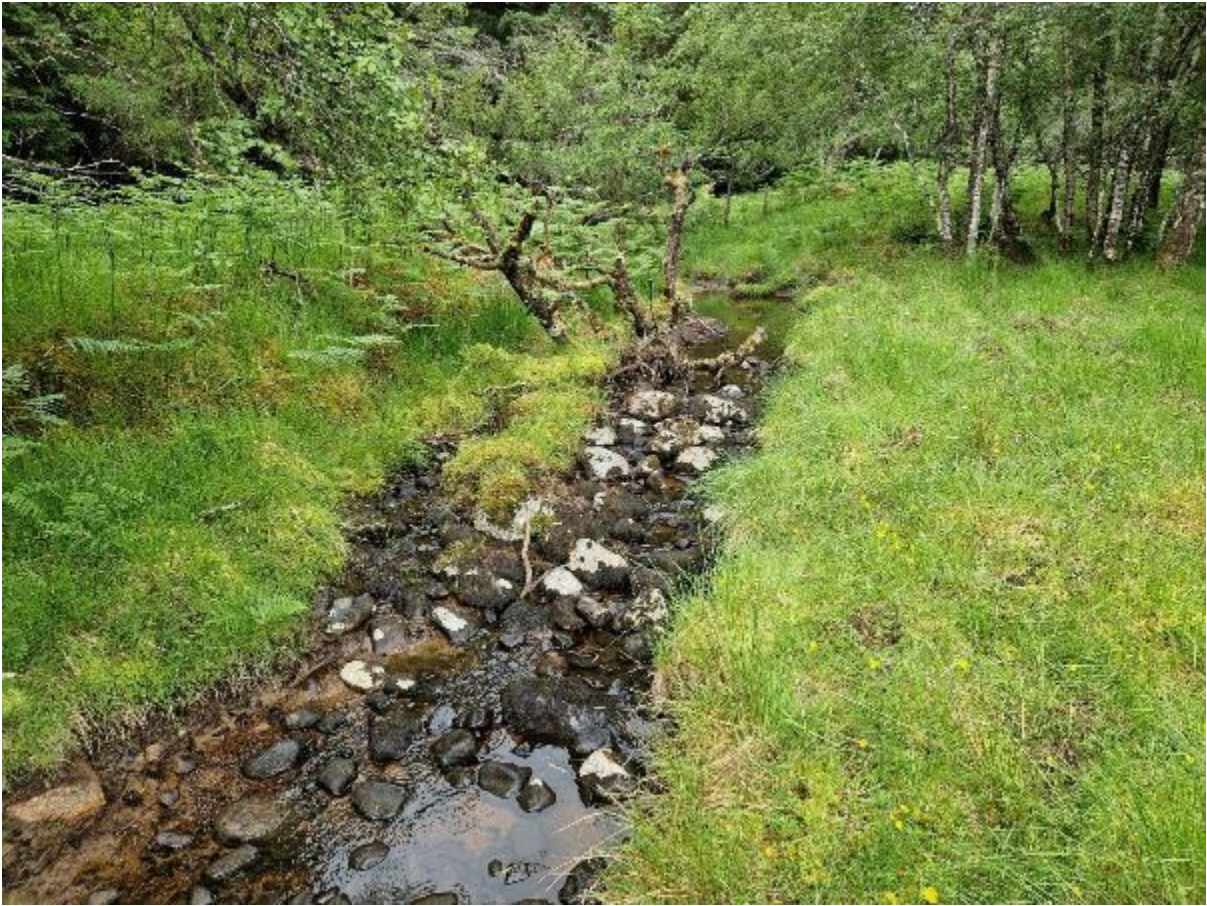
*Figure 37: Excellent instream habitat at ACB2*

Overall, this transect provided excellent habitat for juvenile salmonids. There were no obstacles to migration and it is likely to be utilised by juvenile fish moving in from the river Moriston, as well as fish spawning within. This entire tributary is likely to dry out during extended periods of dry weather, in particular during the summer months. Numerous fallen trees and branches (mainly conifer) were present further providing additional instream cover.

A photograph of excellent instream habitat towards the downstream limit is shown below in **Figure 37**.

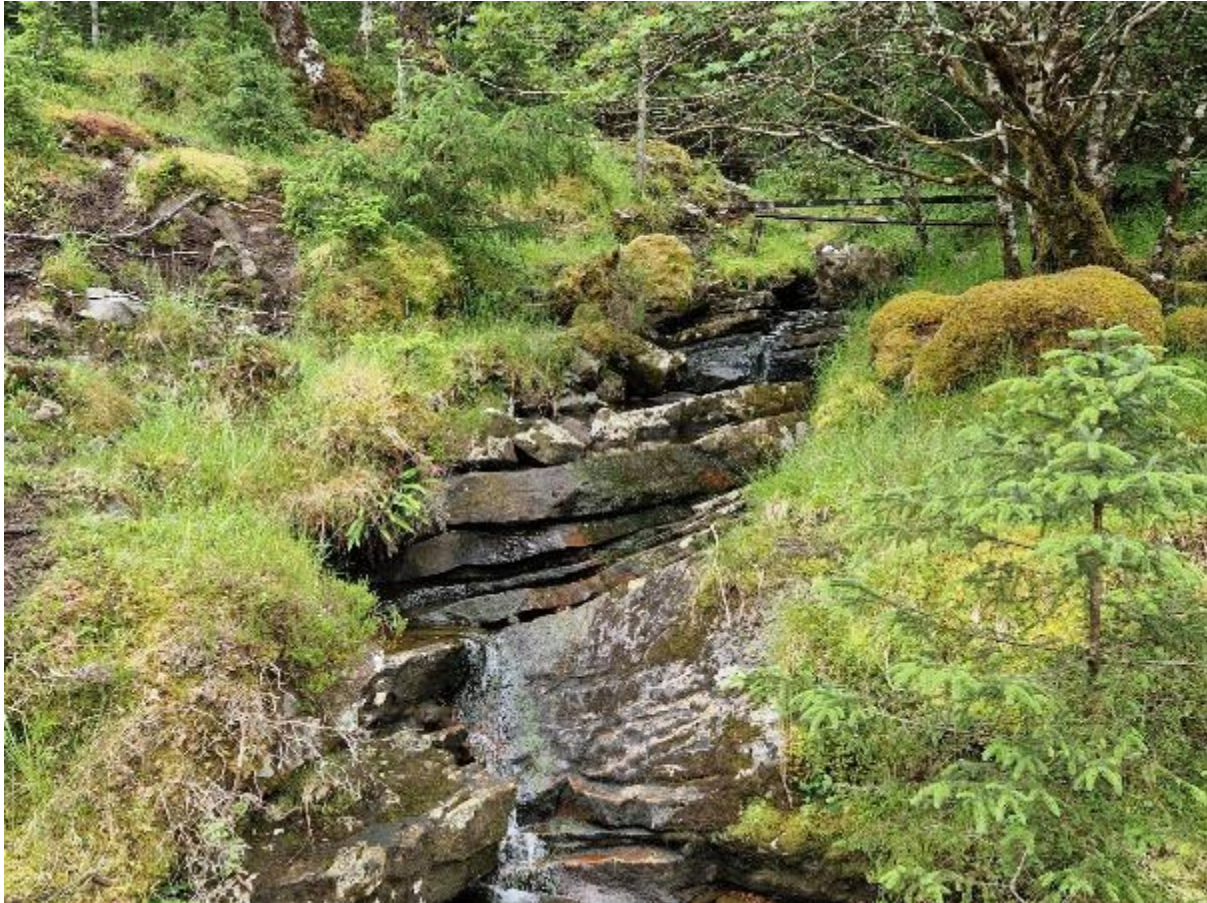
Transect ACC1 starts at the confluence with the river Moriston at grid reference **222532-810466**. This point was marked by a steep bedrock outcrop forming a waterfall. This waterfall was recorded as impassable to upstream migration of salmonids.

*Figure 39: Impassable waterfall at the confluence with the river Moriston.*

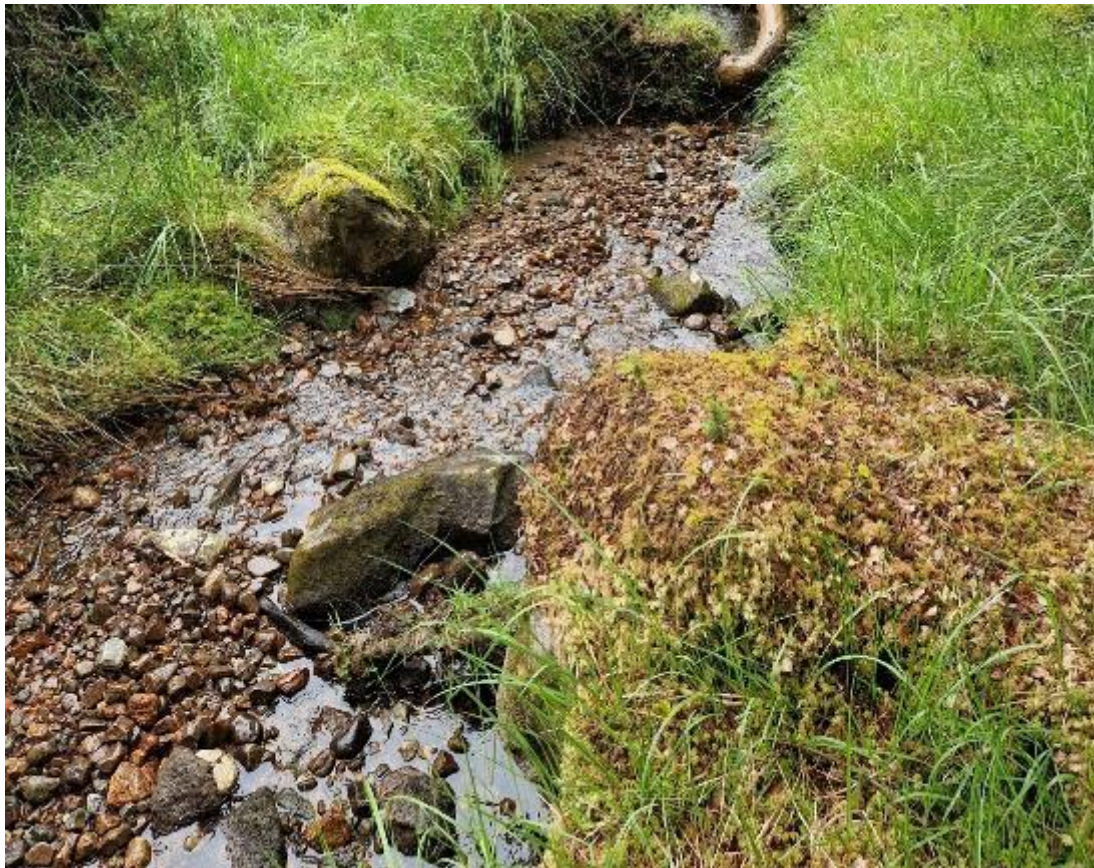
*Figure 41: Area of exposed bed and drying channel.*
