Beinneun 2 Wind Farm

Technical Appendix A6.5: Fish

Document prepared by the Ness District Salmon Fisheries Board for Beinneun 2 Ltd

# Beinneun 2 Windfarm Habitat and Fish Population Survey

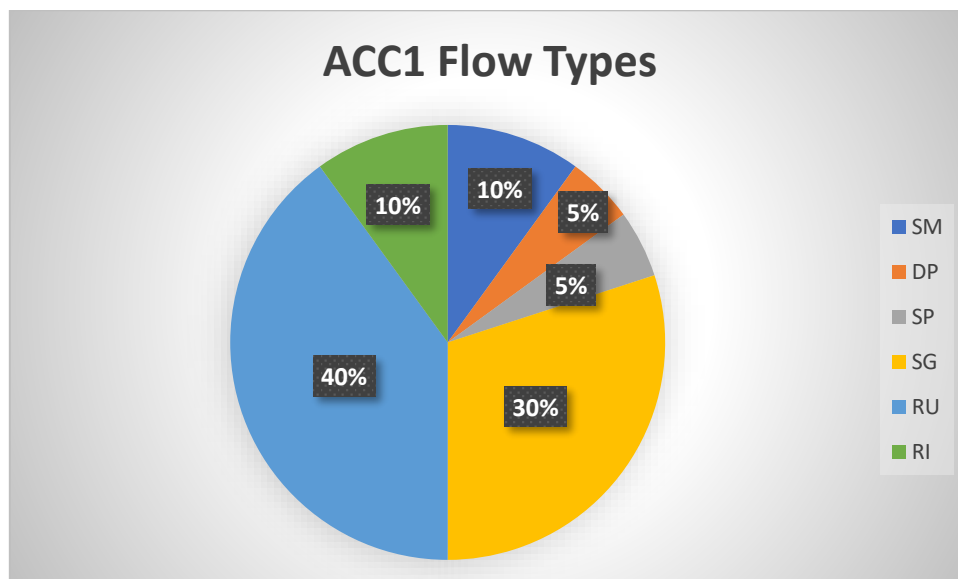
Flows within the transect were variable with many areas dry or drying. Water was often limited to ponding. The lower extremities were limited to shallow glide, pool and still marginal areas, however, as the gradient increased slightly flow speeds increased exhibiting sporadic areas of run and riffle. These areas were shallow and, in some cases, flowed through the substrate rather than over it. A breakdown of flow types for ACC1 is shown below in **Figure 43**.

**Figure 43:** Flow types shown as a percentage for Transect ACC1.

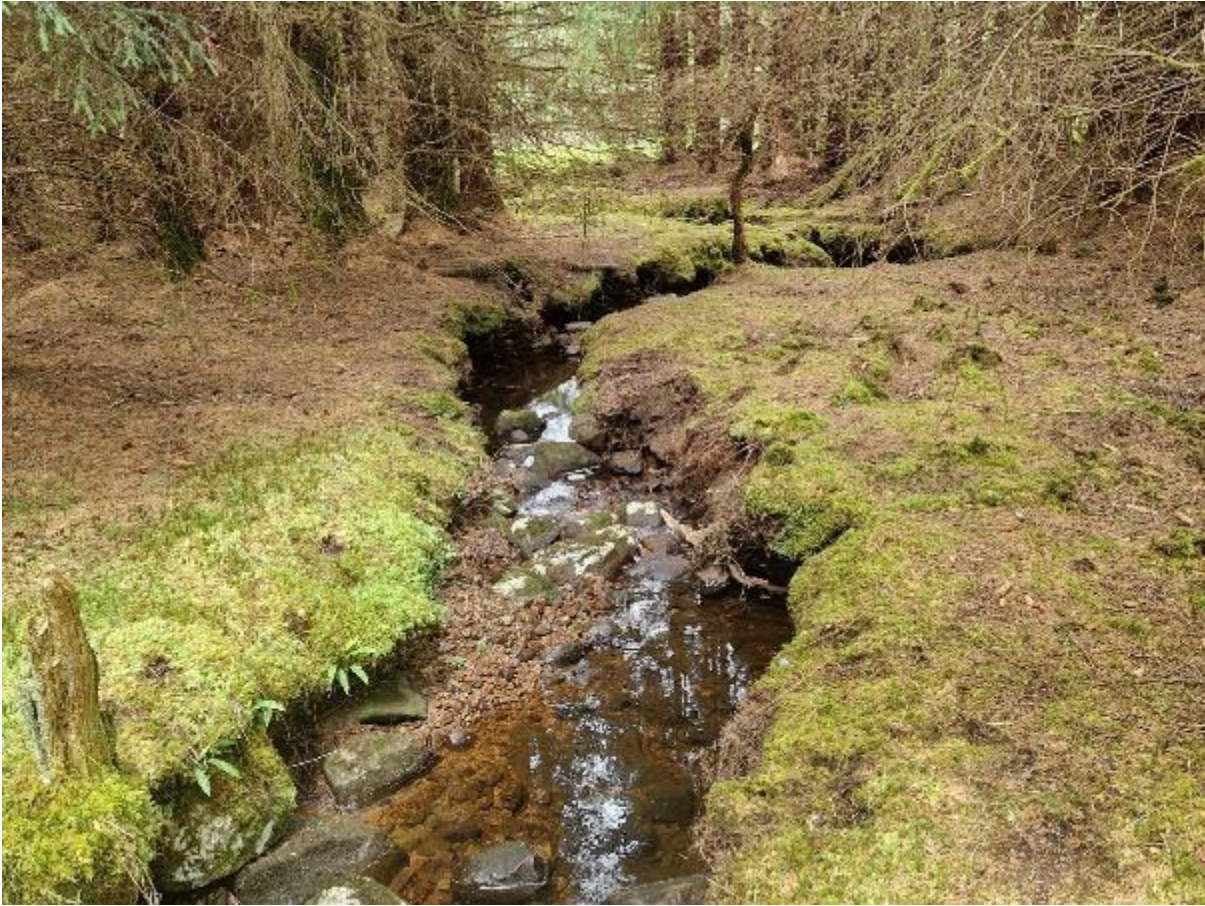
**Figure 44: Representative habitat within Transect ACC1.**

The photo below shows the typical habitat found within transect ACC1.

Bankside fish cover was minimal with approximately 10% on both banks represented by roots and rocks, again water levels were a limiting factor. Groundcover was minimal in places due to the heavy conifer shading. Where there was ground cover there was some evidence of light grazing from the local deer population. The predominant bank face vegetation was classed as uniform with the bank tops being complex in nature. This vegetation was predominantly conifer with sporadic deciduous further upstream.

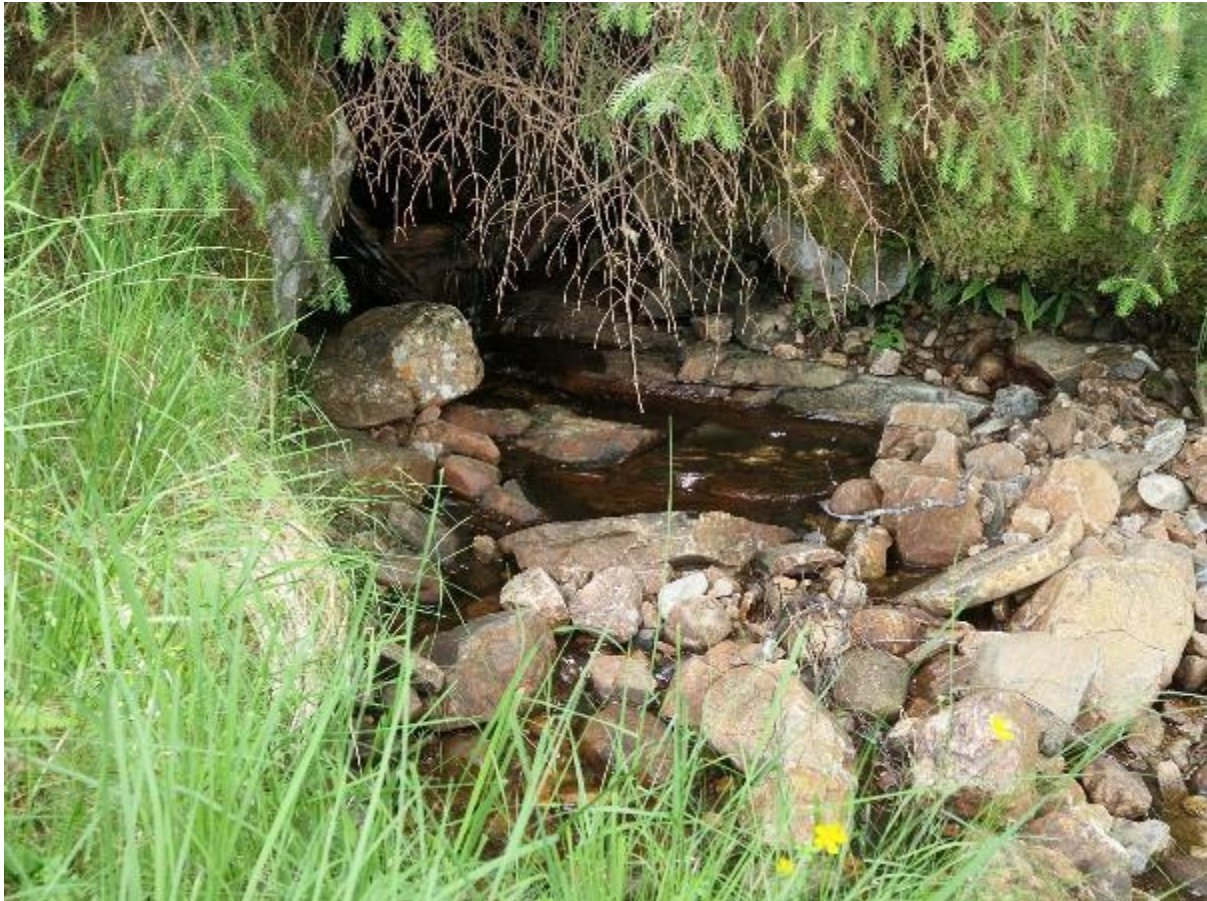
Transect ACC2 began at grid reference **222662-810214** and ended at grid reference **222734-810166** at a culvert where the track crosses the stream. It is likely that this culvert is passable during higher flows.

*Figure 45: Culvert at the upper end of Transect ACC2.*

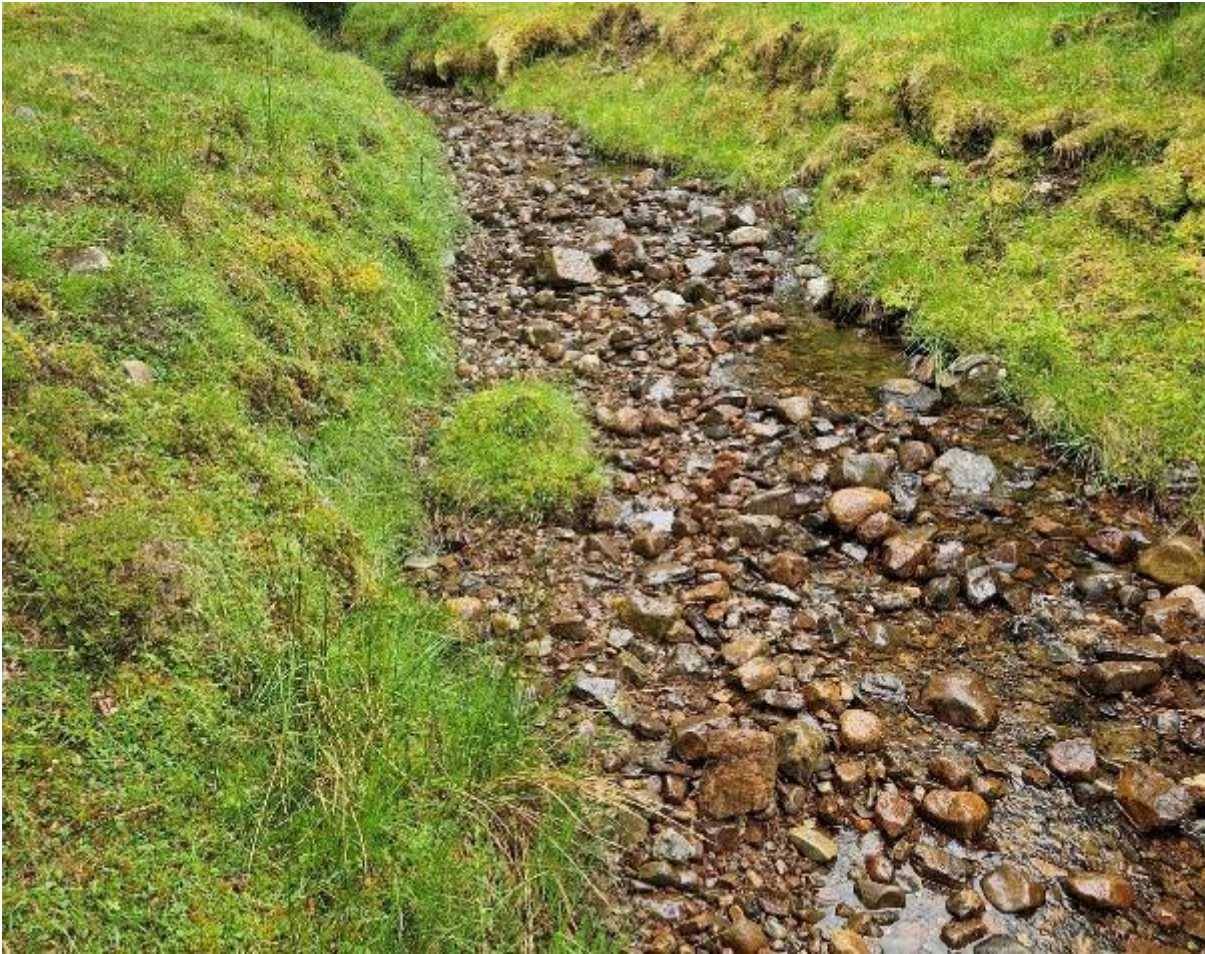
*Figure 46: Excellent instream habitat at the lower limits of transect ACC2.*

The Transect was approximately 90m in length with an average width of 2m. Excellent habitat was present for approximately 40m at the start of the transect, although water levels were low, before the gradient increases and substrate types change to boulder and bedrock with a series of cascades/falls towards the upstream limits. This steep, 50m stretch offers very little usable habitat for fish species due to the steep gradient and low water levels.

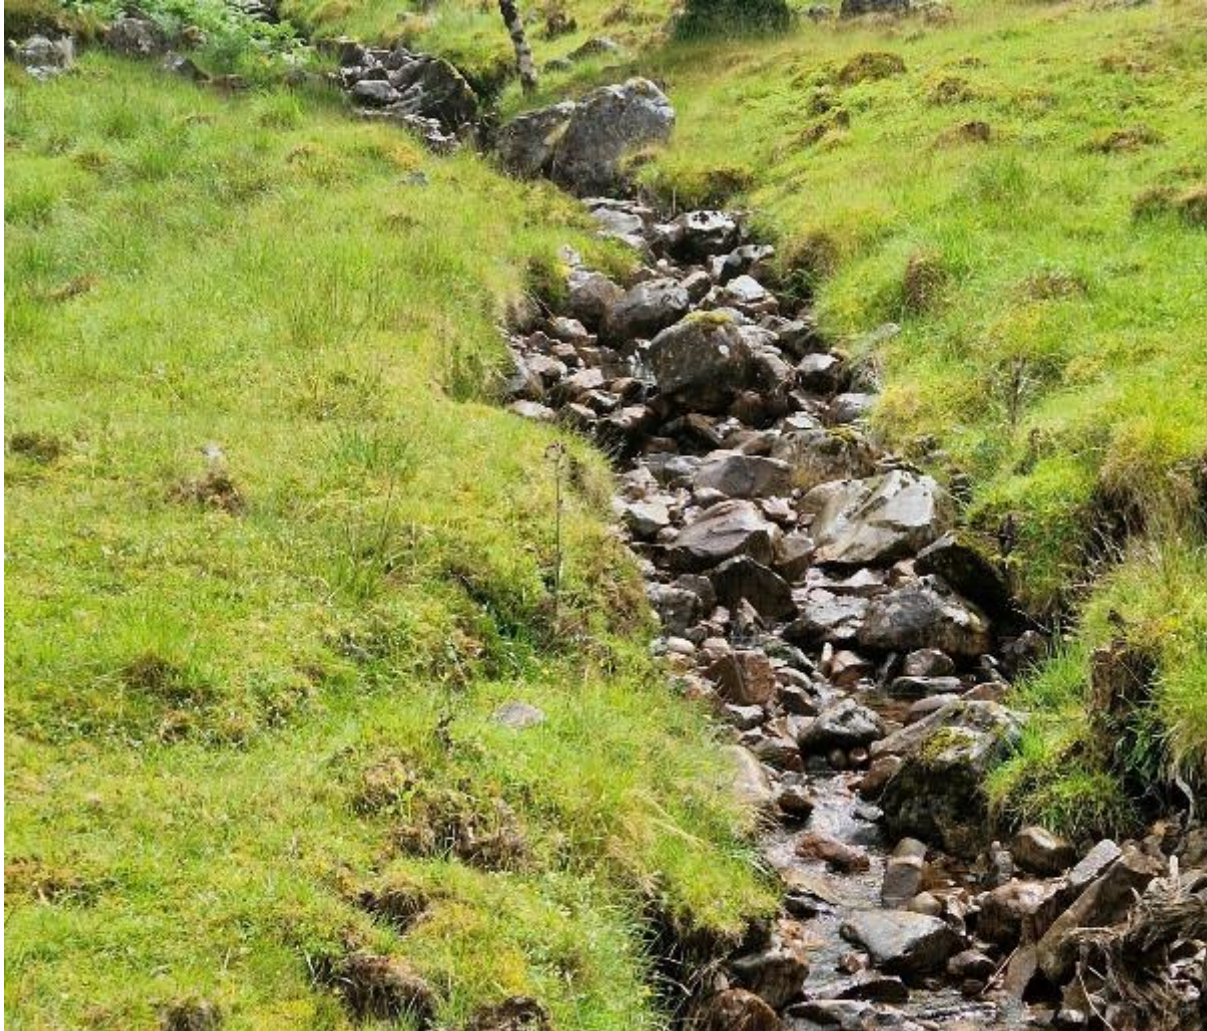
*Figure 48: The start of the boulder/bedrock section in transect ACC2.*

For the first 40m substrate was dominated by cobble and pebble offering excellent habitat for juvenile salmonids, however, low water levels were a limiting factor. The gradient then increased for the remainder of the stretch with a significant change in substrate size. Boulder and bedrock dominated creating a series of cascades and falls with low flows creating an impassable barrier to migrating salmonids.

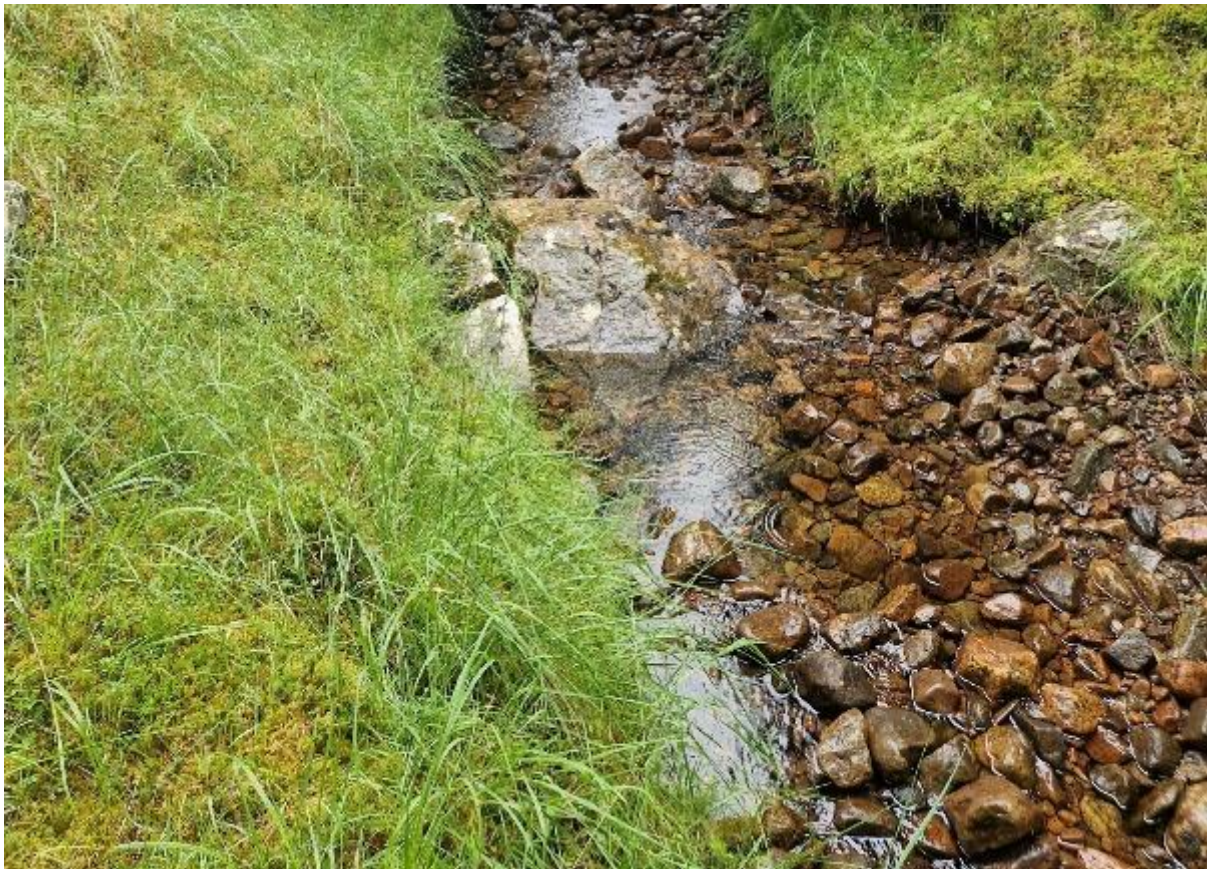
*Figure 50: Shallow pool and still marginal flows.*

Flow types changed compared to the previous section due to the nature of the gradient with run and riffle dominating. Slower areas at the lower extremities consisted of mainly still marginal and shallow pool, due to low water levels as shown in **Figure 50** below.

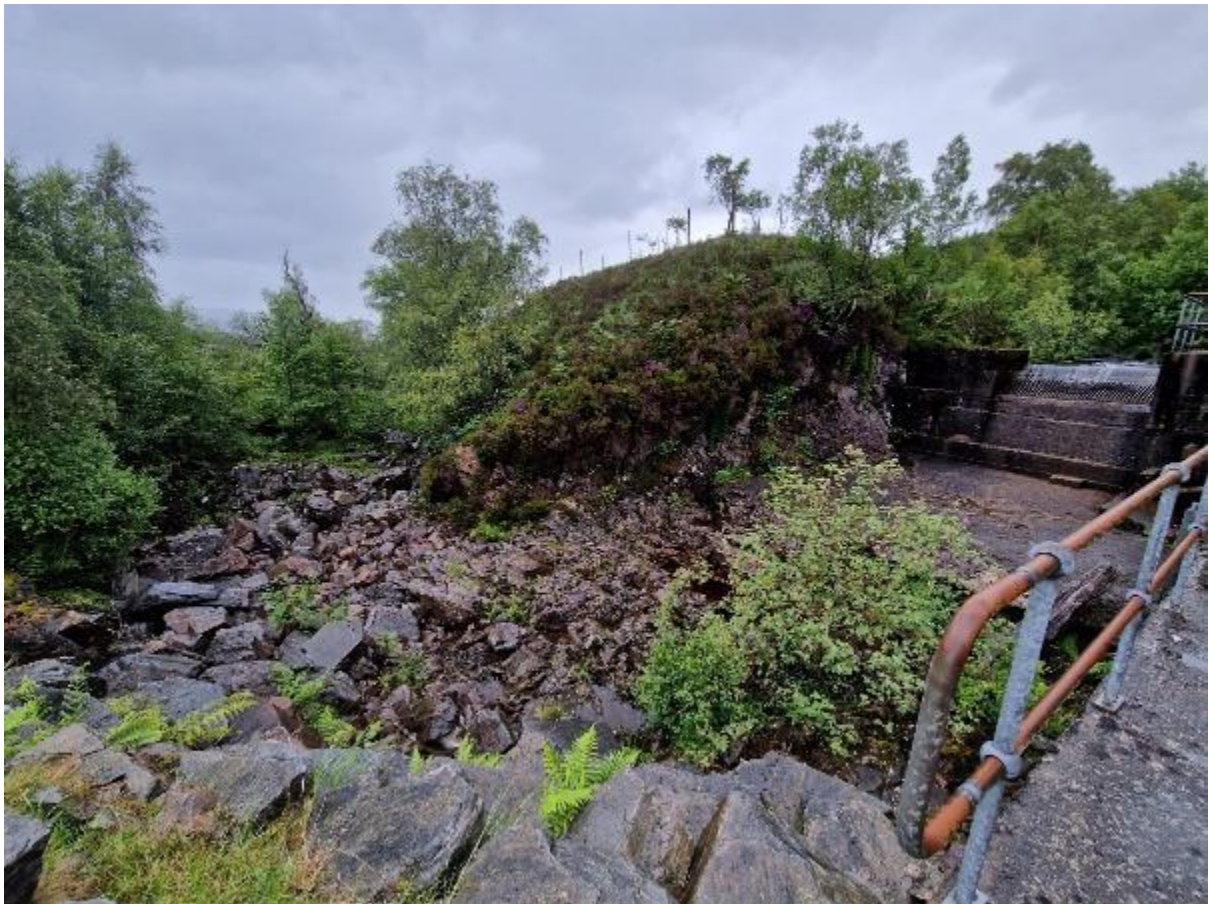
Allt Garbh Doire is a small tributary of the River Loyne with its confluence at Grid reference **220557-808136**. Approximately 500m upstream from here there is a large impassable weir/offtake structure belonging to SSE. This intake effectively de-waters the lower 500m of this burn, isolating the upper wetted section from the Allt Loyne.

*Figure 52: Allt Garbh Doire hydro intake and dewatered section downstream.*

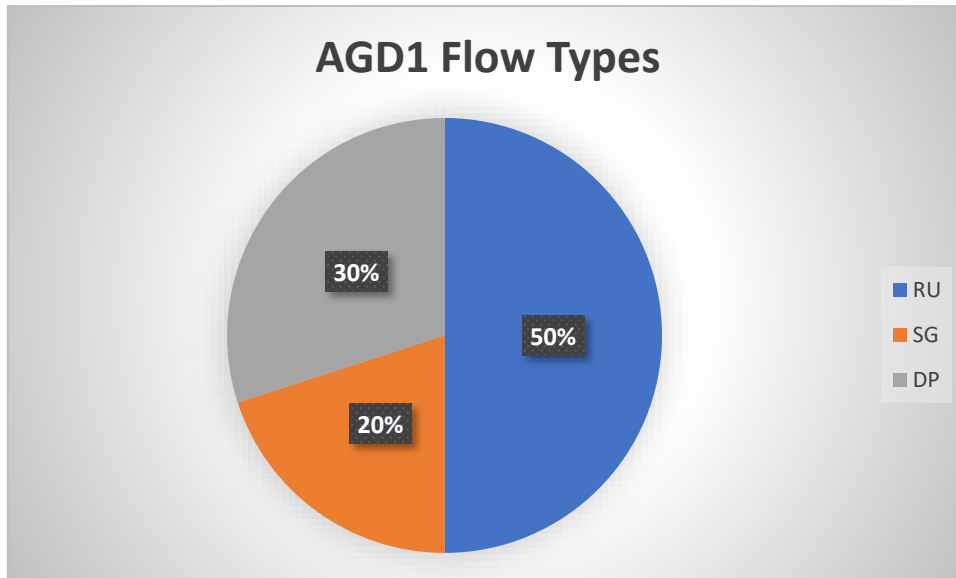
Flow within transect AGD1 were dominated by run with small areas of glide and the deep pool at the start of the stretch. It was observed in the days prior to the survey that this river can have high velocities during spells of heavy rain. A breakdown of flow types is shown below in **Figure 56**.

*Figure 56: Flow types shown as a percentage for transect AGD1*

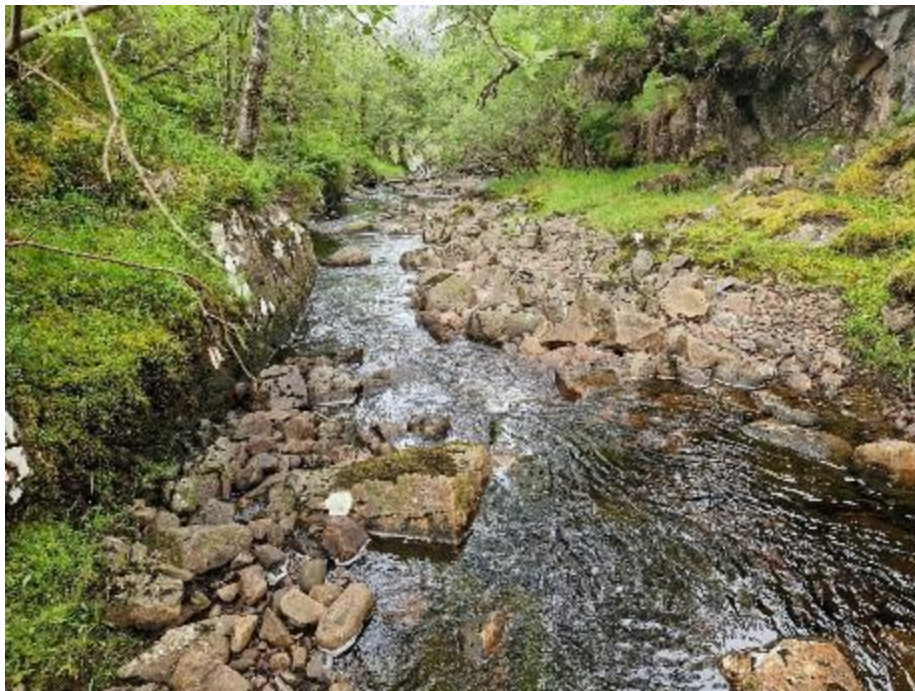
*Figure 57: Typical habitat at Transect AGD1.*

Vegetation on both banks was complex with good canopy cover from deciduous trees, this provided good shading. A photo of transect AGD1 is shown below.

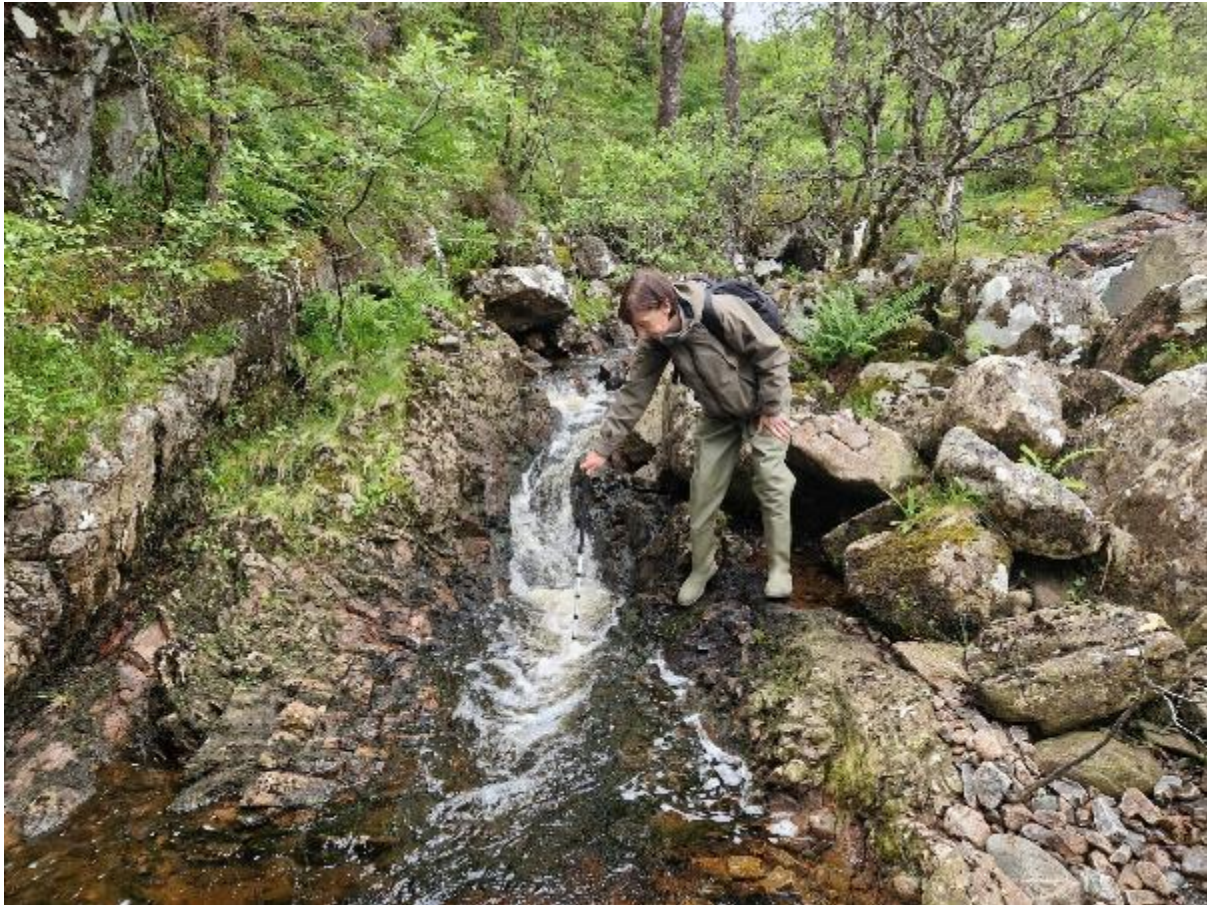
A small waterfall/cascade marked the upstream limit of this transect as the river steepened. No areas of suitable spawning for salmonids were observed.

*Figure 58: Waterfall/cascade at the upper limit of Transect AGD1.*

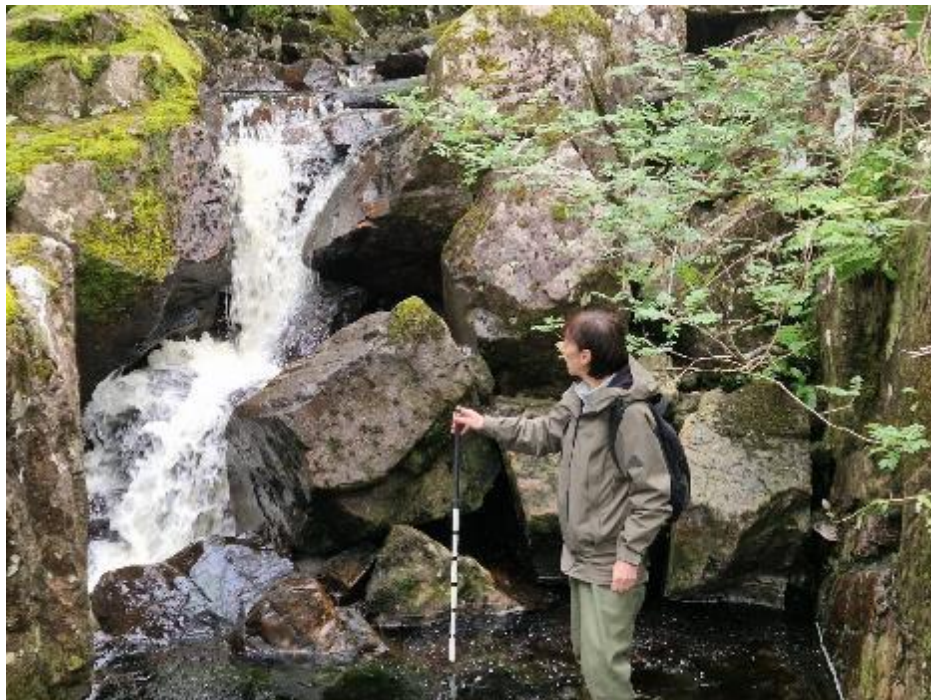
*Figure 60: Allt Garbh Doire transect AGD2 showing waterfall at upper limit.*

Overall, Allt Garbh Doire offers very little suitable habitat for salmonids. Access to the wetted area is denied due to the dam/structure. Above here the gradient is high with turbulent velocities during

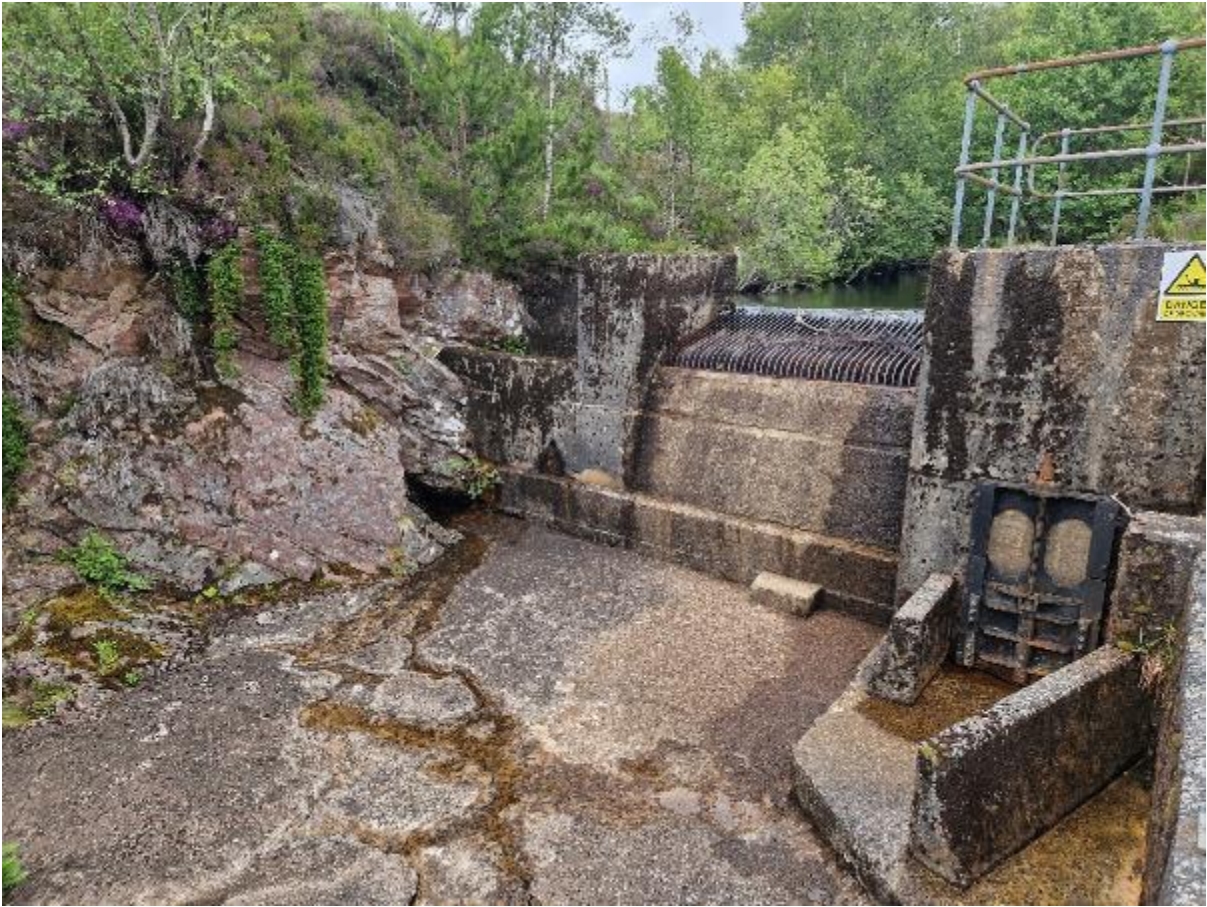
*Figure 61: SSE Hydro intake structure at the lower end of the survey area.*

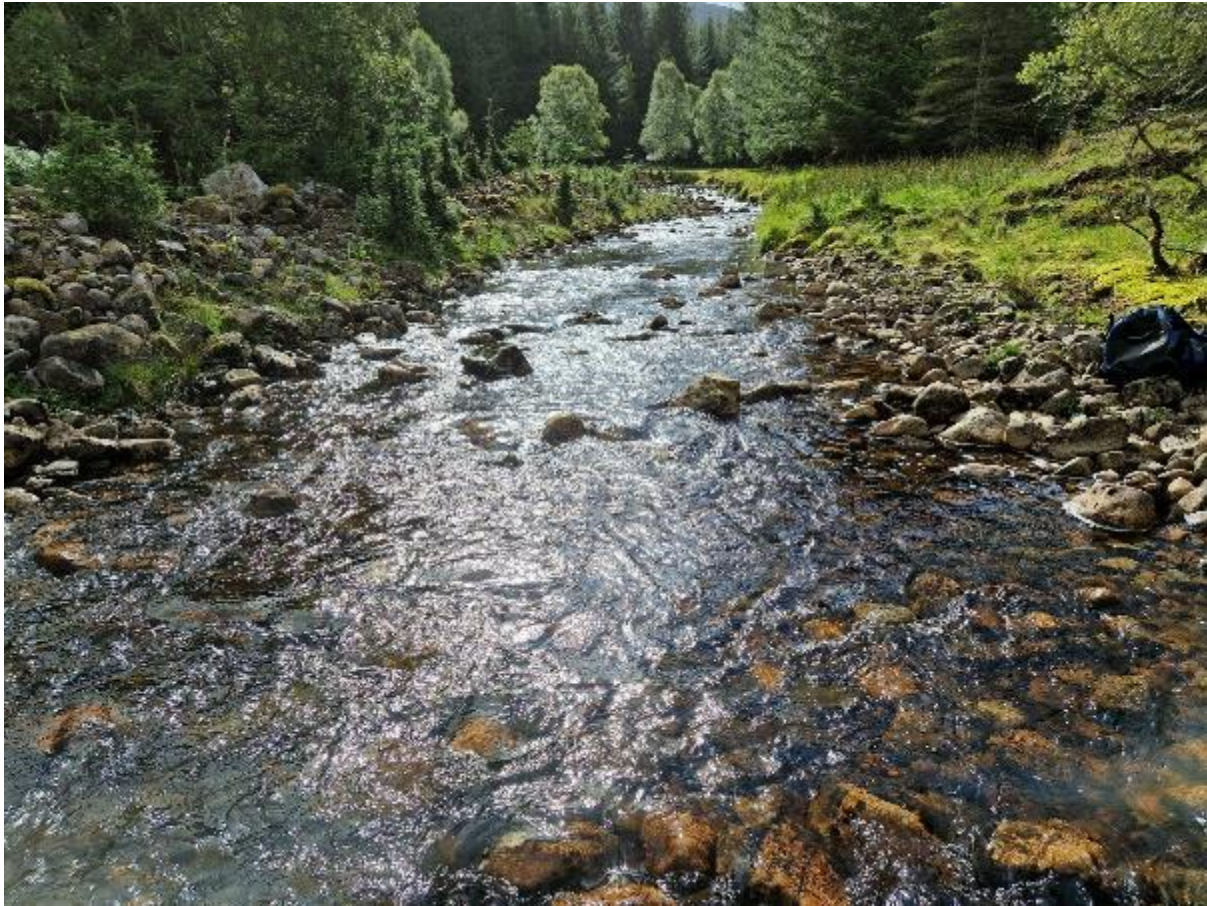
Figure 64 BWF1 Site Photograph

The survey was carried out on 06/08/2024. A wetted area of 102m was fished. A total of 17 salmon parr was recorded generating a density of 16.5 per 100m<sup>2</sup>. This can be classified as 'Moderate' under the SFCC classification scheme. A length frequency histogram is shown below.

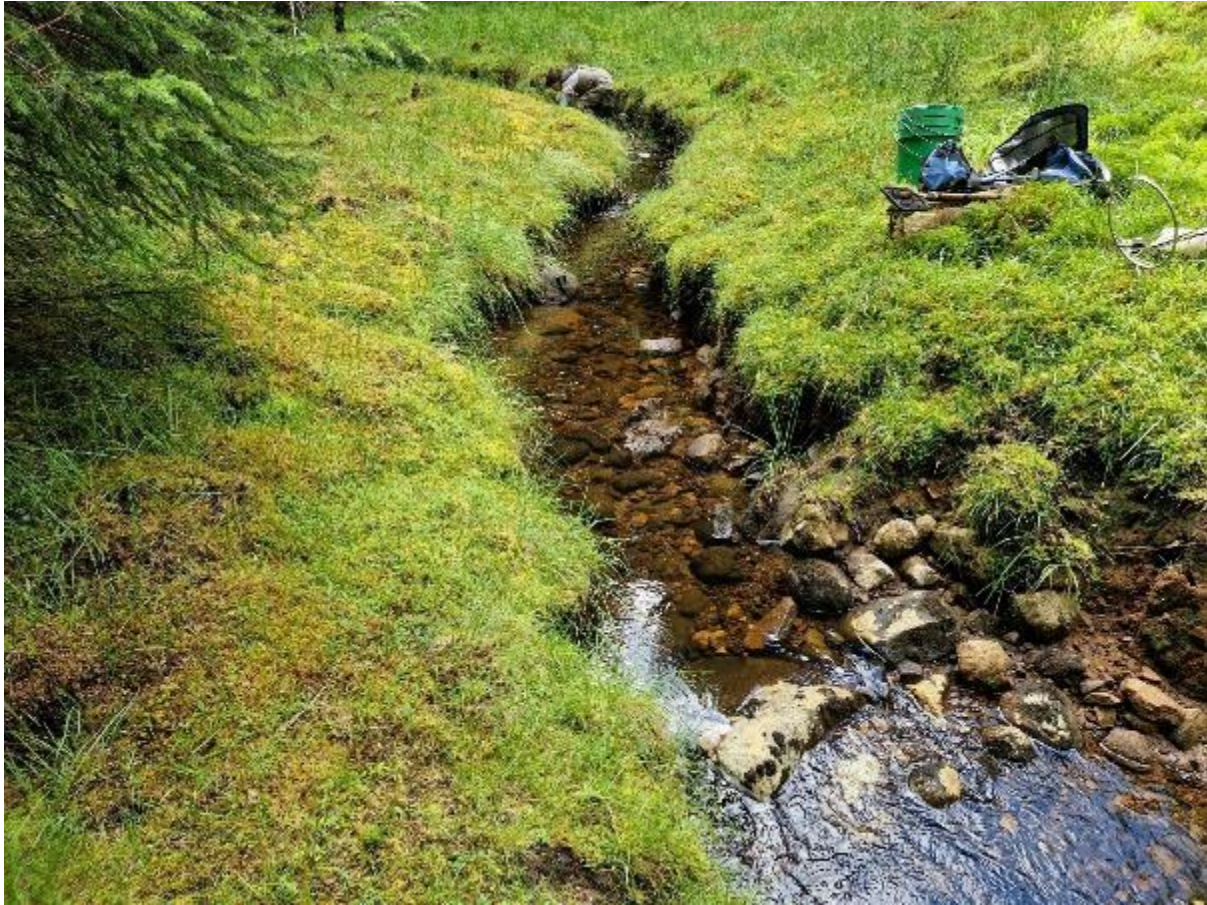
*Figure 67 BWF2 Site Photograph*

The survey was carried out on 06/08/2024. A wetted area of 74m was fished. A total of one salmon parr was recorded generating a density of 1.35 per 100m<sup>2</sup>. This can be classified as 'Very Low' under the SFCC classification scheme. A length frequency histogram is shown below.

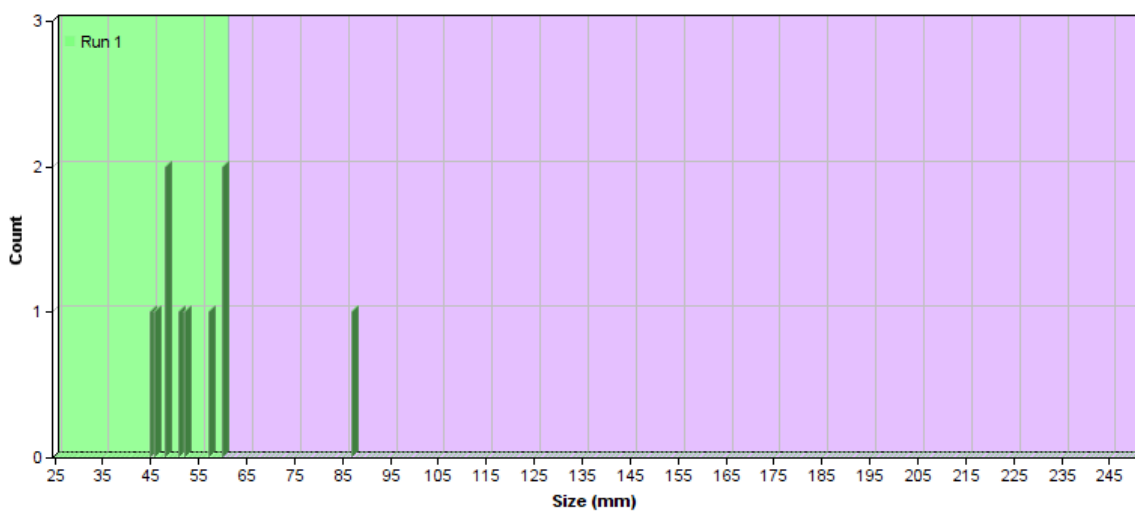
A total of nine trout fry and one trout parr was recorded generating densities of 12.1 per 100m<sup>2</sup> and 1.3 per 100m<sup>2</sup> respectively. These densities can be classified as 'Low' for fry and 'Very Low' for parr. Small tributaries of this size in the Moriston catchment are prone to drying out under drought conditions. However, it may remain wetted over the winter and early spring sufficiently long for trout to spawn and for the resulting fry to emigrate downstream to the main river. A length frequency histogram for trout is shown below.

*Figure 69 Length Frequency Histogram for trout at BWF2*

Trout are present in very low numbers suggesting limited spawning and production by a trout population utilising burn and mainstem habitat.

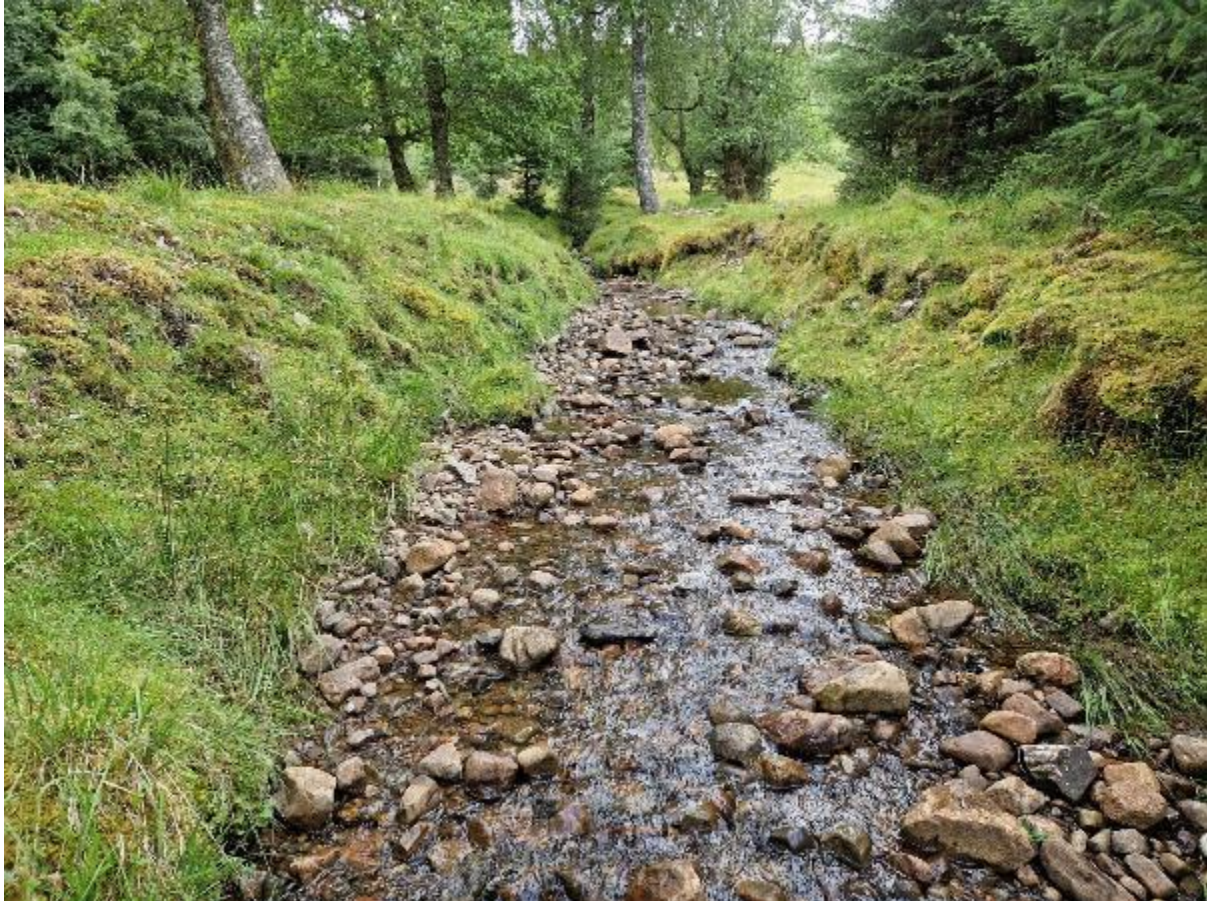
*Figure 70: BWF3 electrofishing site photograph*

The survey was carried out on 06/08/2024. A wetted area of 80m<sup>2</sup> was fished. All fish species were absent. A large impassable waterfall at the confluence with the mainstem river Moriston accounts for the lack of fish species making any migration into the river impossible. The high likelihood of drying out during extended dry period precludes the presence of fish of any species.

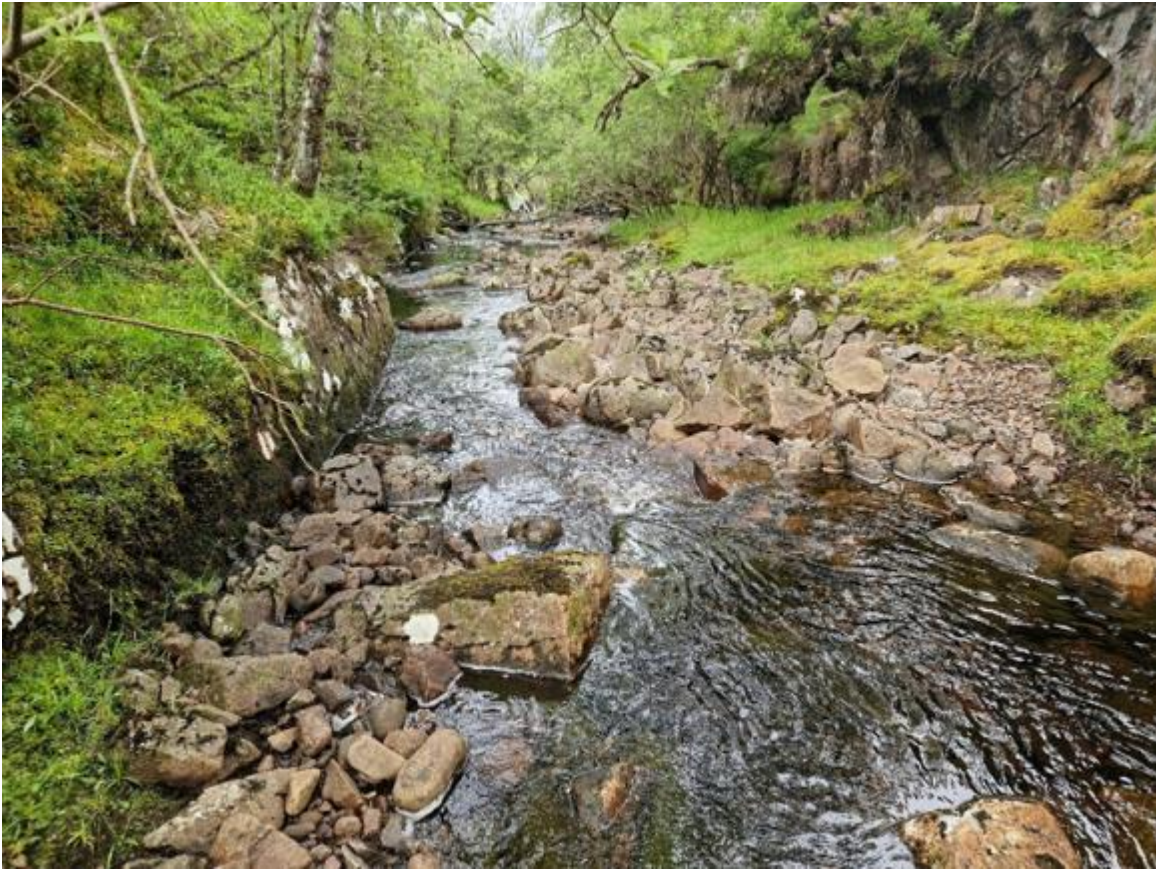
*Figure 71: BWF4 electrofishing site photograph*

The survey was carried out on 06/08/2024. A wetted area of 138.6m<sup>2</sup> was fished. All fish species were absent. This is likely to be due to a large dam/structure downstream of the site. Below this, the river is permanently dry therefore making any access impossible. A site photograph is shown below.

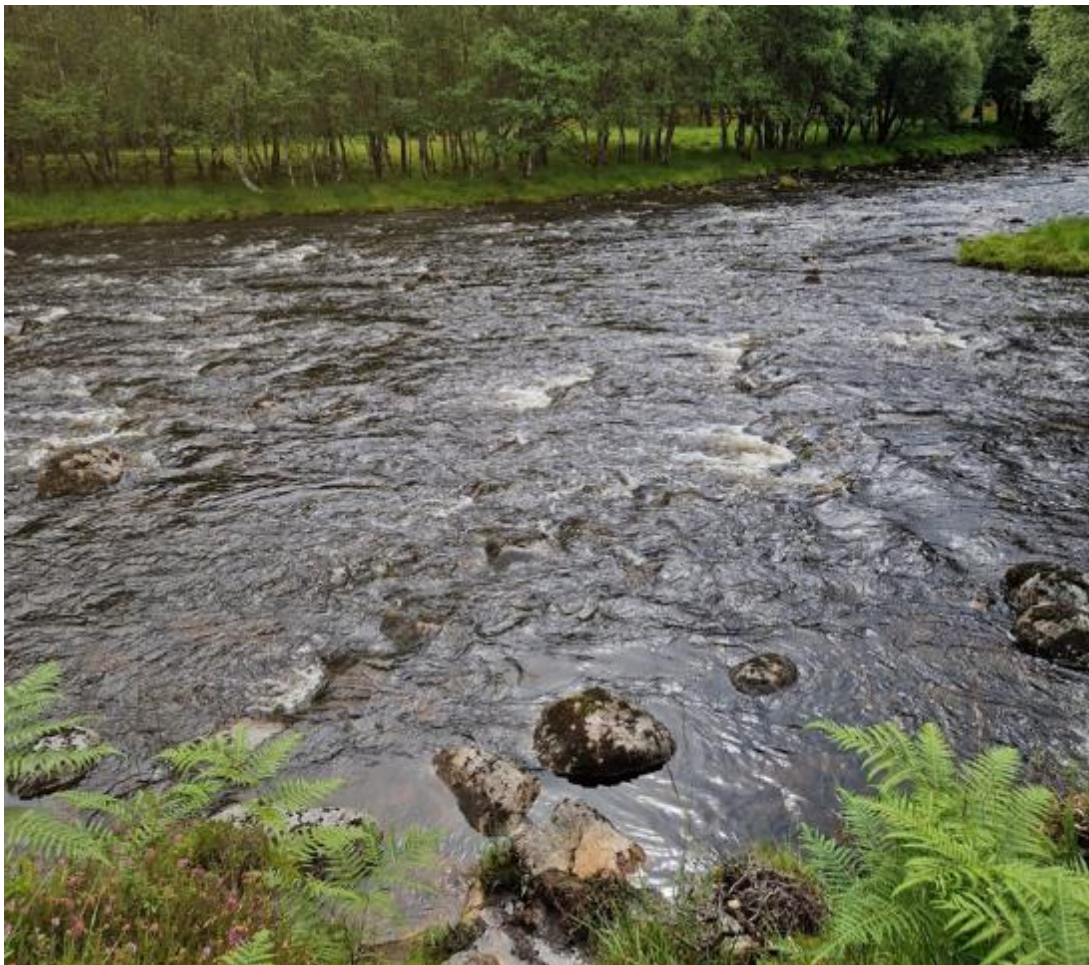
**Figure 75 BWF6 Site Photograph**

These densities reflect the excellent habitat found within the site and also a marked improvement when compared to previous surveys at the same location carried out by NDSFB. The localised distribution of salmon fry in the Moriston is interesting. Sites BWF5 & BWF6 are separated by little over 100m, yet salmon fry were absent in one of the sites. It is possible that salmon spawn in the channel to the north of the island at the Allt Belach Odhair confluence, and that fry from there have migrated downstream into site BWF6.
