# Cullum Welch House

Golden Lane Windows Project

Studio Partington

CITY OF LONDON

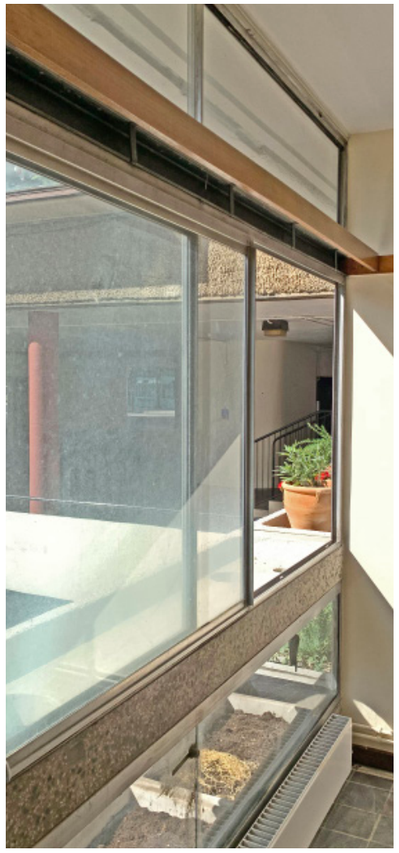
*Photograph of the south elevation windows from inside the living/bedroom space*

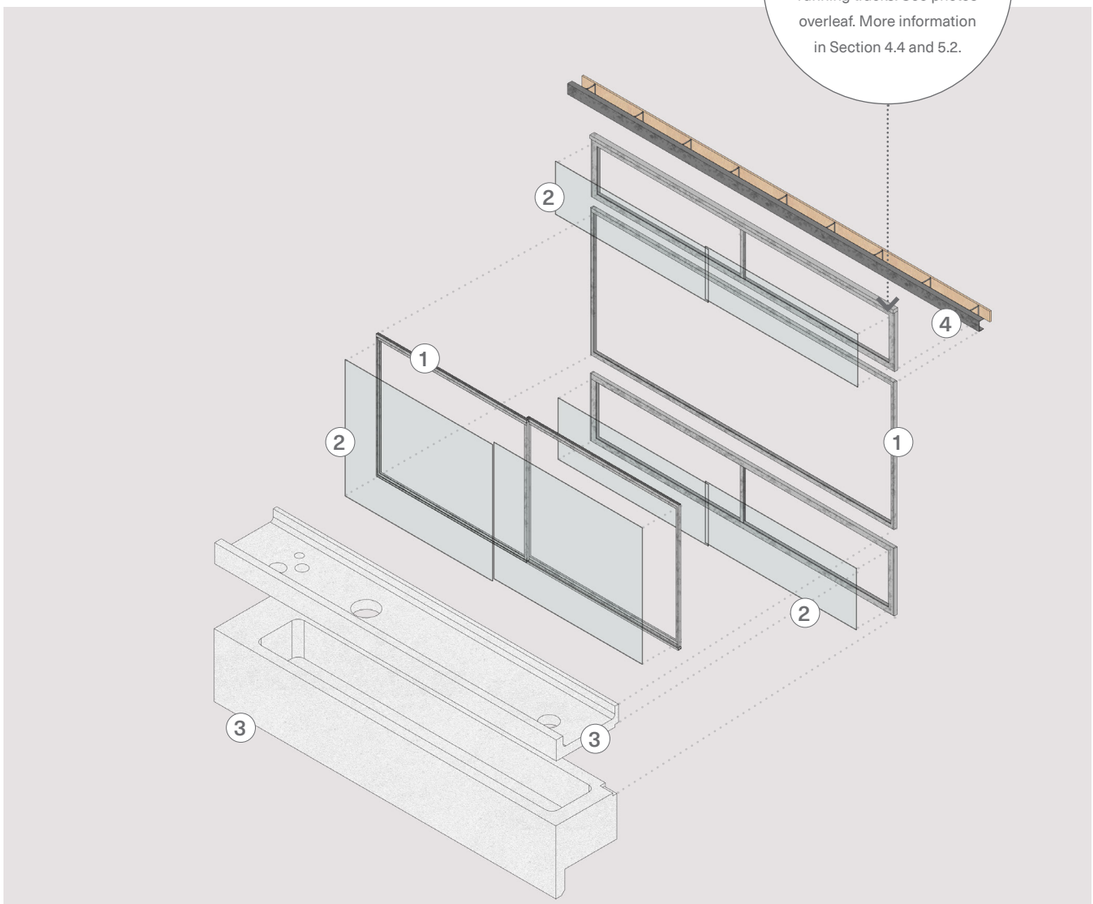
## 4.2 Typical Existing Window

Existing windows showing signs of deterioration, especially the aluminium running tracks. See photos overleaf. More information in Section 4.4 and 5.2.

*This drawing highlights the different elements of a typical, existing window found in Cullum Welch House. The principles can be applied to all windows in the block; all frames are aluminium and all windows areconsistently horizontally sliding on the south facade. The images on the following page highlight the typical window design at Cullum Welch House, including the window frame, types of glazing (fixed/opening), methods of operation and additional, unique details.*

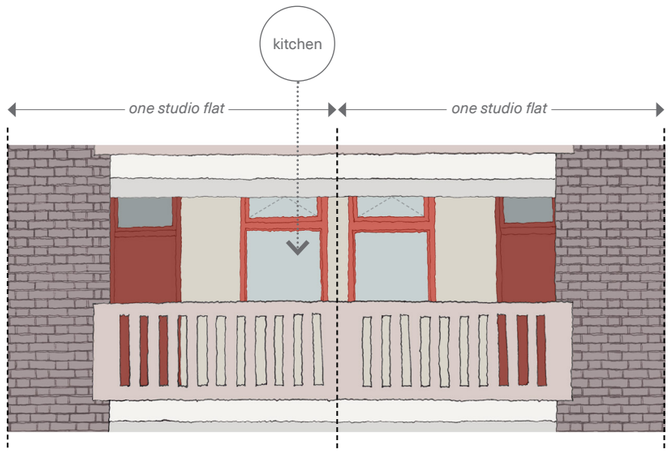
***North Elevation:*** *Sketch of a typical flat elevation on the south side of the building. Note that the flats are paired and this section of the elevation shows two neighbouring flats. All the flats are a 1 bedroom studio flat and this elevation has red painted timber window frames.*

*Photo of a section of the north facing side of the building, which faces the communal tennis courts.*

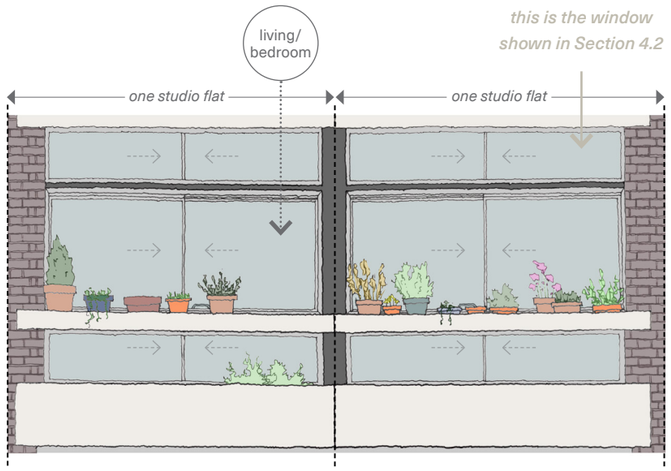
***South Elevation:*** *Sketch of a typical flat elevation on the north side of the building. Note that the flats are paired and this section of the elevation shows two neighbouring flats. All flats are a 1 bedroom studio flat and this elevation has 3 sliding windows, stacked from floor to ceiling, of which only the middle one is aluminium framed.*

*Photo of a section of the south facing side of the building which faces onto a courtyard, fronting Fann street.*

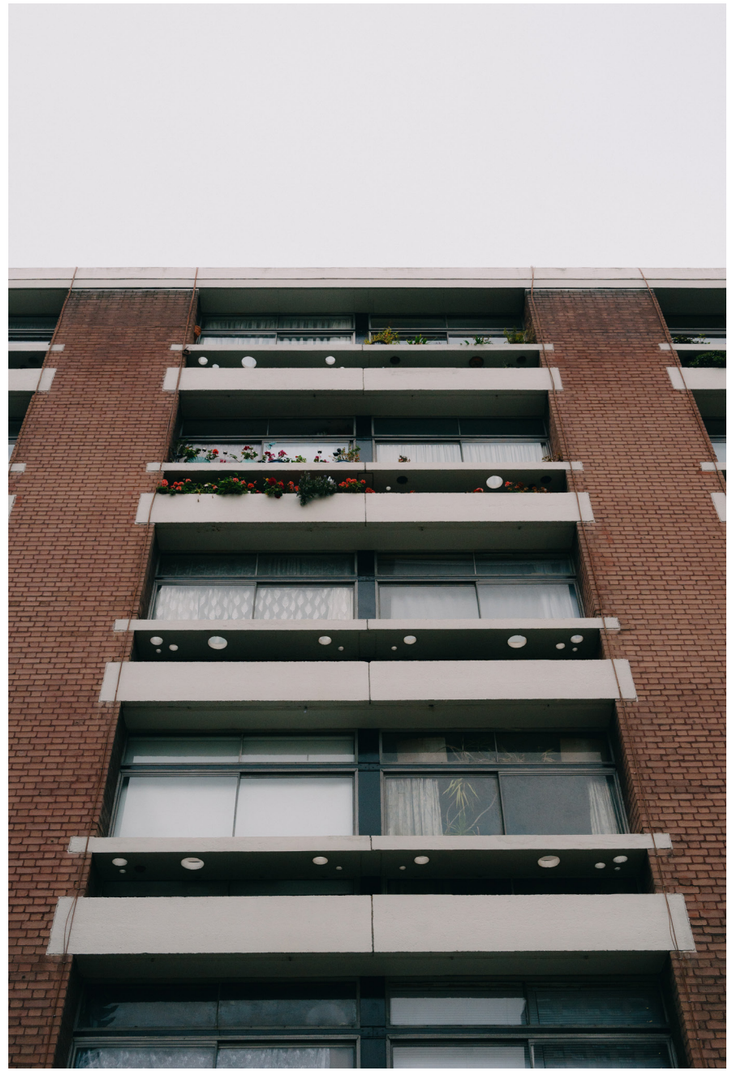
Studio Partington has undertaken a visual survey of a selection of windows at Cullum Welch House. After over sixty years of use, the condition of the windows across the estate has deteriorated. The aluminium is showing signs of deterioration, leaving the frames exposed and vulnerable.

All the windows and their integrated ironmongery appear to be original, with the aluminium frames exhibiting signs of weathering and stiffness. Although it is clear that many of the aluminium windows are damaged or decaying in parts, the extent of repair or replacement works that are required is unknown and a thorough condition survey is required to confirm this.

*Photograph of Cullum Welch House, showing the fully glazed south elevation and pre-cast concrete planters at floor and cill level, highlighting the holes for flower pots.*

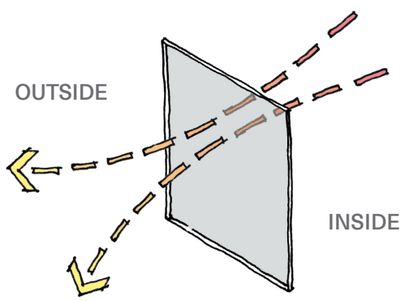
Without the benefit of double or triple glazing, heat from inside the flat escapes easily. This is exacerbated in the living/bed rooms of the Cullum Welch House flats, where most of the external wall is glass. Central heating, cooking, washing, bathing and breathing all add heat and moisture to the internal air. Condensation forms when warm moisture laden air hits a cold surface - whenever the external temperature is lower than the internal temperature there is potential for condensation to form on the inner surface of single glazing. This risk is significantly reduced/eliminated with double or triple glazing, where a cavity separates the inner pane from the lower, external temperature. Condensation is forming and tends to pool at the bottom of the timber frames, resulting in their deterioration. A lack of efficient ventilation within the homes then leads to mould growth in areas of lingering condensation.

*Heat loss through single glazing is significant as the glass has a high thermal transmittance - it is a very good transferer of heat (not good for heat retention in homes!). Glass is better at retaining heat when it is high performance (vacuum/ double/triple) and in an insulated (thermally broken) frame*

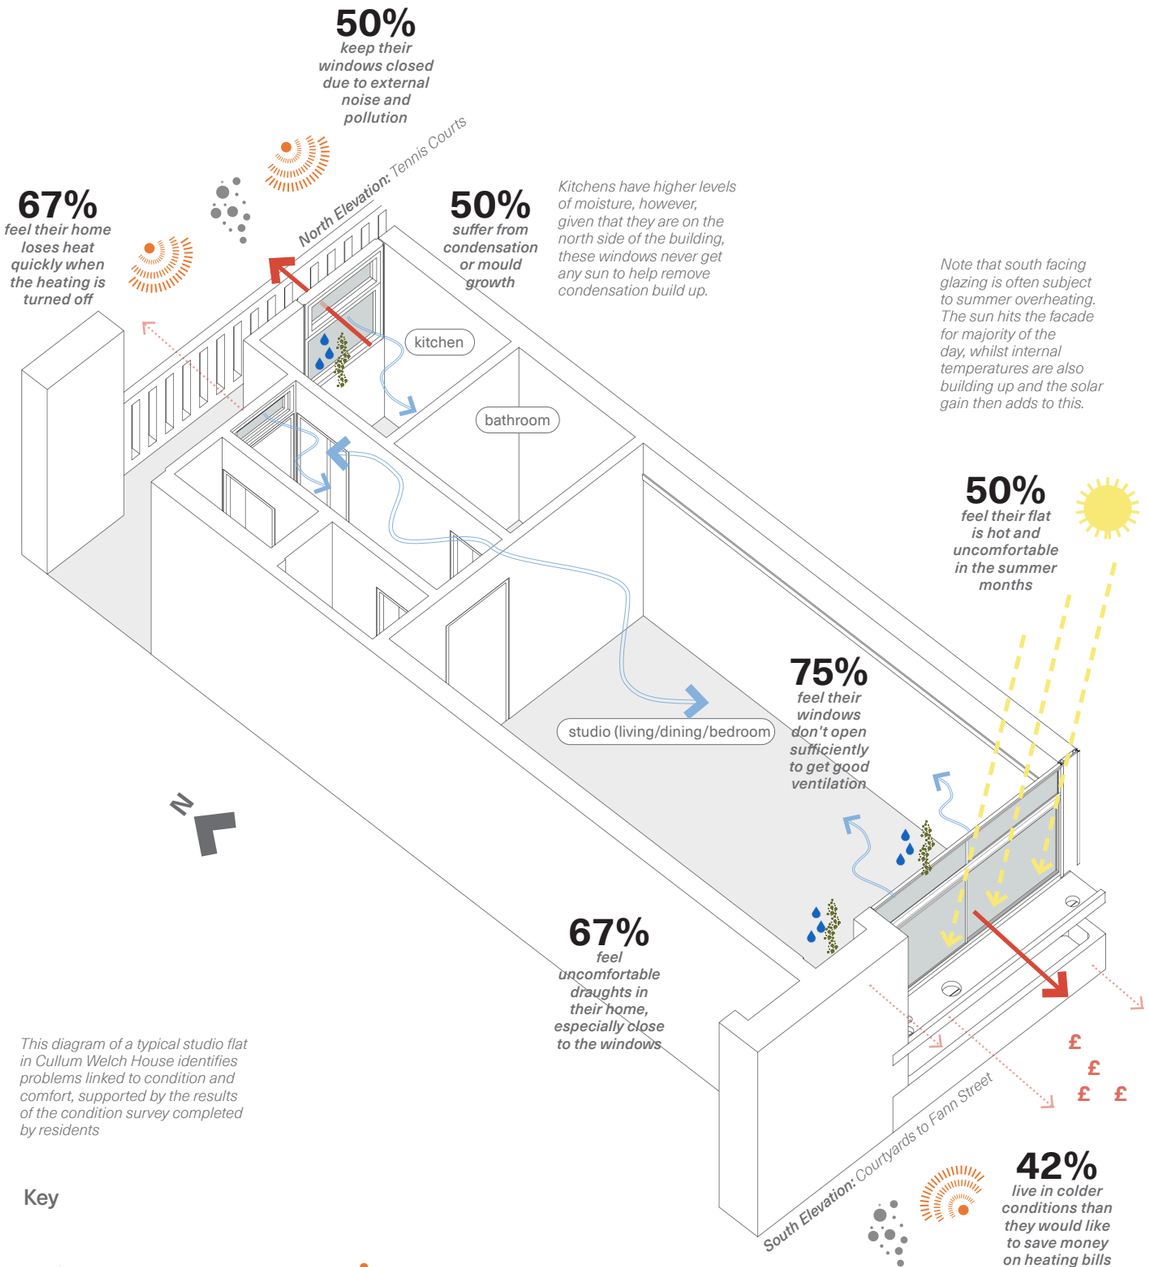
*This diagram of a typical studio flat in Cullum Welch House identifies problems linked to condition and comfort, supported by the results of the condition survey completed by residents*

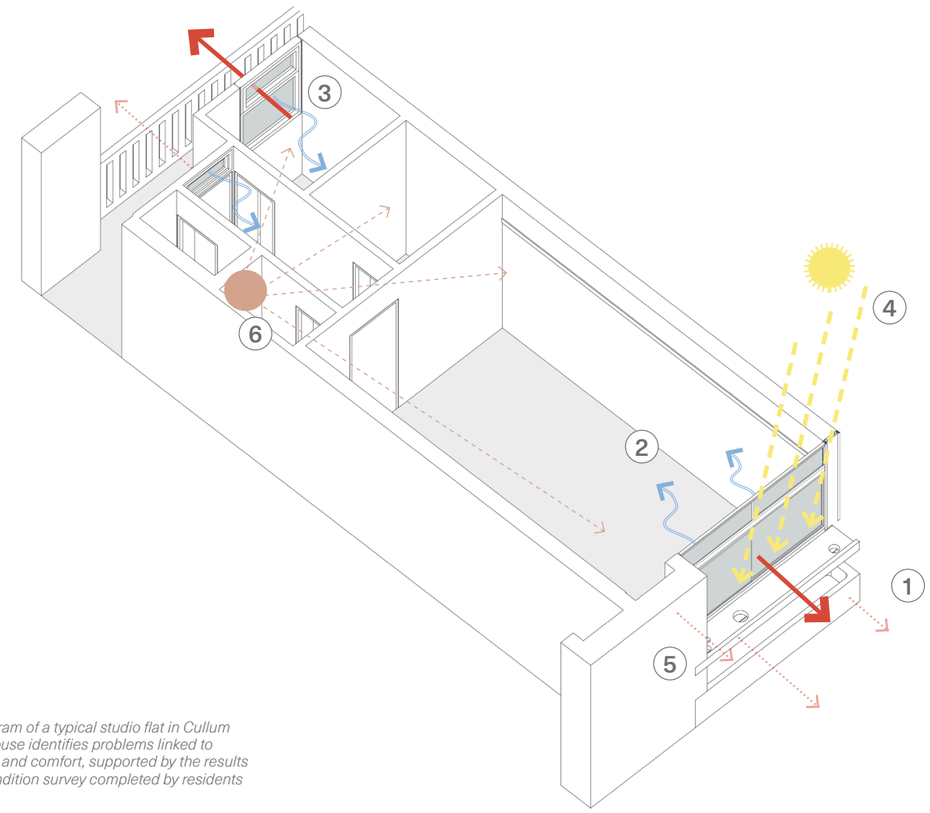
*This diagram of a typical studio flat in Cullum Welch House identifies problems linked to condition and comfort, supported by the results of the condition survey completed by residents*

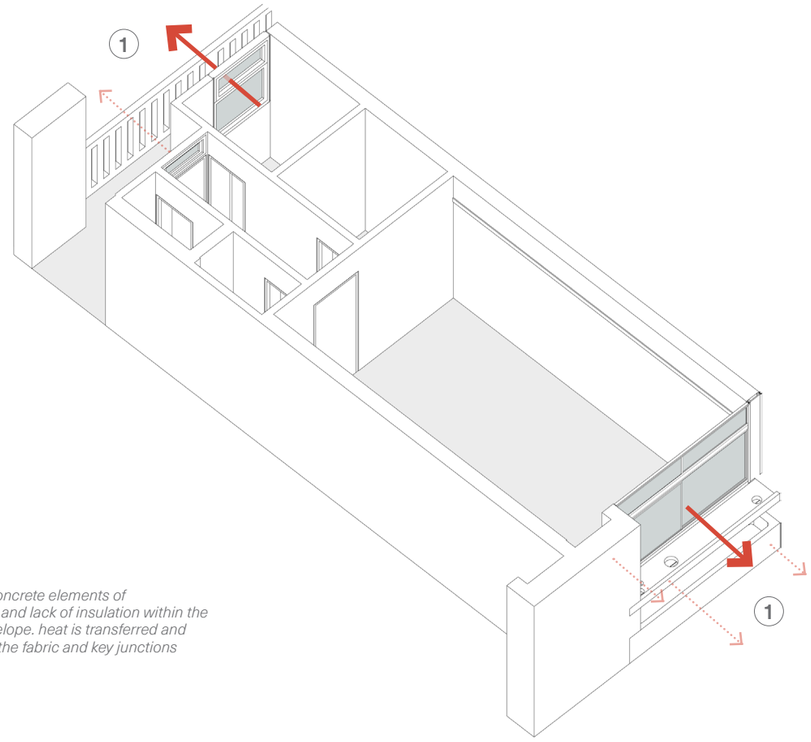
1 *Due to the concrete elements of construction and lack of insulation within the building envelope. heat is transferred and lost through the fabric and key junctions*

- **Windows/doors (confirmed):** Improvement of the windows thermal performance. New frames would be thermally broken, further reducing thermal bridging and heat loss.
- **External walls:** In addition to this, install insulation to the cavity to the external walls. Where there is no cavity, install insulation internally or externally, to ensure that the existing poor thermal performance isn't exacerbated by the improved windows.
- **Roof:** In addition to this, install insulation to the roof, internally or externally.
- **Floor slab:** In addition to this, install external insulation to any exposed floor slab
