Maisonettes

Golden Lane Windows Project

This document has been prepared by Studio Partington on behalf of the City of London Corporation. It explores several possible approaches for improvements to the condition and performance of windows in the Maisonette blocks. Please note that Basterfield, Bayer, Bowater, Cuthbert Harrowing and Hatfield House are grouped together and referred to as the 'Maisonettes' within this study.

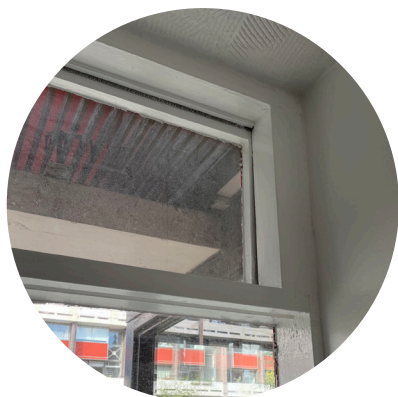
Softwood timber window frame

Window frames to the kitchen & bathroom on the north elevations are softwood. Frame supports fixed glazing at lower level and an openable light above. Painted white internally and red externally. Note that none of the windows have built-in trickle ventilators

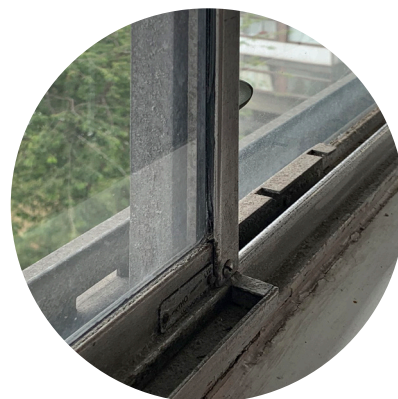
Aluminium window frame

Aluminium frames to all windows (including oriel windows and the vertical door to balcony), apart from in kitchens/ bathrooms. Mix of fixed panes and horizontal sliding panes. Single-glazed. Note that none of the windows have built-in trickle ventilators.

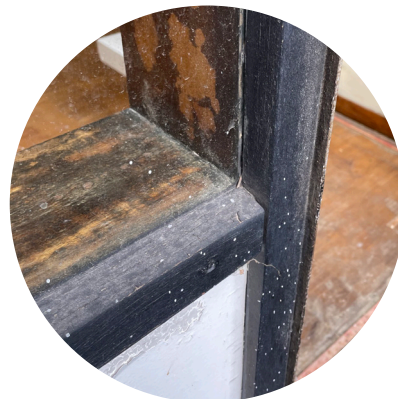
Hardwood frame

Hardwood framed windows beneath the oriel window. Hardwood functions as both sill in the exterior and window board in the interior. Painted black externally, clear finish internally. Plywood infill's below the glazing within timber frame.

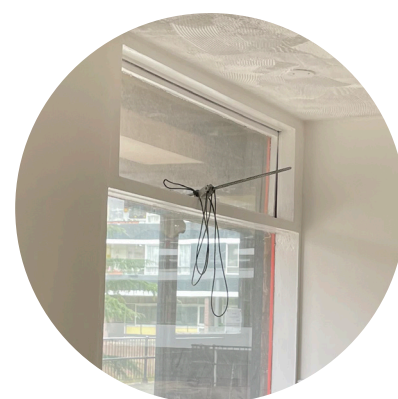
Top-hung opening light

Softwood top-hung opening windows in fan-light style. Painted red finish externally and white internally. Found in bathrooms and kitchens on the north elevation. Single-glazed. Note screwjack opening/fixing mechanism. Fixed glazing below.

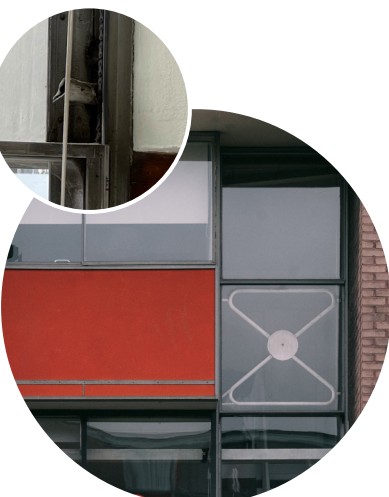
Coloured glass cladding

Coloured, Muroglass spandrel panels found beneath the oriel windows on both the north and south elevations (colours vary). Note the retained figure-of-eight heating coil and evidence of pipework where coil has been removed.

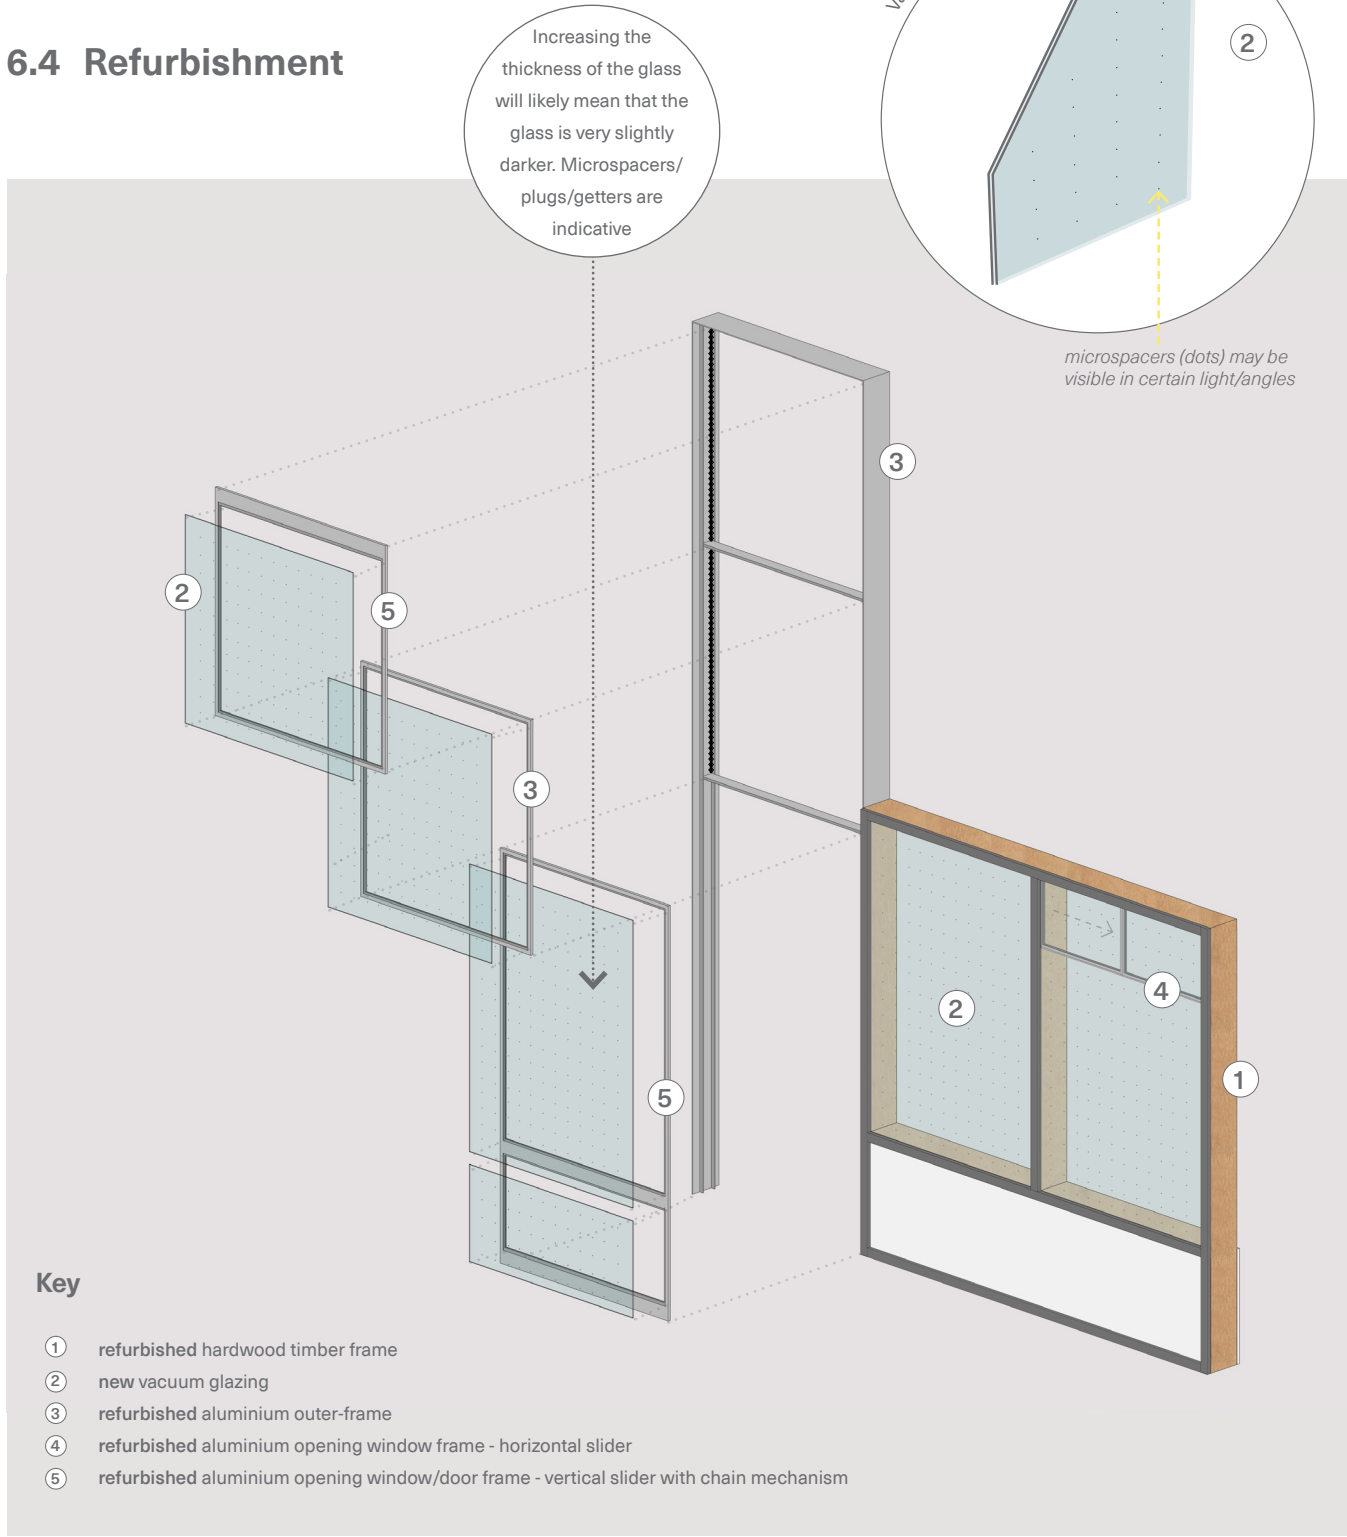
This drawing highlights the different elements of a typical, **refurbished** window found in one of the Maisonette blocks. The principles can be applied to all windows in the block, apart from the north facing softwood window (these are not described as significant in heritage terms). Principally, the vast majority of the

- REFURBISHED (repairs/partial replacement where needed)
- NEW
- 1 refurbished hardwood timber frame
- 2 new vacuum glazing
- 3 refurbished aluminium outer-frame
- 4 refurbished aluminium opening window frame - horizontal slider
- 5 refurbished aluminium opening window/door frame - vertical slider

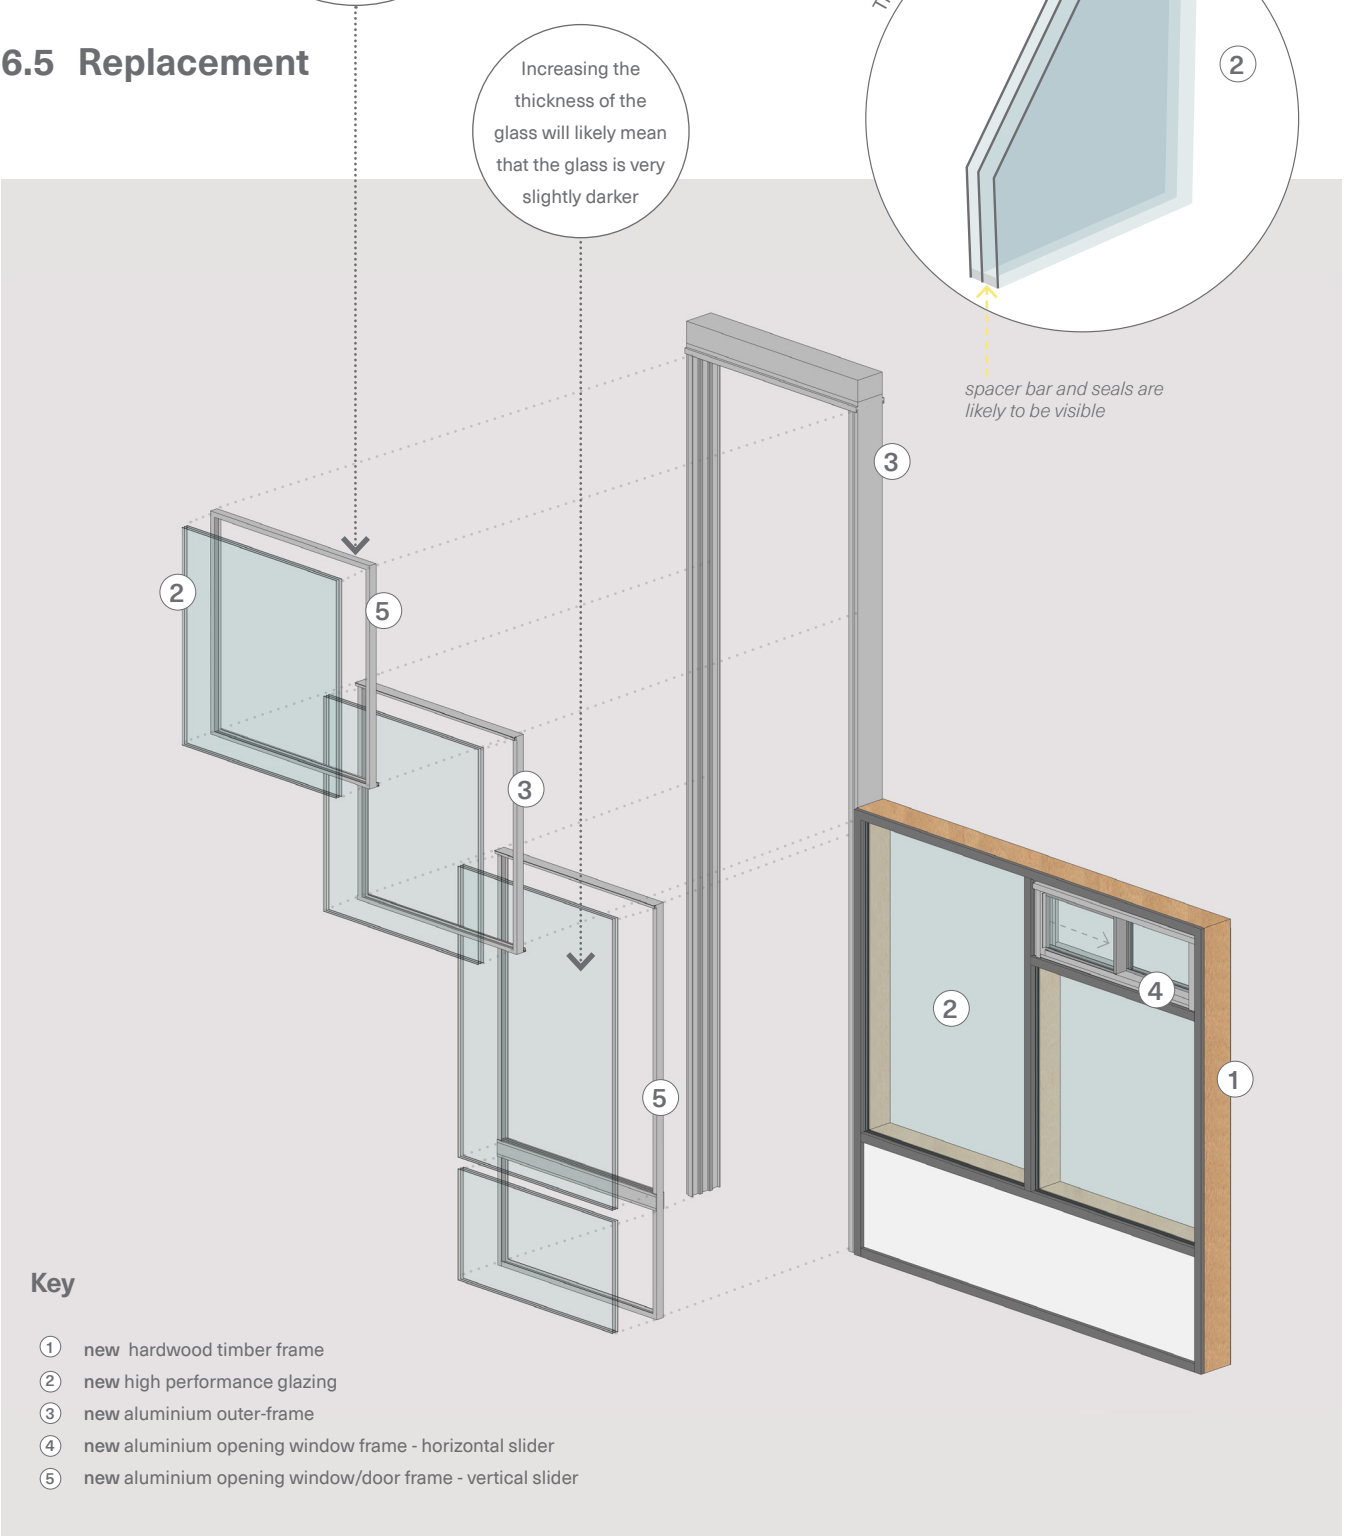
This drawing highlights the different elements of a typical, **replacement** window found in one of the Maisonette blocks. The principles can be applied to all windows in the block, apart from the north facing softwood window (these are not described as significant in heritage terms). Principally, the vast majority of the frames are aluminium and open by moving horizontally or vertically. High performance glazing could be vacuum, double or triple, however, triple glazing is shown as this would have the maximum impact.

- NEW
- 1 new hardwood timber frame (note that this could be retained)
- 2 new high performance glazing
- 3 new aluminium outer-frame
- 4 new aluminium opening window frame - horizontal slider
- 5 new aluminium opening window/door frame - vertical slider

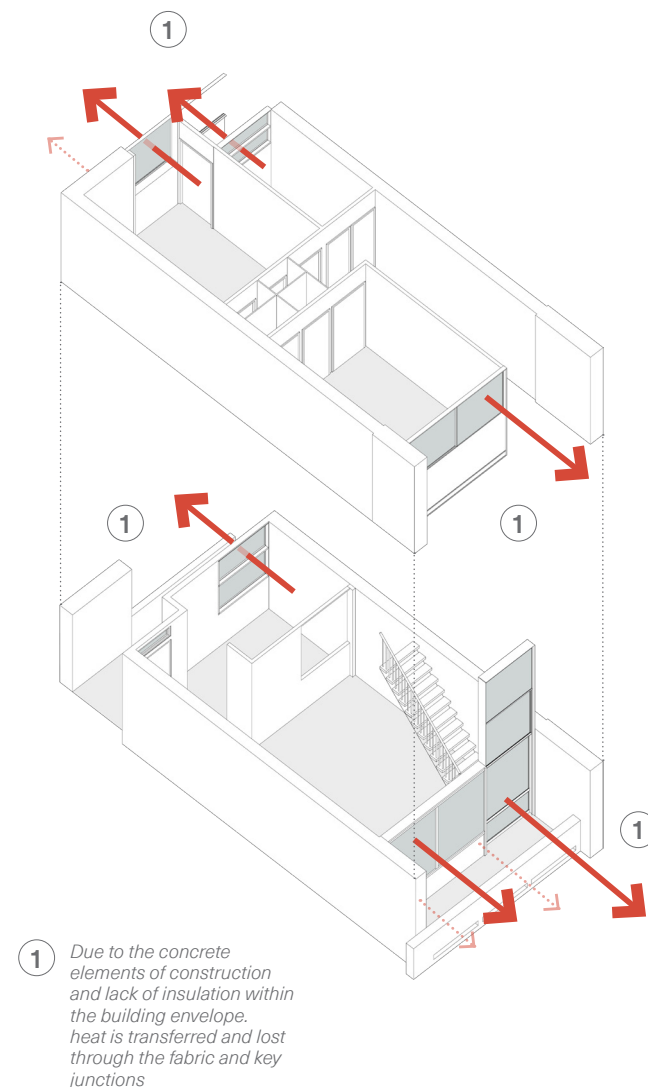
The fabric of the buildings at Golden Lane Estate is generally in good condition for the age of the buildings, however, it is poorly insulated and sealed.

The uninsulated concrete and brick construction of the Maisonette blocks means that a number of significant thermal bridges exist. This means heat is transferred and lost through the building envelope and key junctions, including external walls, floors, roofs, windows and doors. In addition, the existing window frames are not thermally broken, which means that they are not insulated. This creates a significant thermal bridge where heat can escape from inside the flat.

- **Windows/doors (confirmed):** Improvement of the windows thermal performance. New frames would be thermally broken, further reducing thermal bridging and heat loss. Insulation can be included within the glass cladding spandrel panels.
- **External walls:** In addition to this, install insulation internally or externally, to ensure that the existing poor thermal performance isn't exacerbated by the improved windows.
- **Roof:** In addition to this, install insulation to the roof, internally or externally.
- **Floor slab:** In addition to this, install external insulation to any exposed floor slab.

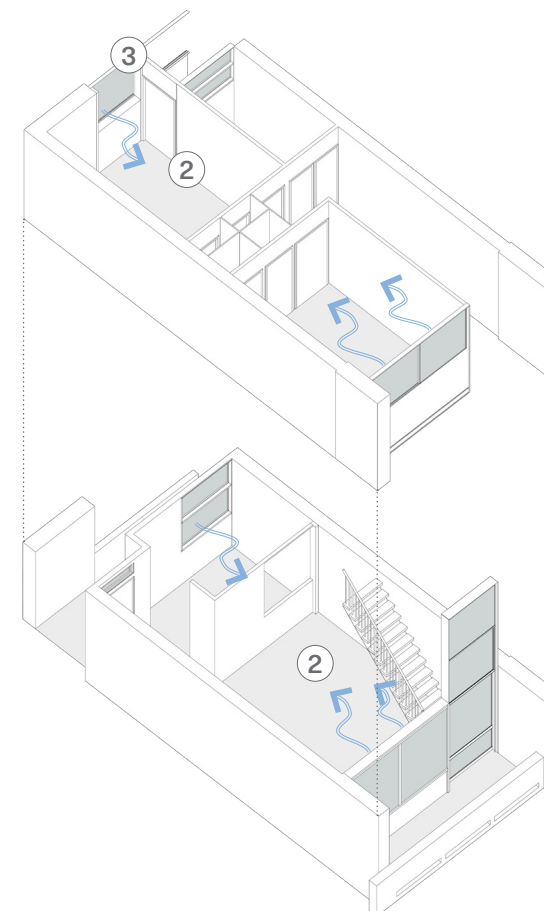
7.3 Air Infiltration

Poor airtightness can be attributed to gaps (big and small) in the building fabric. Excess air infiltration is experienced in homes as draughts. Majority of these draughts are felt due to poorly sealed windows and doors, which reduce the airtightness of the dwellings and subsequently increase heat loss.

- **Windows/doors:** Improved seals to windows and doors and airtightness around structural openings to help keep the heat inside the homes. New windows/doors installed with improved airtightness.
- **External walls/junctions:** Improved airtightness throughout the flat through installation of airtightness material e.g. airtightness tape.
