# Executive Summary

This document has been prepared by Studio Partington on behalf of the City of London Corporation. It explores several possible approaches for improvements to the condition and performance of windows in Stanley Cohen House.

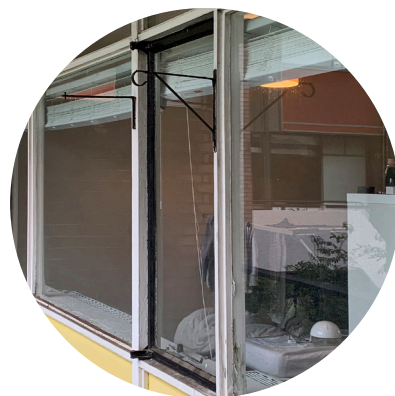
*Side-hung opening light*

*Side-hung, steel-framed, opening casement windows. Single-glazed. Painted black finish externally and white internally. Found in some bathrooms and kitchens and all bedrooms and living spaces.*

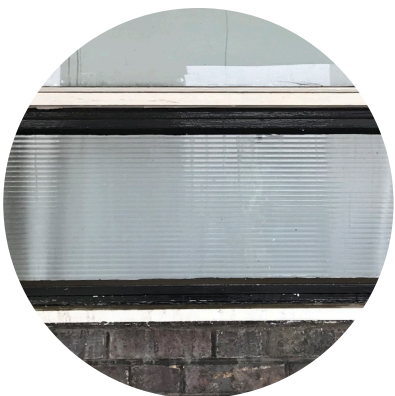
*Reeded glass*

*Also known as fluted glass or ribbed glass. Horizontally reeded glass to steel-framed, pivoting opening light in bathroom (east elevation, ground floor only).*

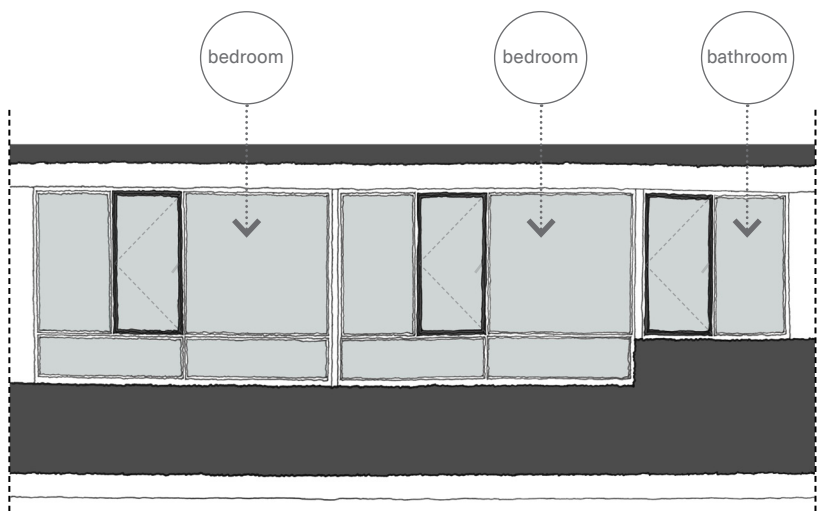
East Elevation: Sketch of a typical flat elevation on the east side of the building. This flat is a 2-bed and has two bedrooms and a bathroom on this elevation, with side-hung opening windows painted black.

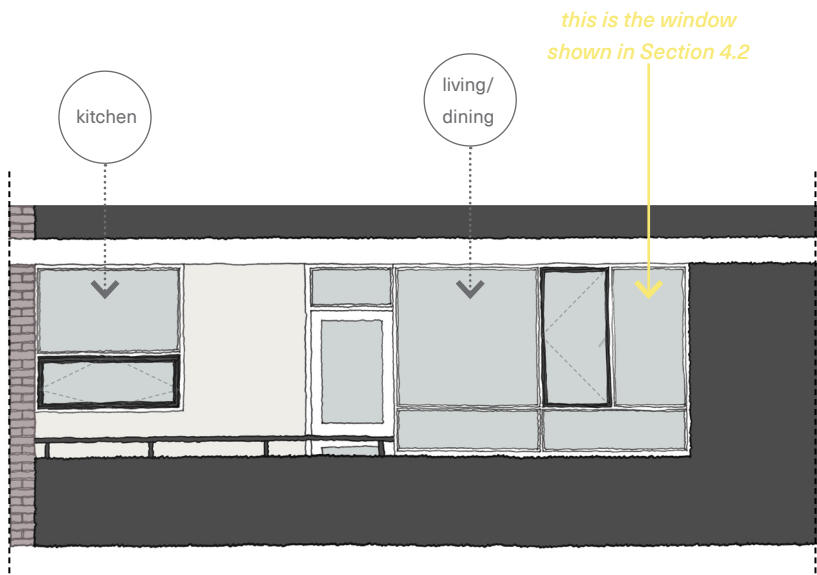
West Elevation: Sketch of a typical flat elevation on the west side of the building. This flat is a 2-bed and has the kitchen and a living/dining room on this elevation, with side-hung and pivot-style opening windows painted black.

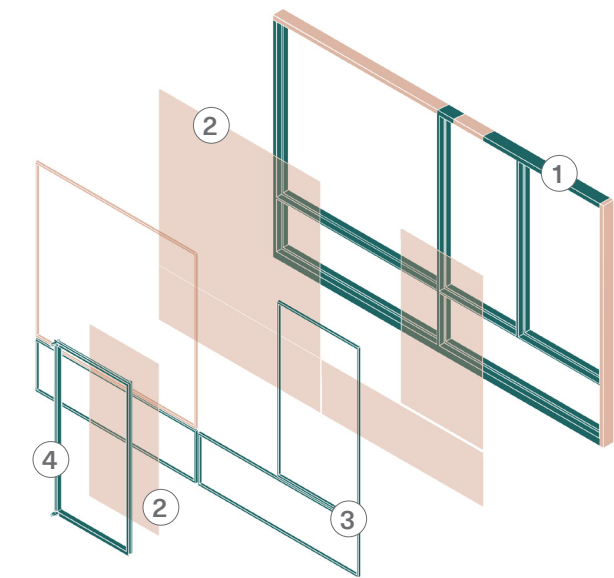
REFURBISHMENT

- REFURBISHED (repairs/partial replacement where needed)
- NEW
- ① refurbished softwood timber frame
- ② new vacuum glazing
- ③ refurbished softwood timber beading - external (repairs/partial replacement where needed)
- ④ refurbished steel opening window casement

- A percentage of the window frames in the 'refurbishment' option will likely require replacement, where frames cannot be repaired effectively. These replacements will match the existing like for like. Note that the elements of 'new' frame on the diagram below are indicative - this could range from no new areas to a full new frame.
- Within the full replacement approach, the configuration and style of the openings and proportions of the windows will be the same as existing. Replacement frames will be matched to the existing design intent as closely as possible, however, certain changes will be unavoidable, such as frame thickness.

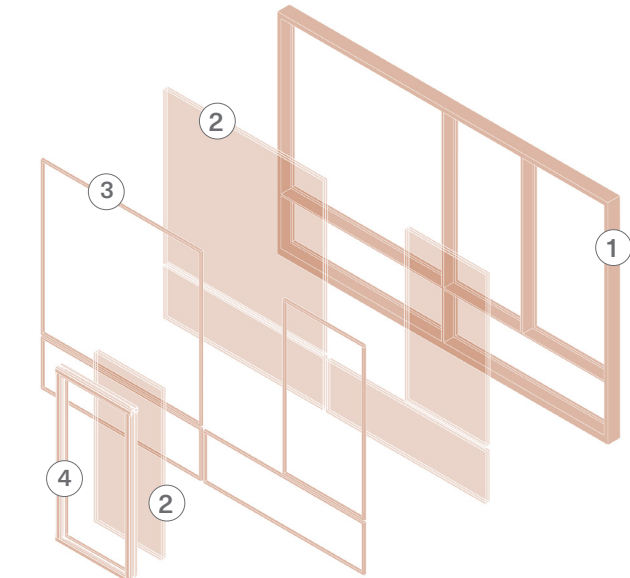
REPLACEMENT

- NEW
- ① new softwood timber frame
- ② new high performance glazing
- ③ new softwood timber beading - external
- ④ new steel opening window casement

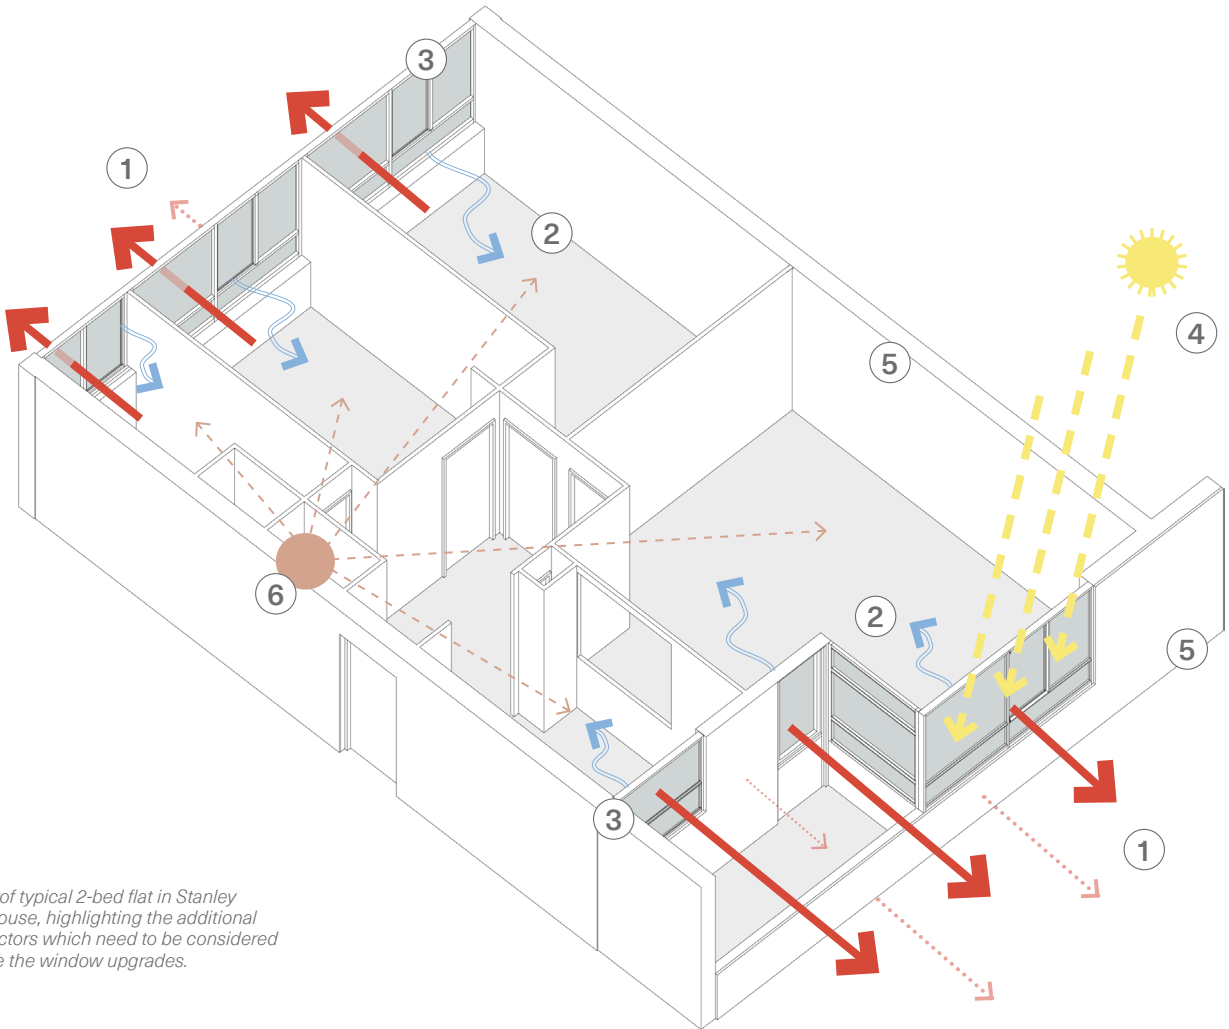
- 1 Heat loss through fabric**  
Due to the concrete and masonry elements of construction and lack of insulation within the building envelope, heat is transferred and lost through the fabric and key junctions.
- 2 Air infiltration**  
Excess air infiltration is experienced as cold draughts, particularly near windows.
- 3 Ventilation**  
Moisture is not being effectively removed from all homes. None of the existing windows have trickle vents for background ventilation and there is no mechanical background ventilation.

- 4 Solar heat gains**  
Solar gains from the west provide free heat on sunny days in the winter but means that this side of the home can suffer from overheating in summer.
- 5 Thermal mass**  
Concrete and masonry are thermal mass materials - they absorb, store and release heat slowly. In summer this helps to keep homes cool, but in winter it can mean that they take longer to heat up.
- 6 Heating System**  
Inefficient heating systems increase energy consumption and energy bills. Also, increased maintenance costs.

Diagram of typical 2-bed flat in Stanley Cohen House, highlighting the additional retrofit factors which need to be considered alongside the window upgrades.
