6.4 Refurbishment

CRESCENT HOUSE PILOT PROJECT

Airtightness Testing

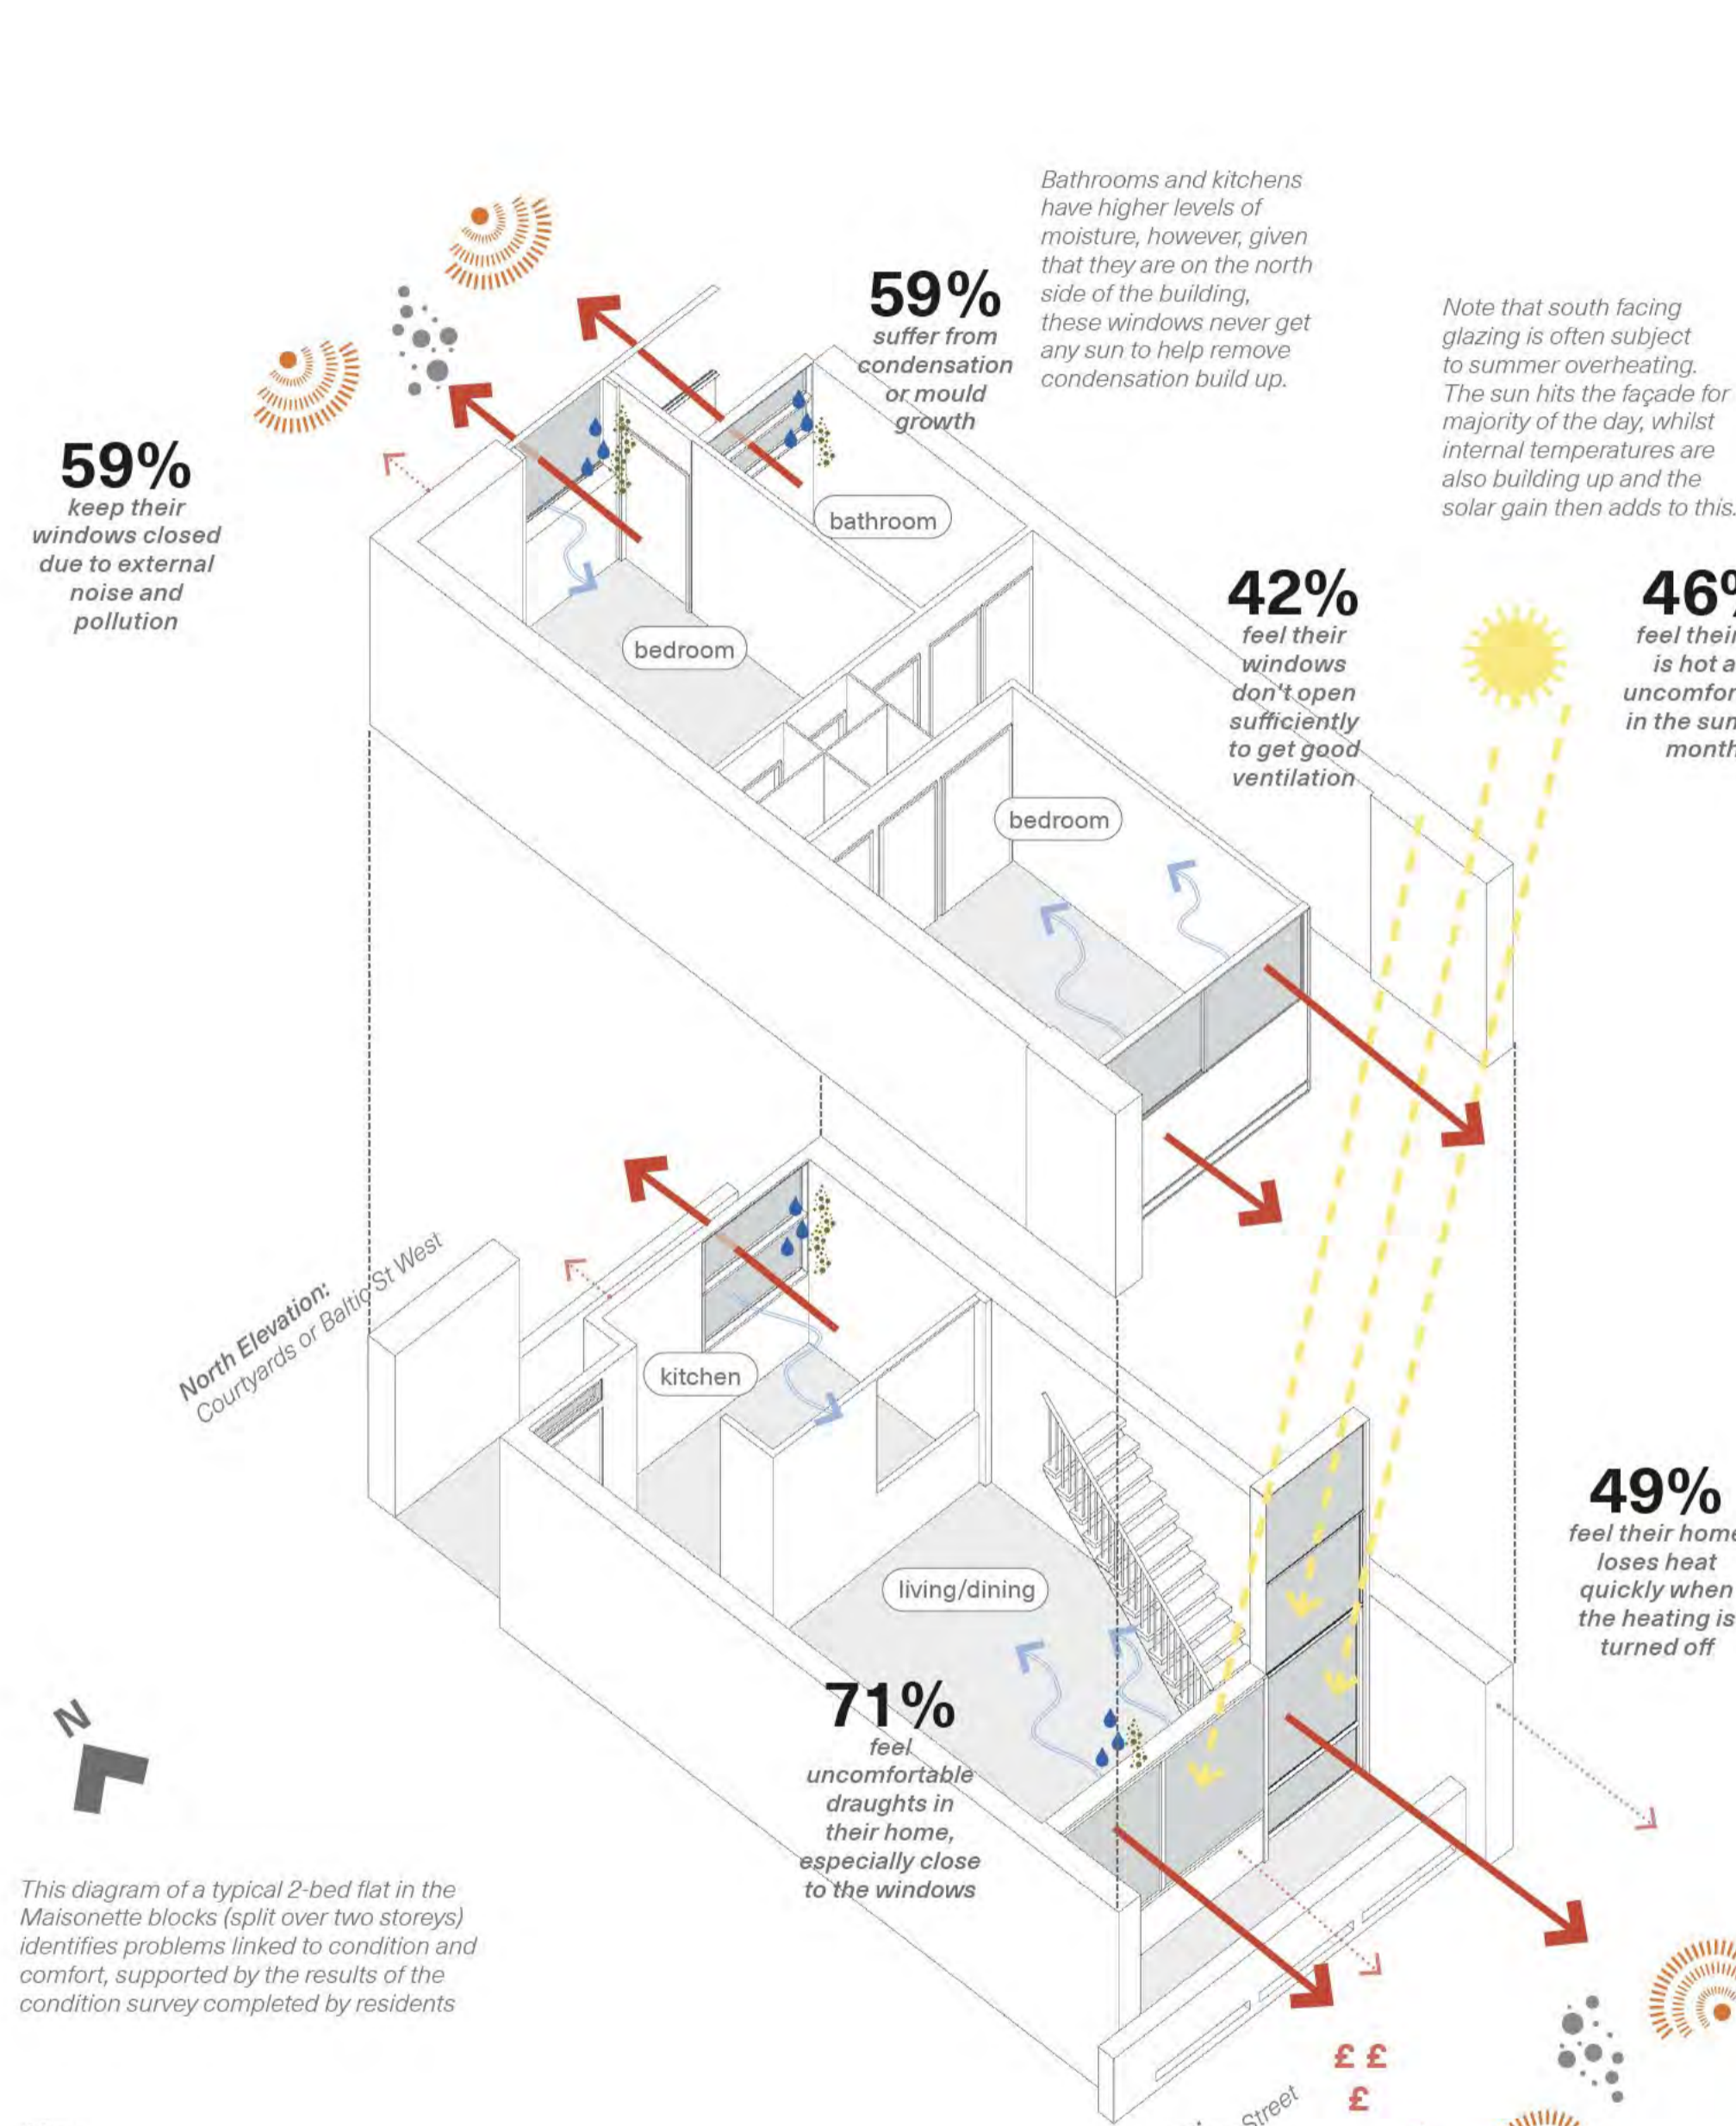
- Key**
- Heat loss through single glazing
 - Heat loss through external walls & thermal bridges (incl. window frame)
 - Uncontrolled incoming air (draughts)
 - Excess solar gains (summer)
 - ☀️ Noise pollution
 - ☁️ Air pollution
 - 🍄 Mould growth
 - 💧 Condensation build-up

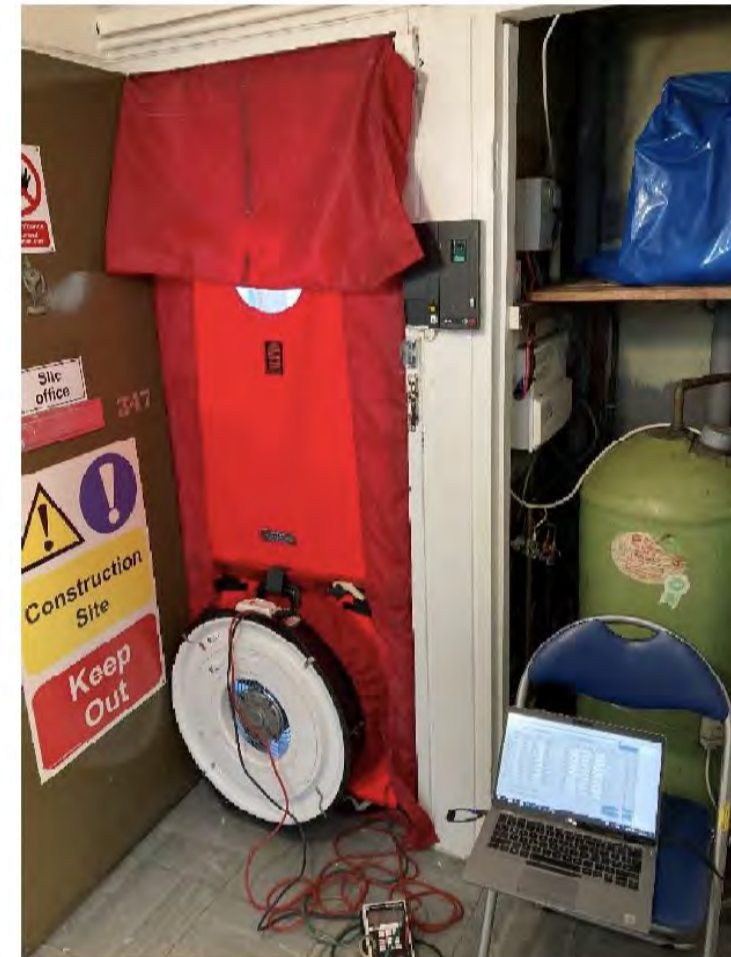
Figure 2: Test set-up showing the blower door mounted in the front door.

The apartment was tested as a whole by mounting the test equipment (blower door) within a hallway door serving the space under test, see Figure 2. All internal doors wedged opened to allow airflow through entire area under test, as required by CIBSE TM23:2022.
