# CRESCENT HOUSE

# CRESCENT HOUSE PILOT PROJECT

## TESTING OF EXISTING BUILDING FABRIC

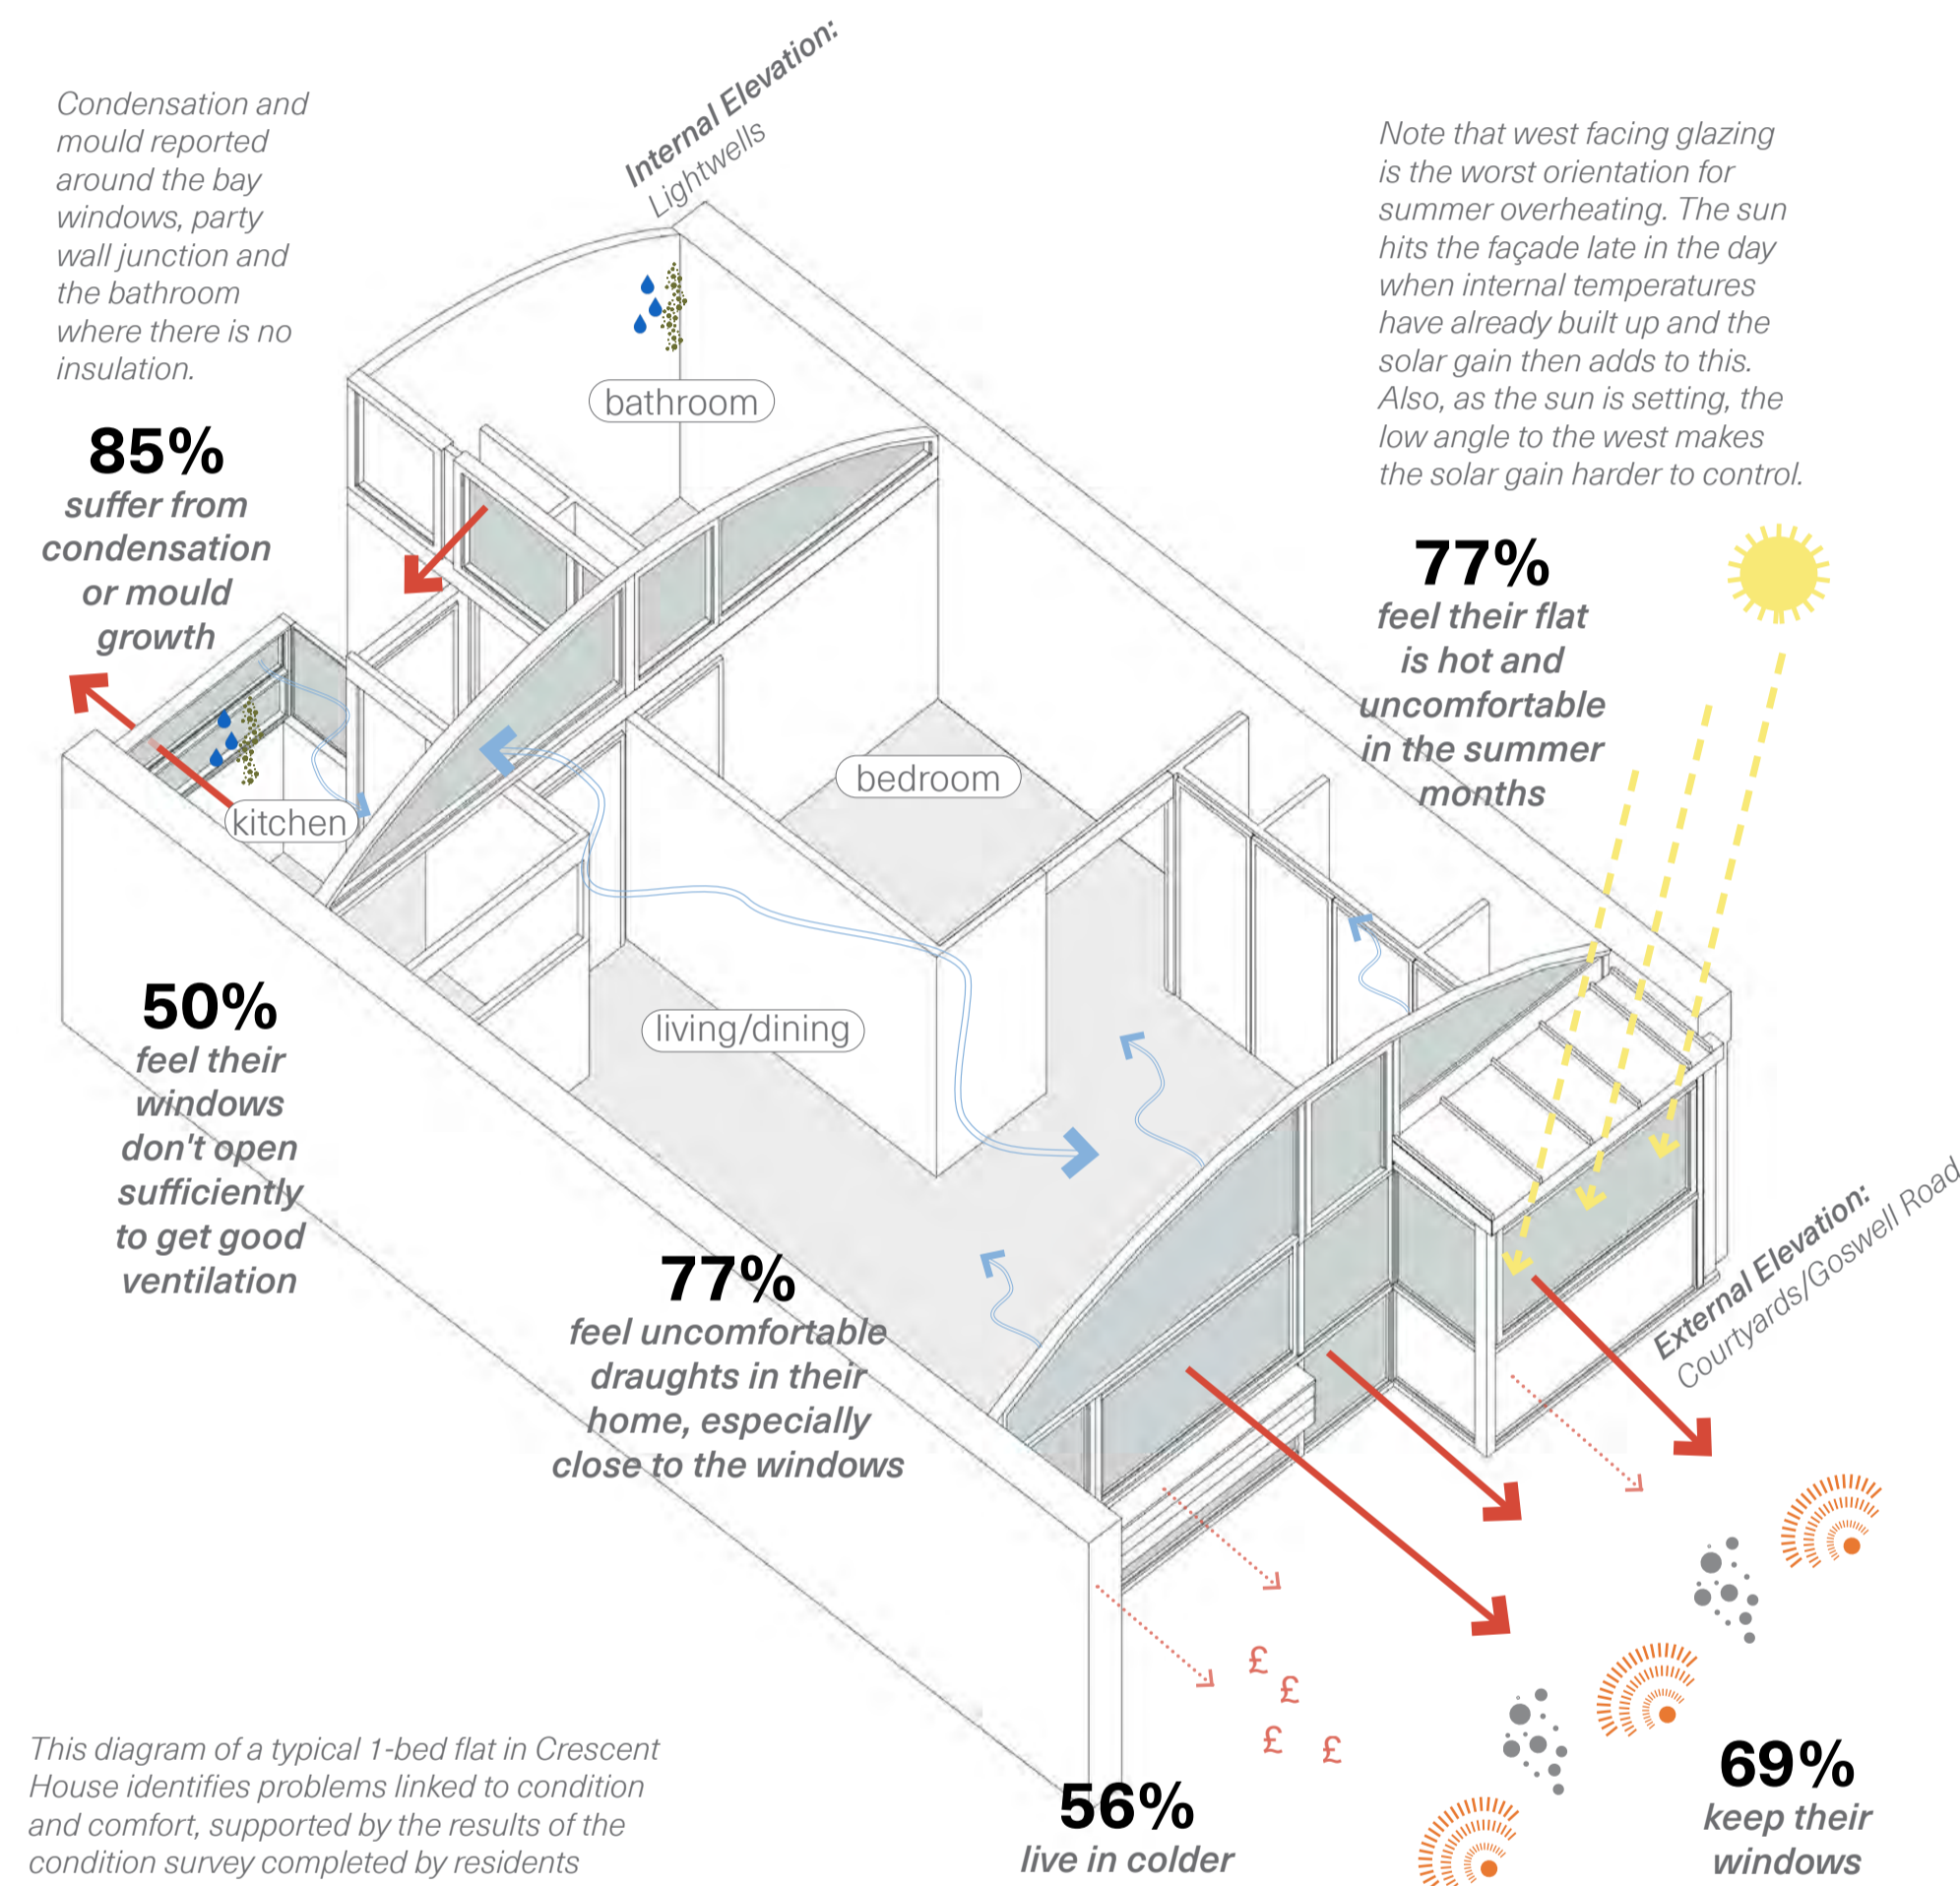
## NOW

- Key**
- Heat loss through single glazing
  - ⋯→ Heat loss through external walls & thermal bridges (incl. window frame)
  - ~> Uncontrolled incoming air (draughts)
  - > Excess solar gains (summer)
  - Noise pollution
  - Air pollution
  - Mould growth
  - Condensation build-up

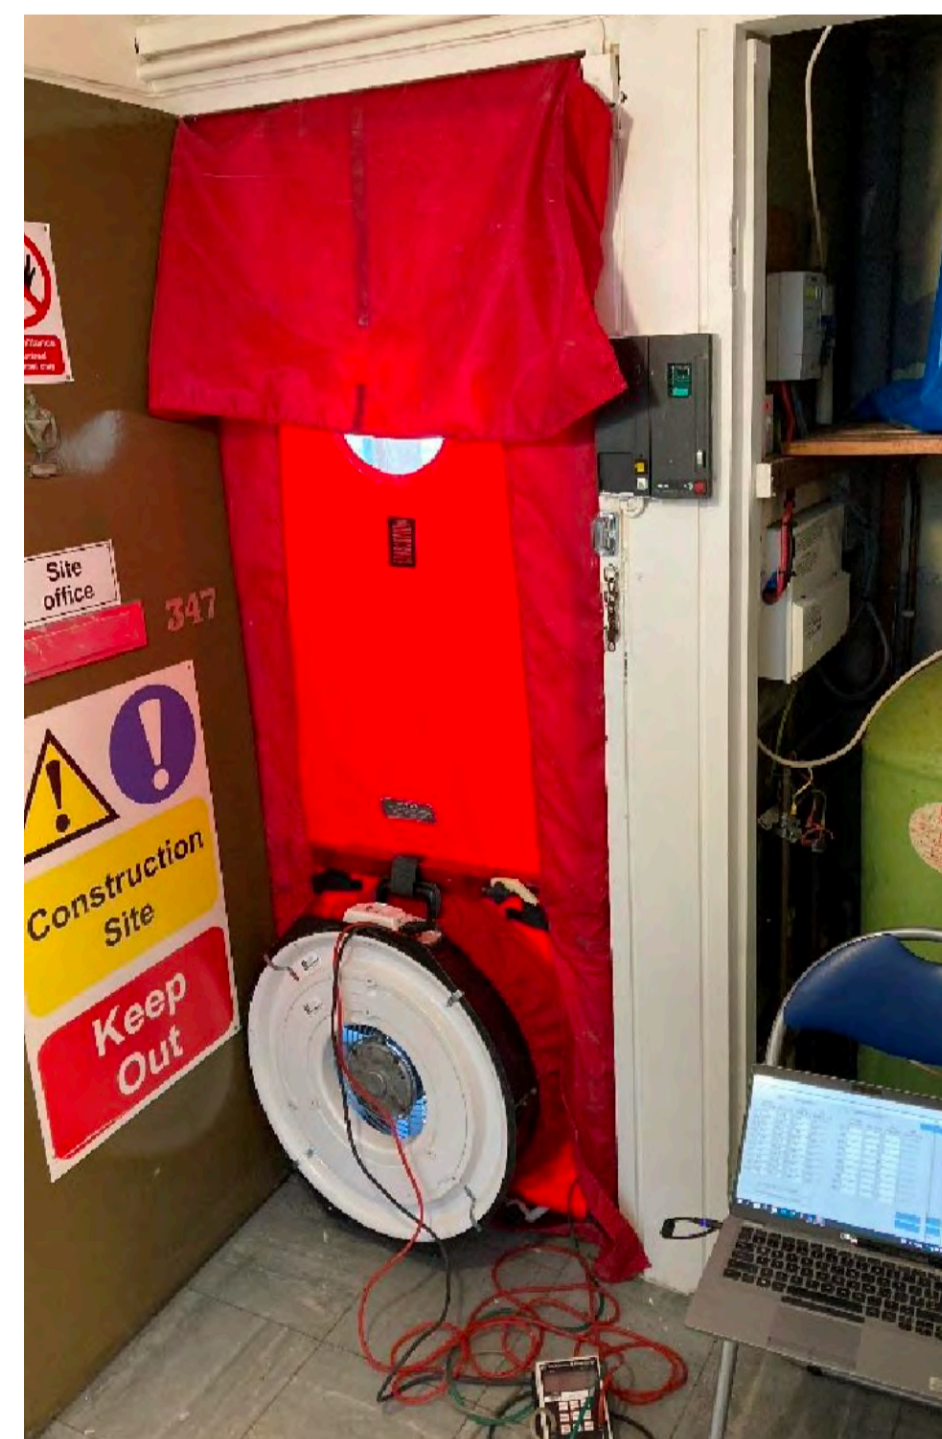
The airtightness of the external façades was tested using a blower door to pressurise the apartment, and smoke pens to show air leakage paths. This showed significant air leakage paths around window frames. The test will be re-run following refurbishment of the window frames & installation of the vacuum glazing to measure the reduction of air leakage.

Above: blower door test equipment mounted in the front door

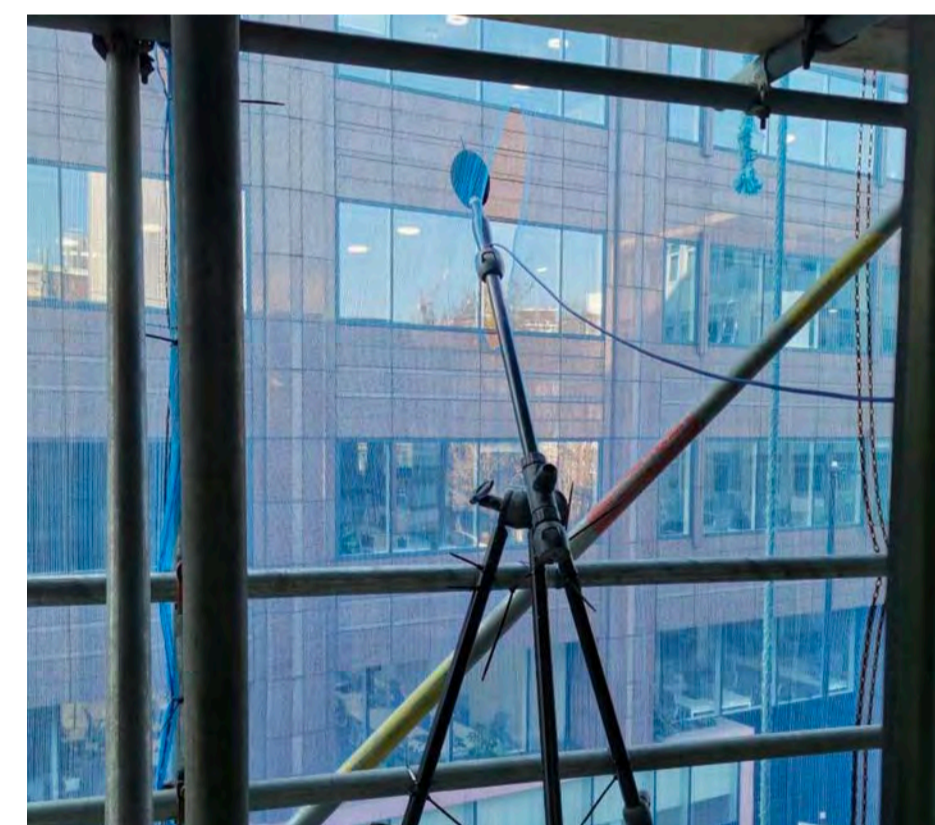
The amount of noise admitted through the façade on Goswell Road was tested using sound meters/microphones measuring the noise externally & internally for a period of seven days. This showed that the existing windows have poor acoustic performance, which is likely to be made worse by the significant air leakage paths. The test will be re-run following refurbishment of the window frames & installation of the vacuum glazing to measure the reduction in noise transmission.

Above: microphone measuring external noise levels

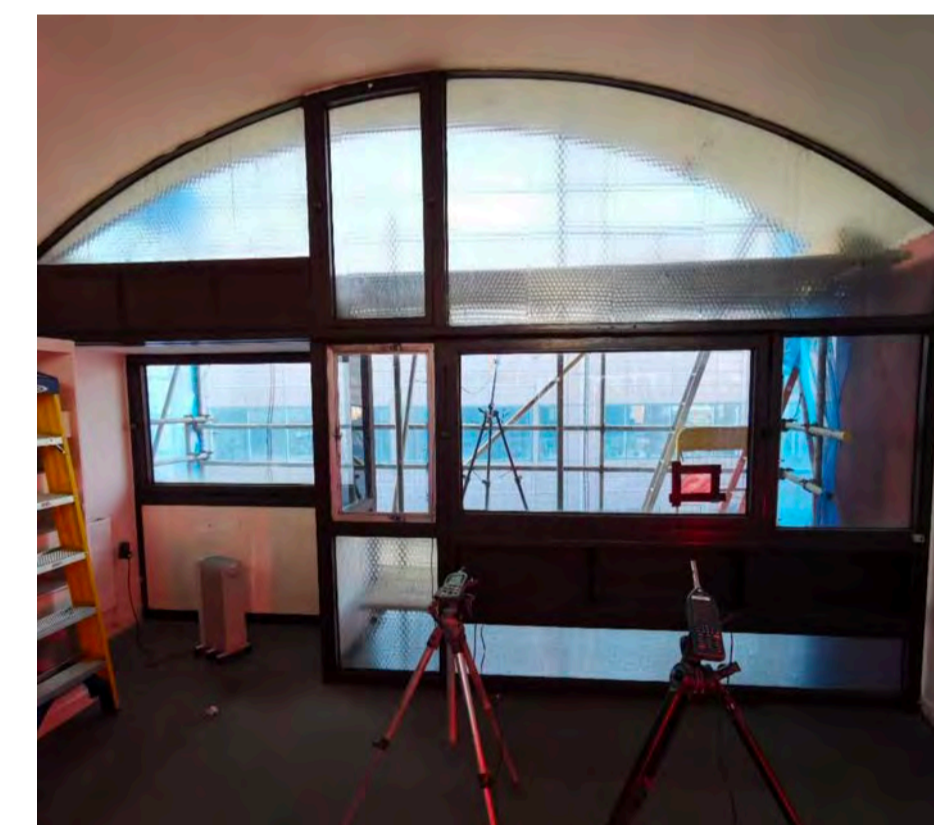
Above: microphone/sound meter measuring internal noise levels
